2015 Kane County Underwater Inspection Report

STRUCTURE NO. 045-3097

Fabyan Parkway / F.A.P. 0363

October 13, 2015

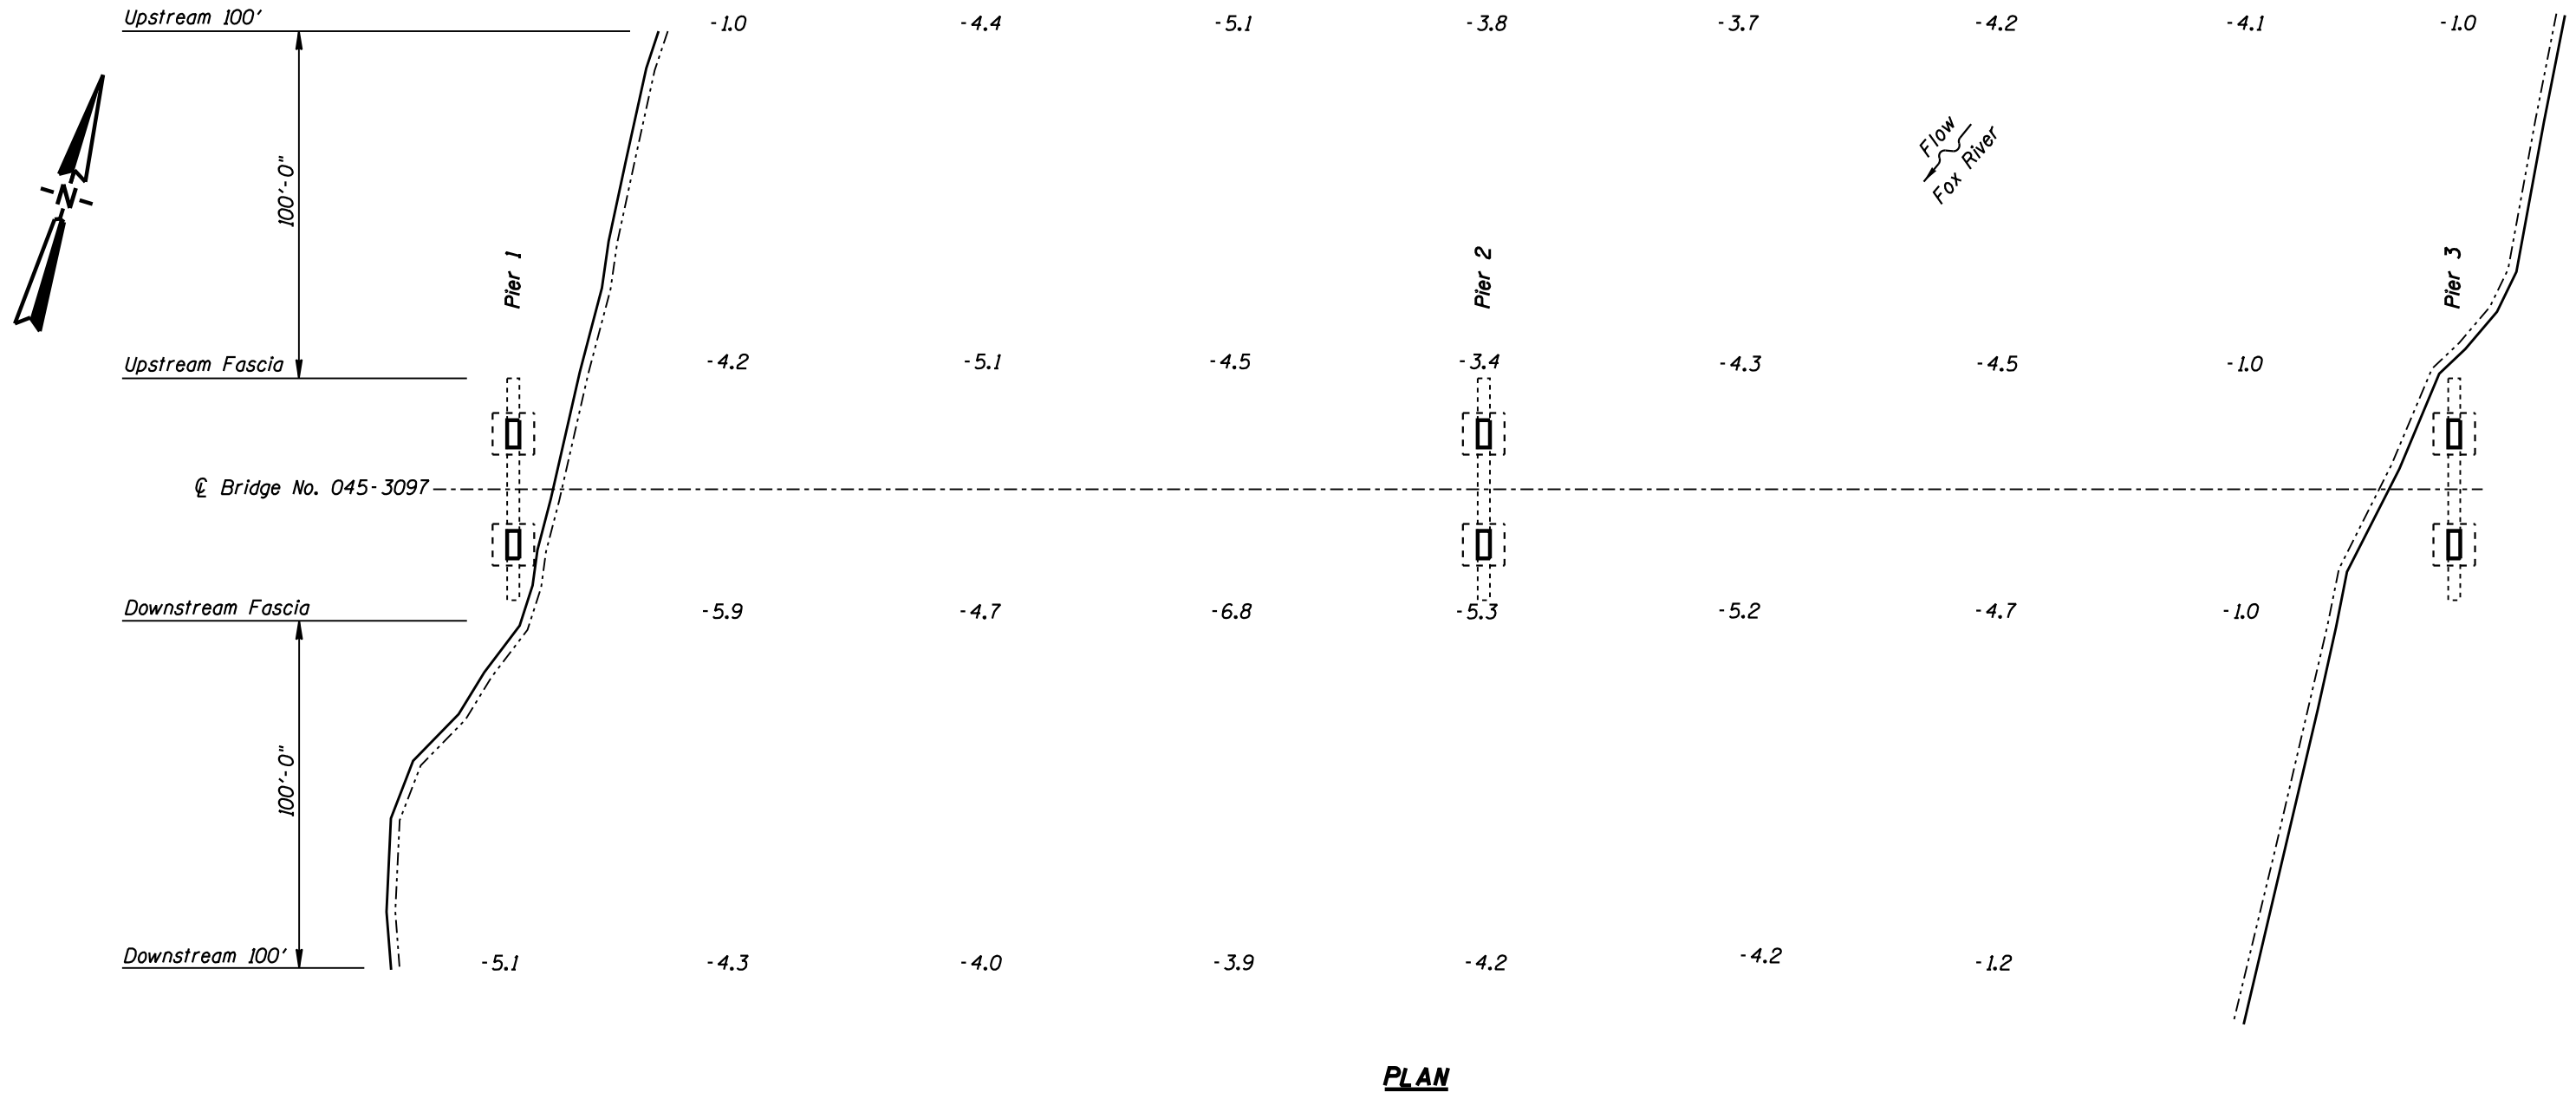
SOUNDING PLAN

The channel bottom around Pier 2 typically consists of riprap up to 2 feet in diameter and 2 to 3 feet deep. Refer to Figure 2 in Appendix A for a Sounding Plan and Figure 3 in Appendix A for the Pier 2 Plan, Elevations, Soundings, and Inspection Notes.

- Continue to monitor channel bottom to ensure that no significant degradation is occurring.
- Monitor areas of section loss on the shafts of Pier 2 for increased loss or exposed reinforcement.
- Continue to monitor scaling to safeguard against any progression.
- Inspection interval to not exceed 60 months in accordance with the National Bridge Inspection Standards (NBIS).
- Complete soundings during or soon after significant flood occurrences.

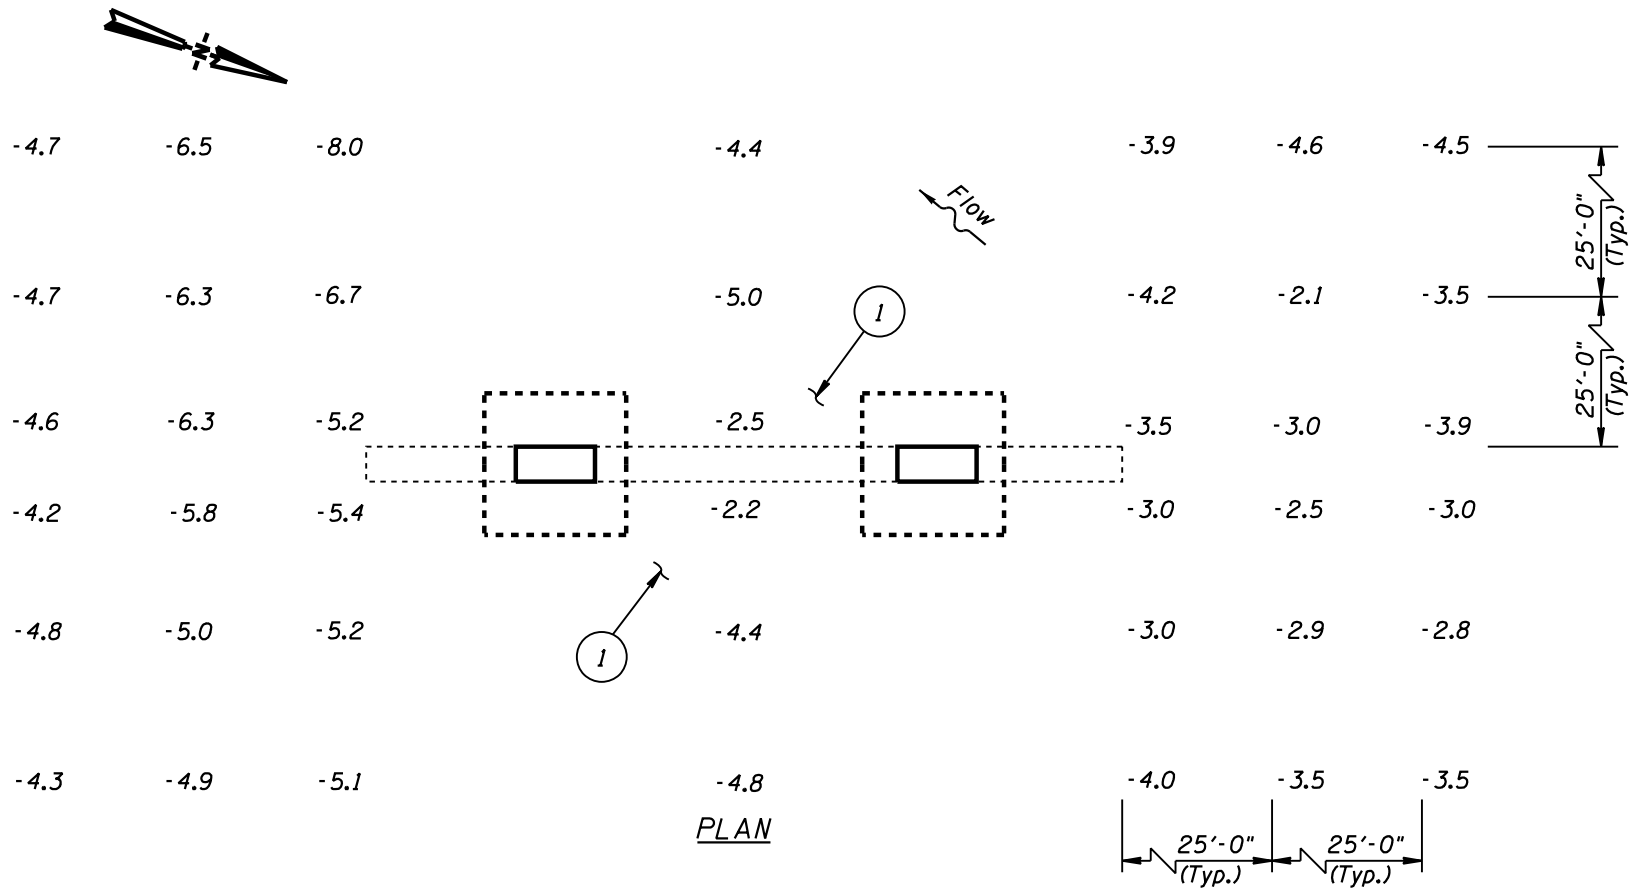
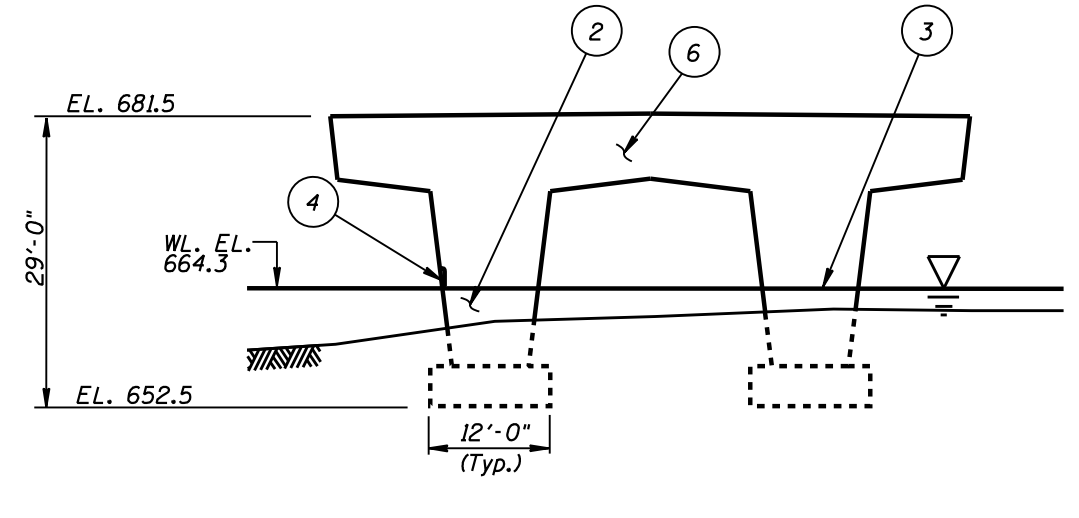
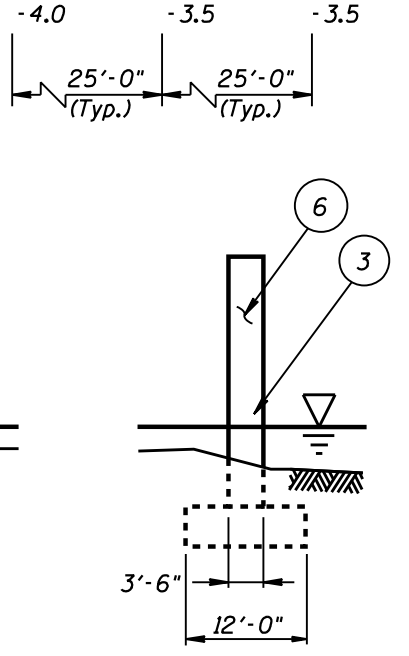
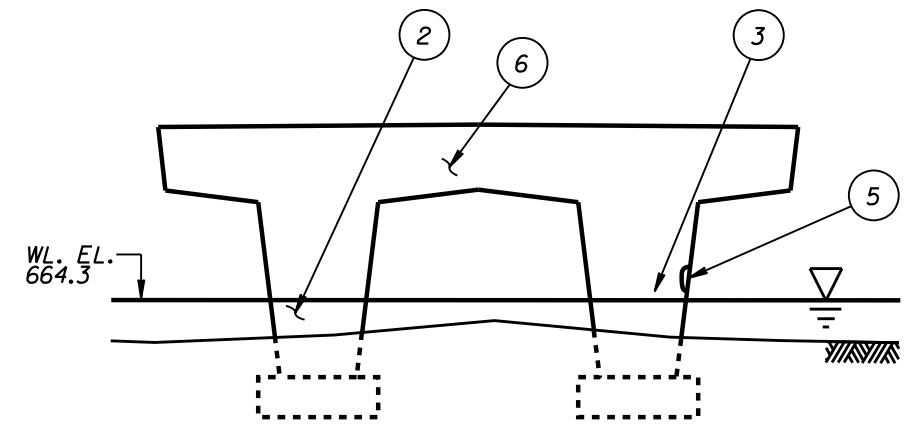
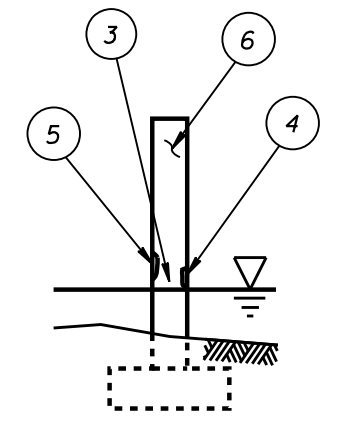
- 1 The channel bottom material around Pier 2 typically consisted of riprap measuring up to 2 feet in diameter and 2-3 feet deep.
- 2 Concrete surfaces were typically smooth and sound with no significant damage below the waterline.

- 3 A band of light scaling was located around both pier shafts, extending from 1.25 feet above to 0.25 foot below the waterline, with up to 1/4 inch of penetration.

- 4 An area of concrete section loss was located at the waterline at the southeast corner of the south pier shaft. The area extended from 1.25 feet above to 0.25 feet below the waterline and measured up to 8 inches wide on the south and east faces of the shaft, with up to a maximum of 2 inches of penetration and no exposed reinforcing steel.

- 5 An area of concrete section loss was located at the waterline at the southwest corner of the south pier shaft. The area extended from the waterline up 1 foot and measured up to 3 inches wide on the south and west faces of the shaft, with up to 1 inch of penetration and no exposed reinforcing steel.

- 6 The above water concrete surfaces of the pier were typically smooth and sound and exhibited heavy rust staining, most likely induced by run-off from the superstructure.

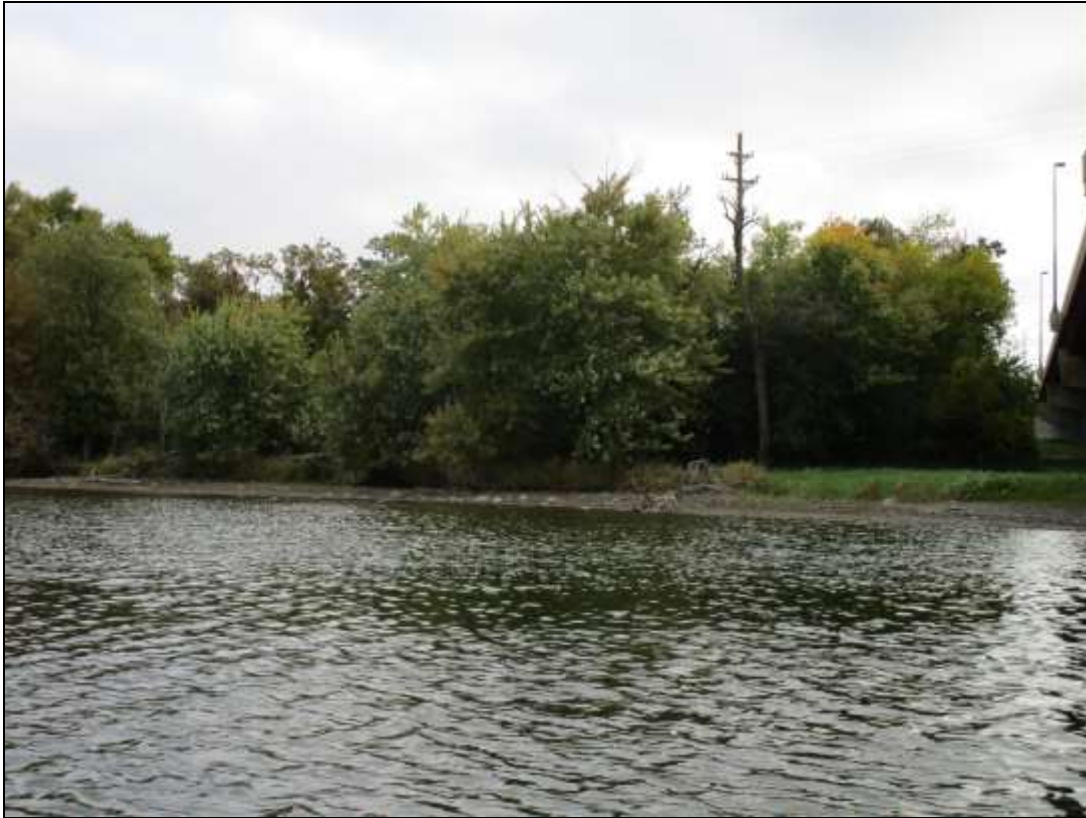
The east and west shorelines, upstream and downstream of the bridge consisted of natural embankments with light to moderate vegetation. No evidence of erosion was observed along either shoreline.

Photo No. 3
East Shoreline Upstream of Bridge, looking Northeast

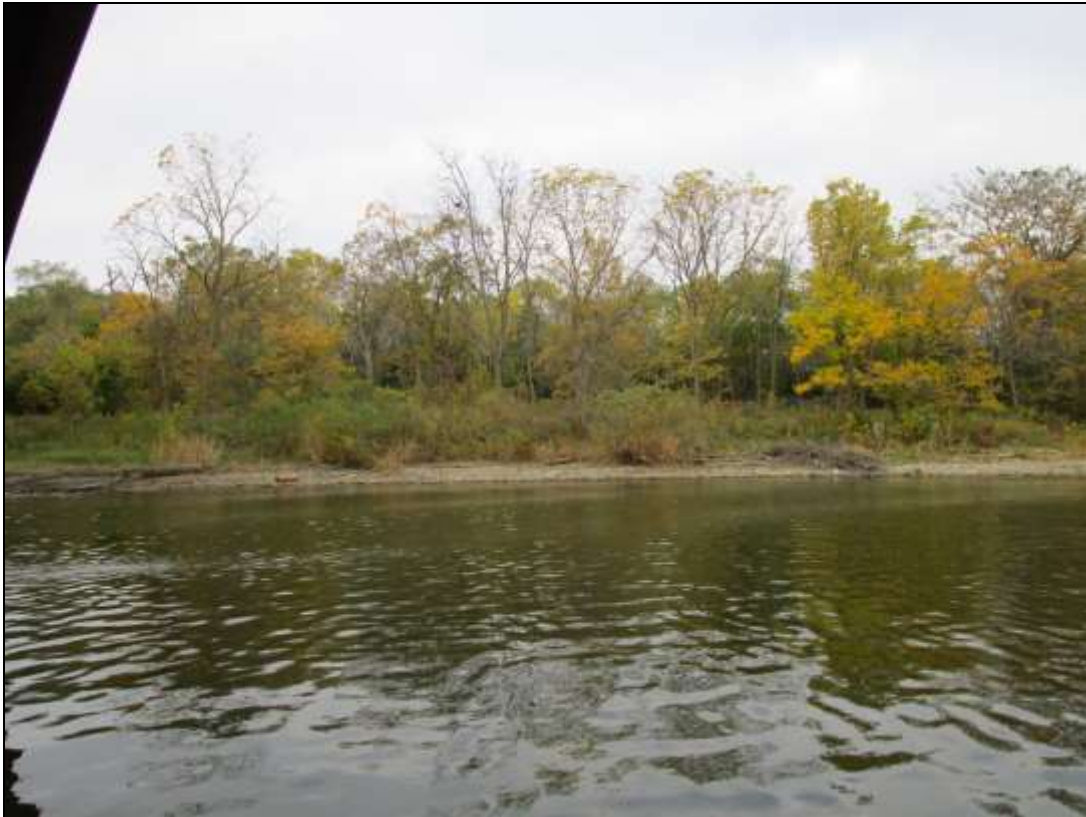
Photo No. 4
West Shoreline Upstream of Bridge, looking Northwest

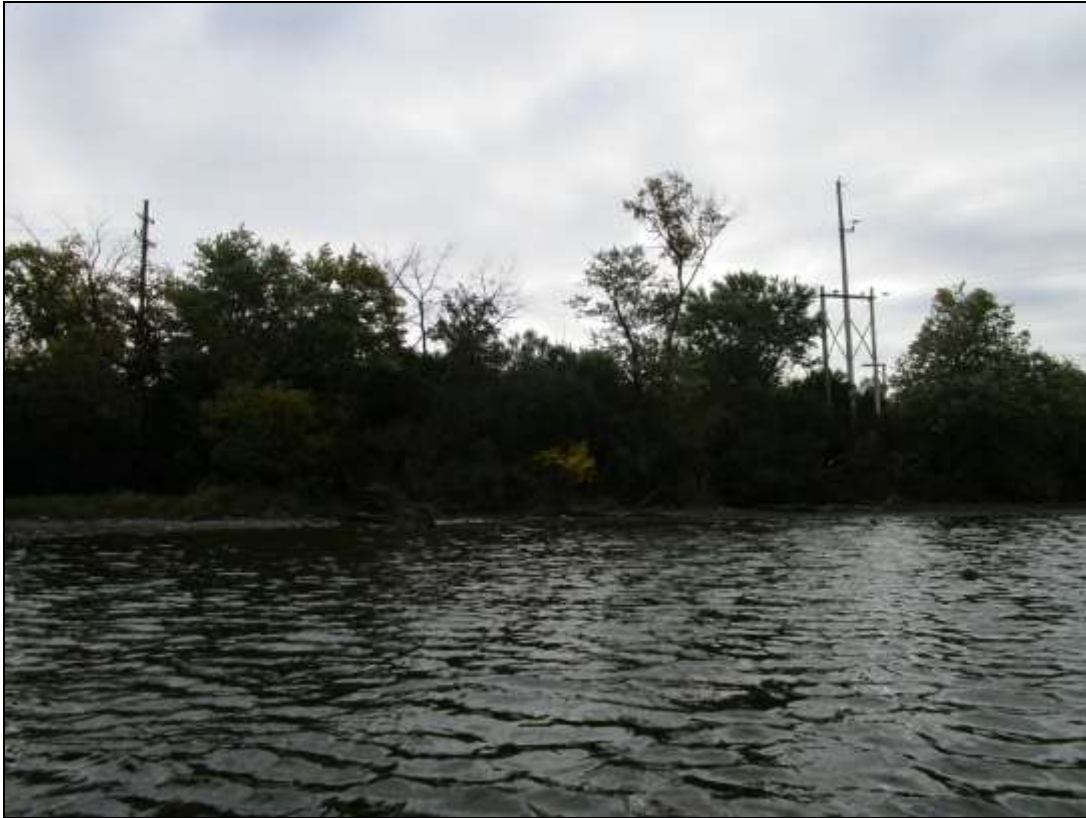
Photo No. 5
East Shoreline Downstream of Bridge, looking Southeast

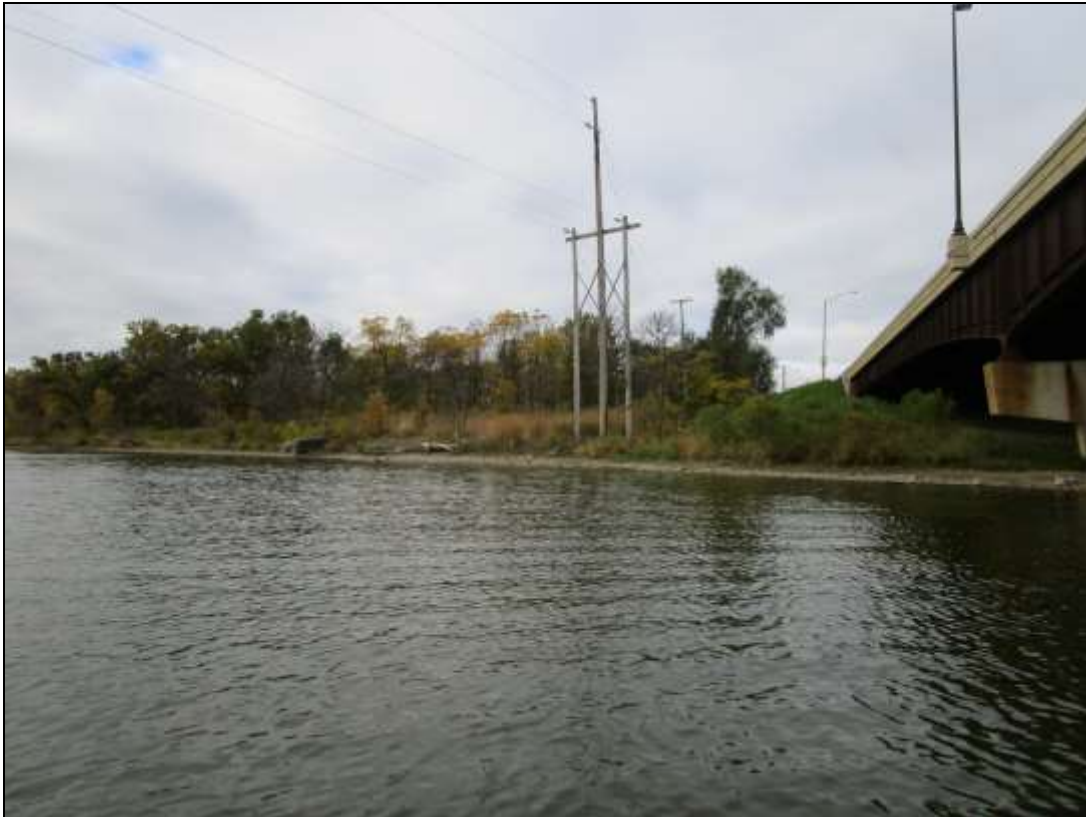
Photo No. 6
West Shoreline Downstream of Bridge, looking Southwest

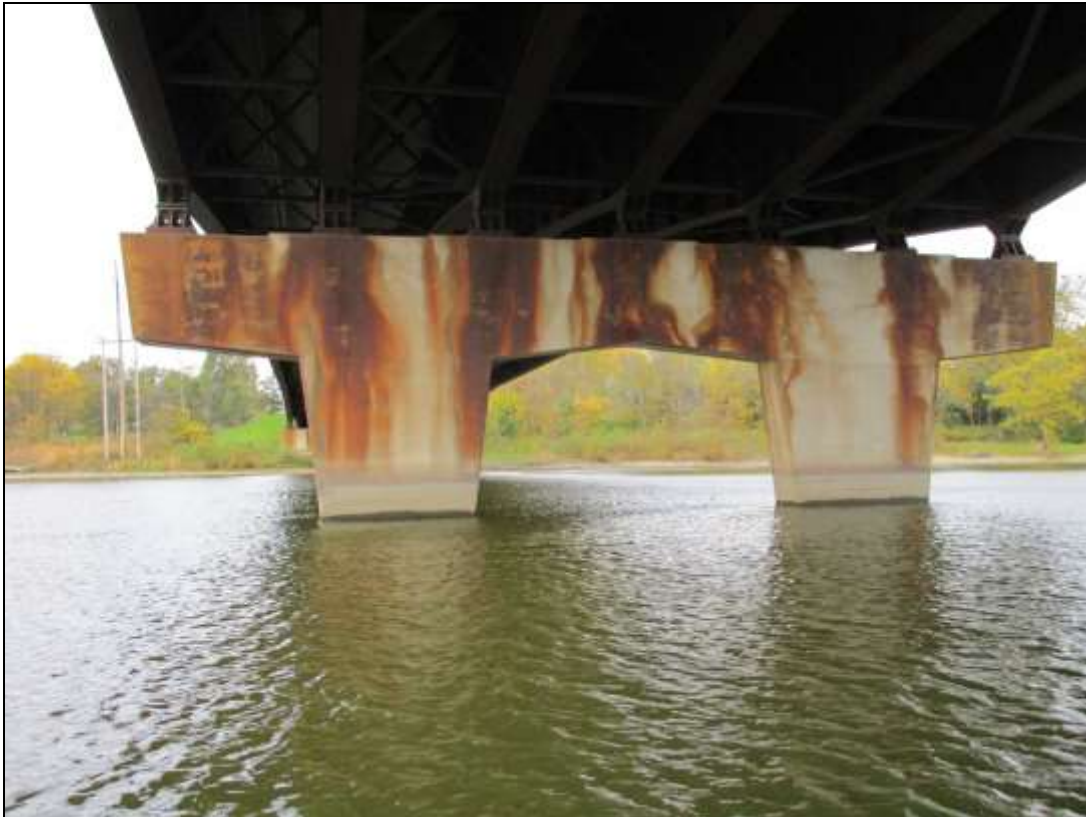
Pier 2 is in **satisfactory condition** with no significant structural defects. No footing exposure was observed during the inspection. The concrete was typically smooth and sound below the waterline, with only slight scaling present around both pier shafts extending from 1.25 feet above to 0.25 feet below the waterline, with up to 1/4 inch of penetration (see *Photo No. 10*). There are two locations of concrete section loss, on the southeast and southwest corners of the south pier shaft. The southeast corner spall is approximately 1.5 feet high and extends 8 inches wide on the south and east faces of the shaft with up to a maximum of 2 inches of penetration (see *Photo No. 11*). The southwest corner is approximately 1 foot in height and extends 3 inches wide on the south and west faces of the shaft, with up to 1 inch of penetration (see *Photo No. 12*). No reinforcement is exposed at either location. The above water concrete of the pier is typically smooth and sound with heavy rust staining, a result of run-off from the superstructure.

Photo No. 8
Pier 2 Elevation (East Face Shown), looking West

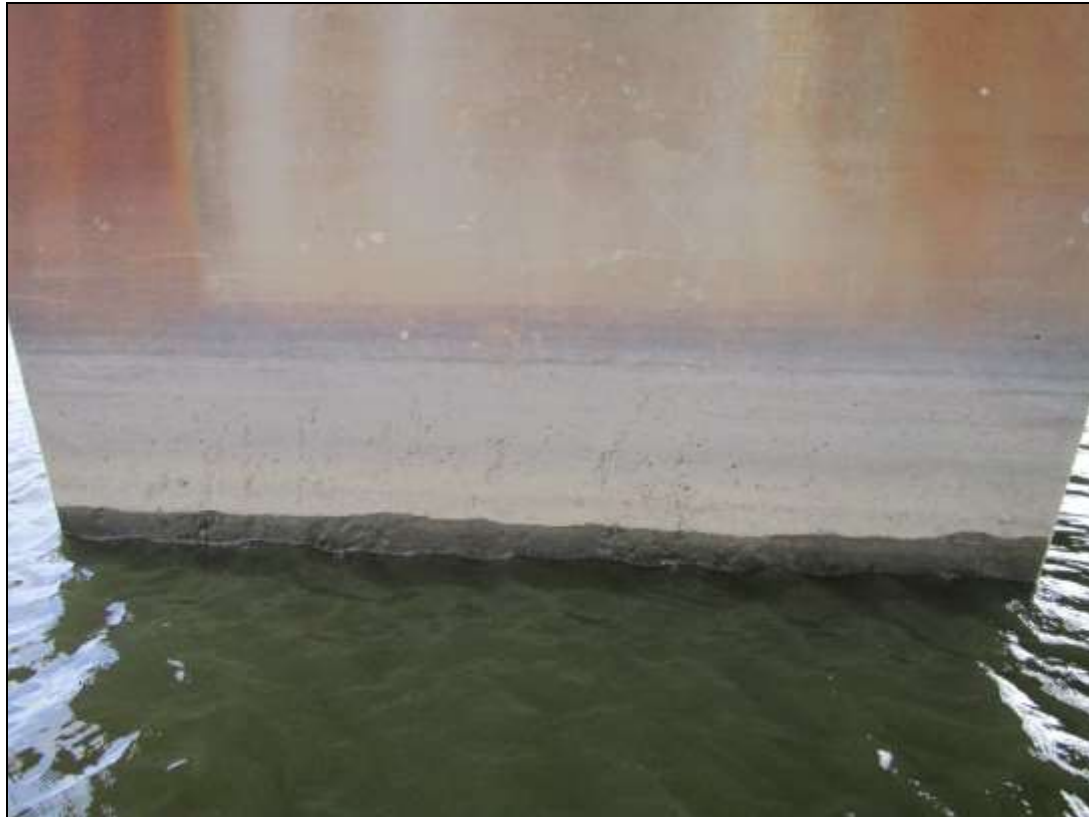
- The minor scaling around the shafts of Pier 2 are also not structurally significant at this time given the small surface area in relation to the overall size of the pier.

Photo No. 10
South Pier Shaft of Pier 2 Scaling (West Face Shown), looking East

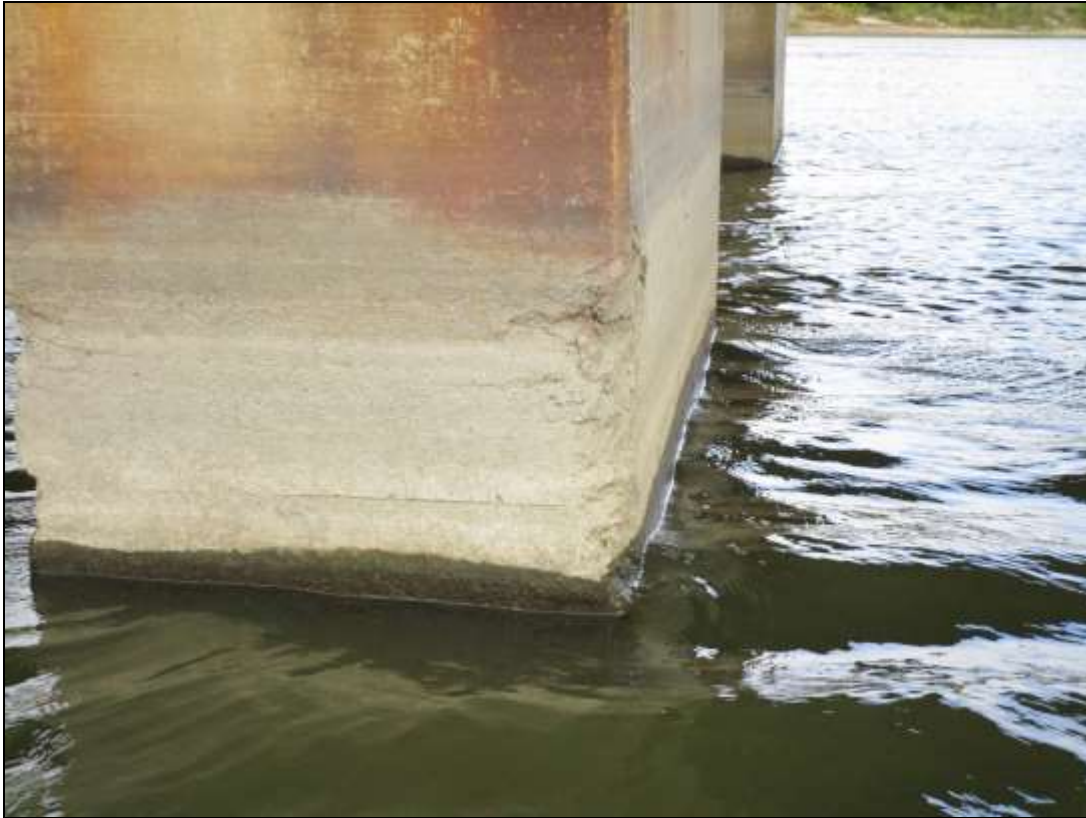
Photo No. 11

- The areas of section loss at the waterline on the south shaft of Pier 2 are not affecting the structural capacity of the pier and they do not seem to have worsened since the previous inspection.

Southeast Corner Spall on the South Pier Shaft of Pier 2, looking North

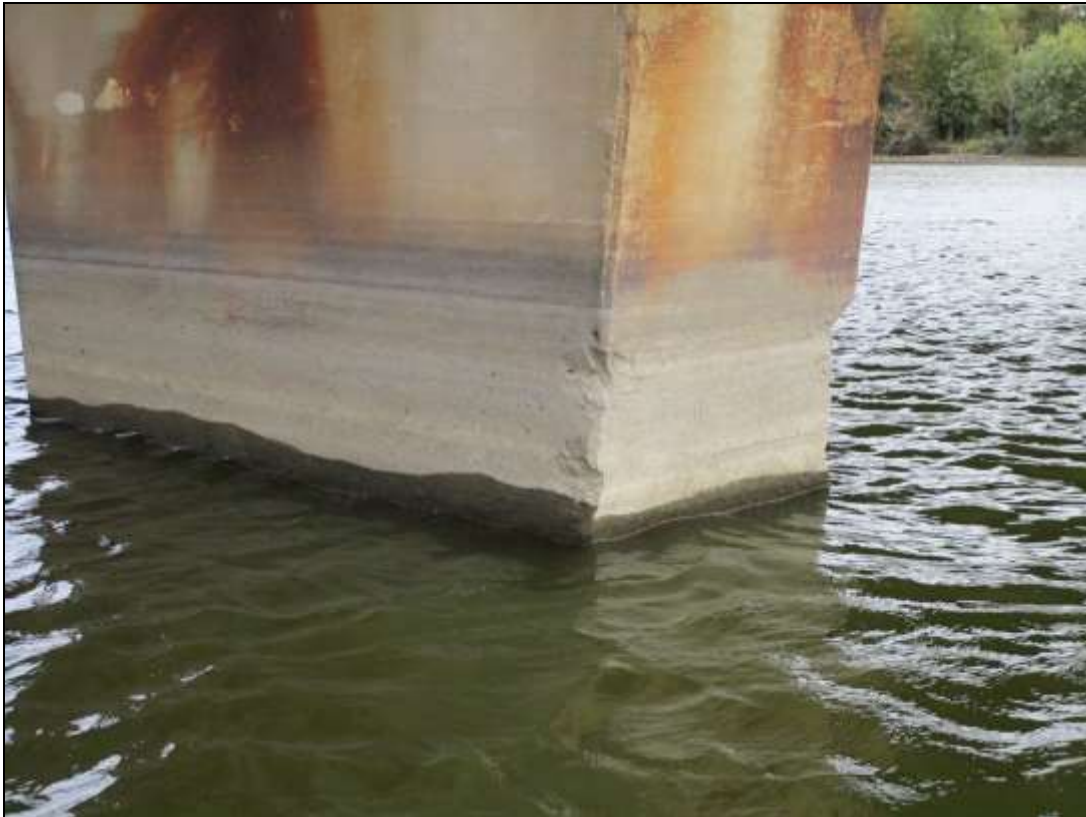
Photo No. 12

Southwest Corner Spall on the South Pier Shaft of Pier 2, looking Northeast
