**2018 QBS  
Request for Statement of Interest (SOI)  
Kane County Division of Transportation (KDOT)  
2019 Structure Inspections  
Section Number 18-00501-00-EG**

# Bridge Inspection Report

## STRUCTURE NO. 045-3166

Stearns Road / FAP 361 over Fox River

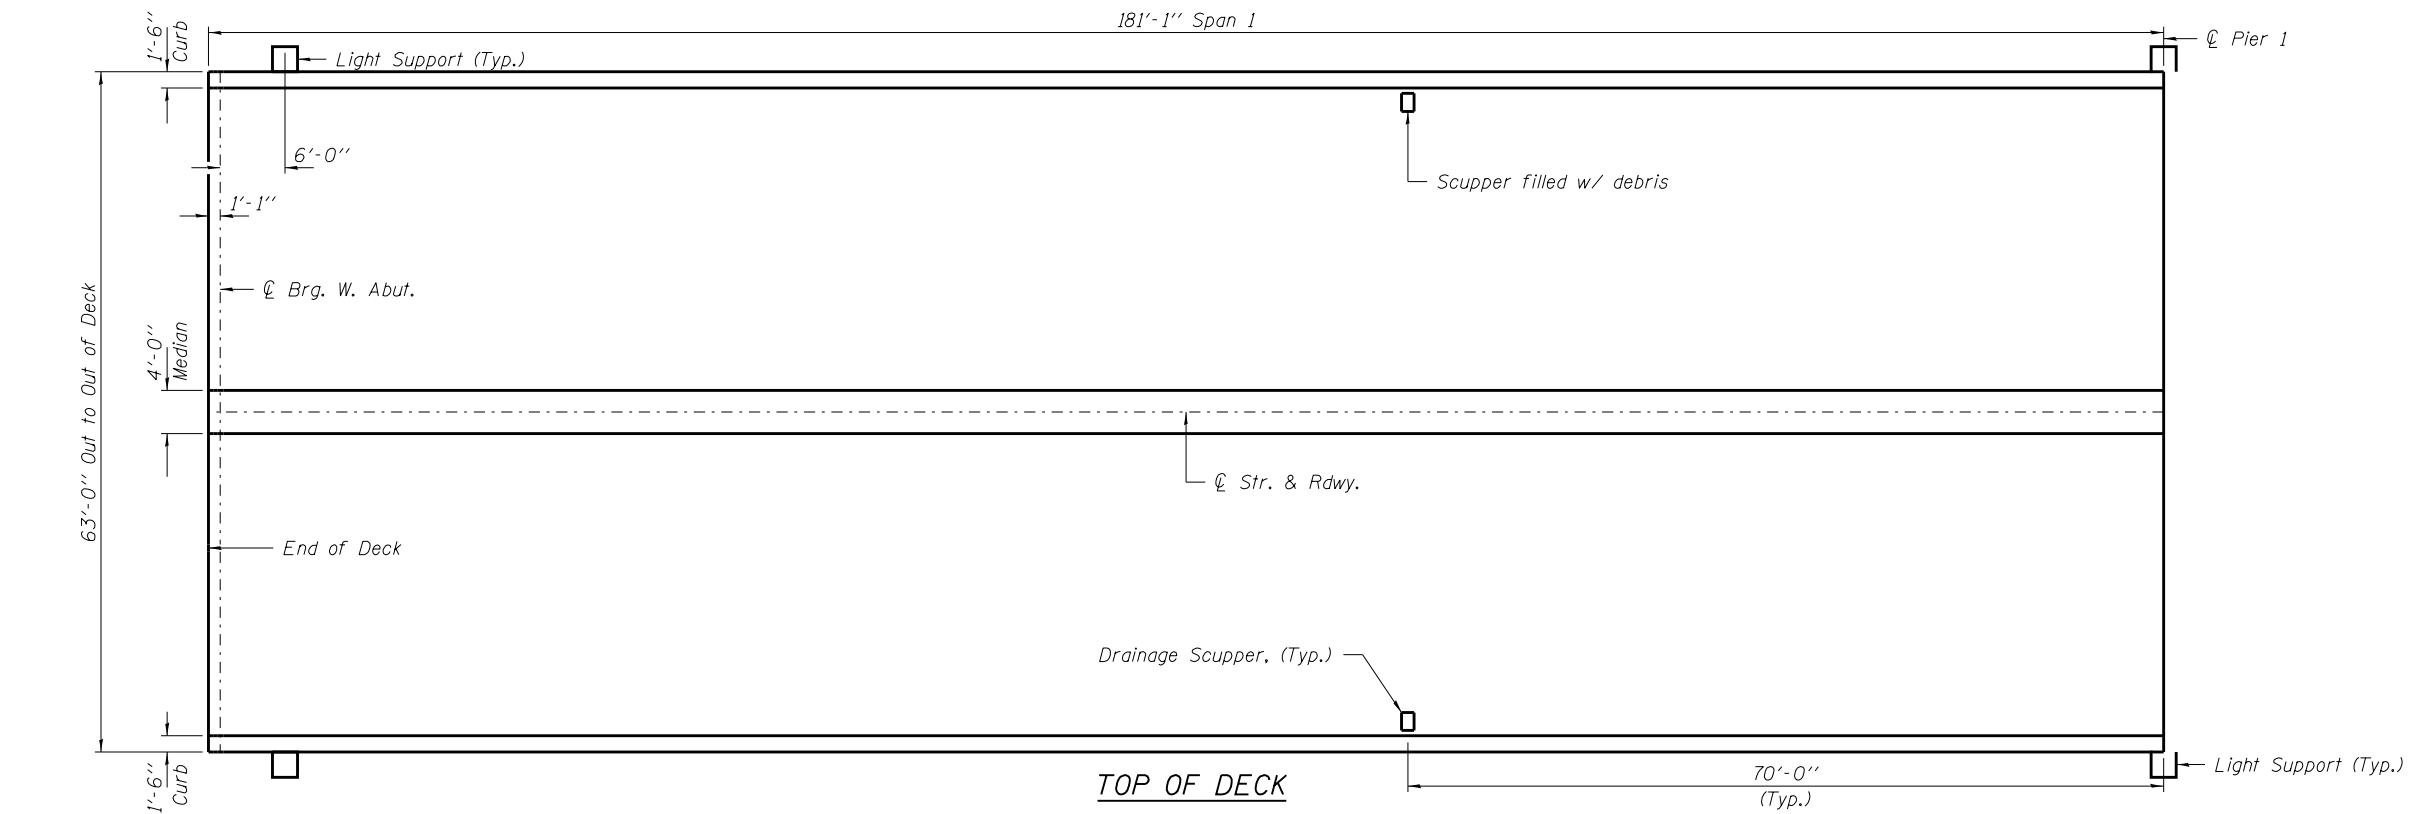
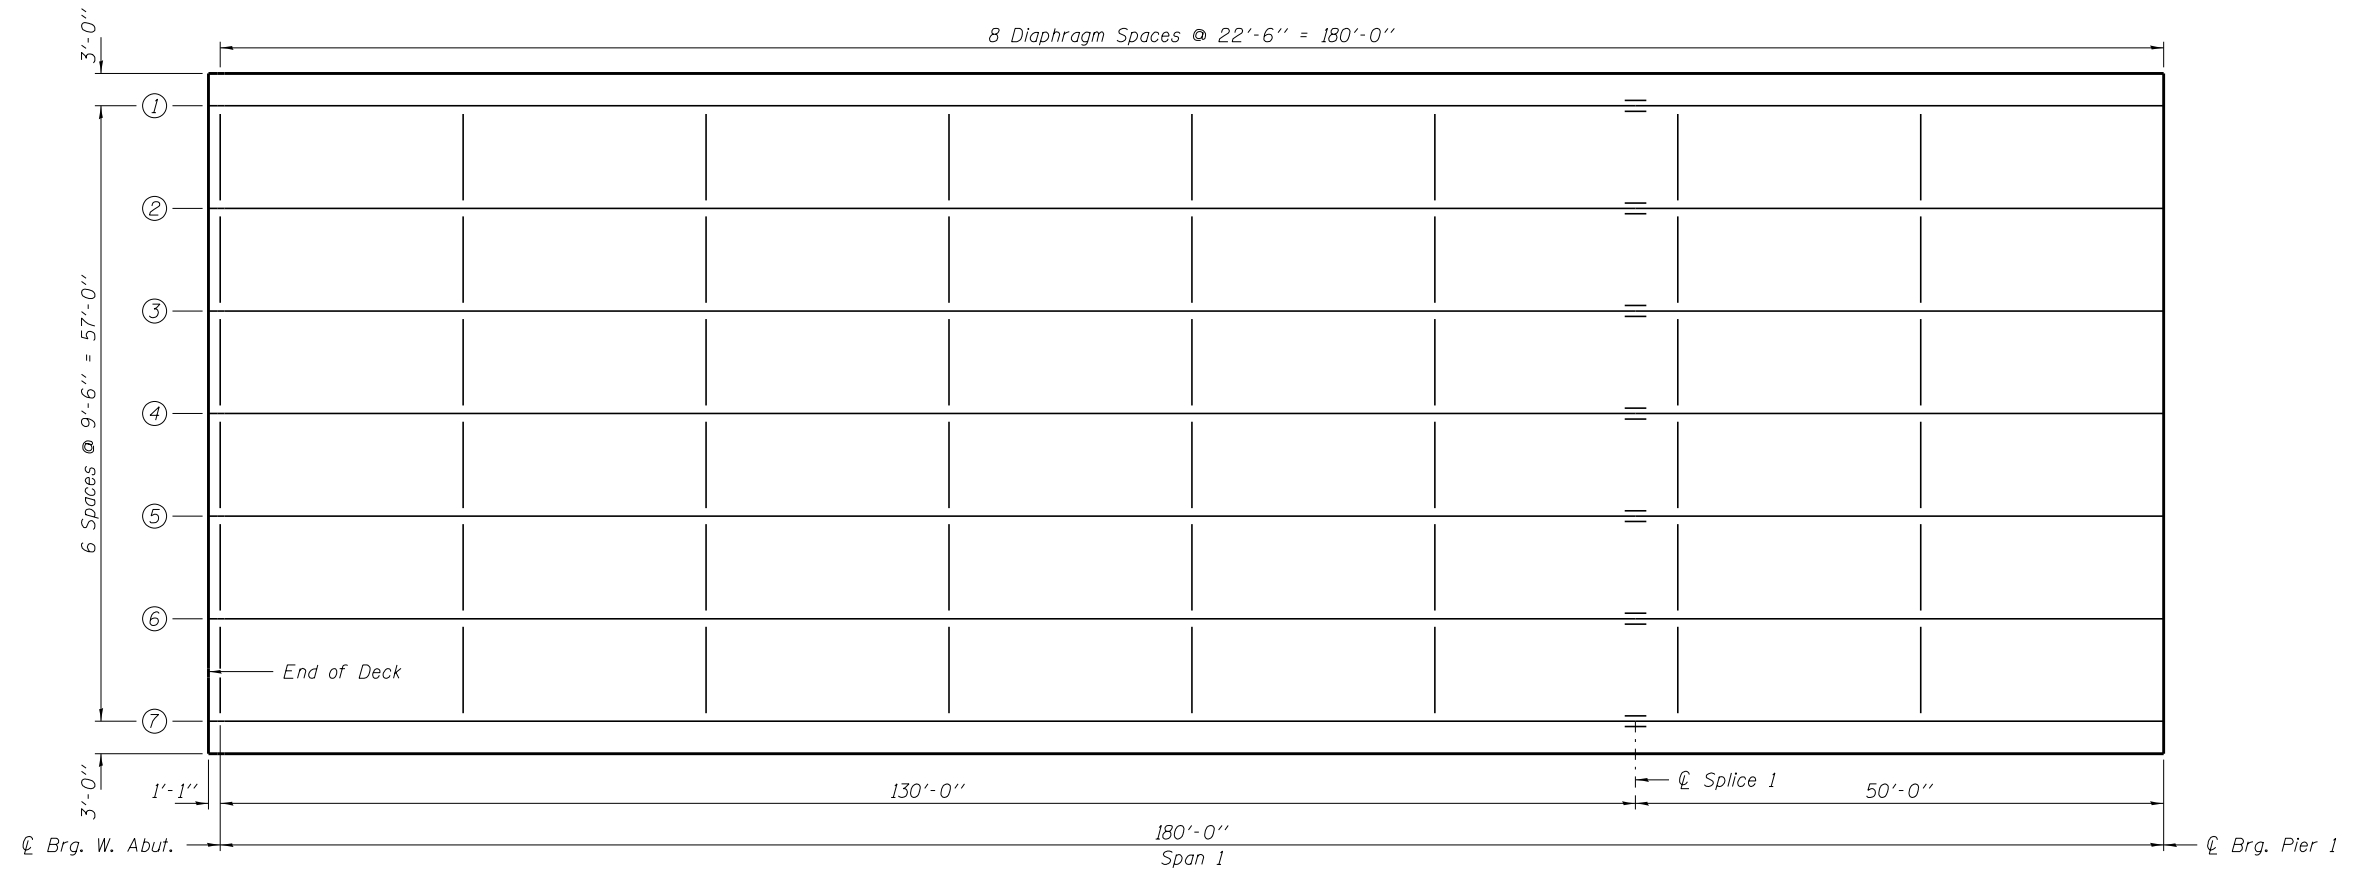
**UNDERSIDE OF DECK**

Notes: Transverse HL cracks in top of deck, typ. at 5' spacing.

Transverse HL cracks with efflorescence along bottom of deck, typ. at 5' spacing.

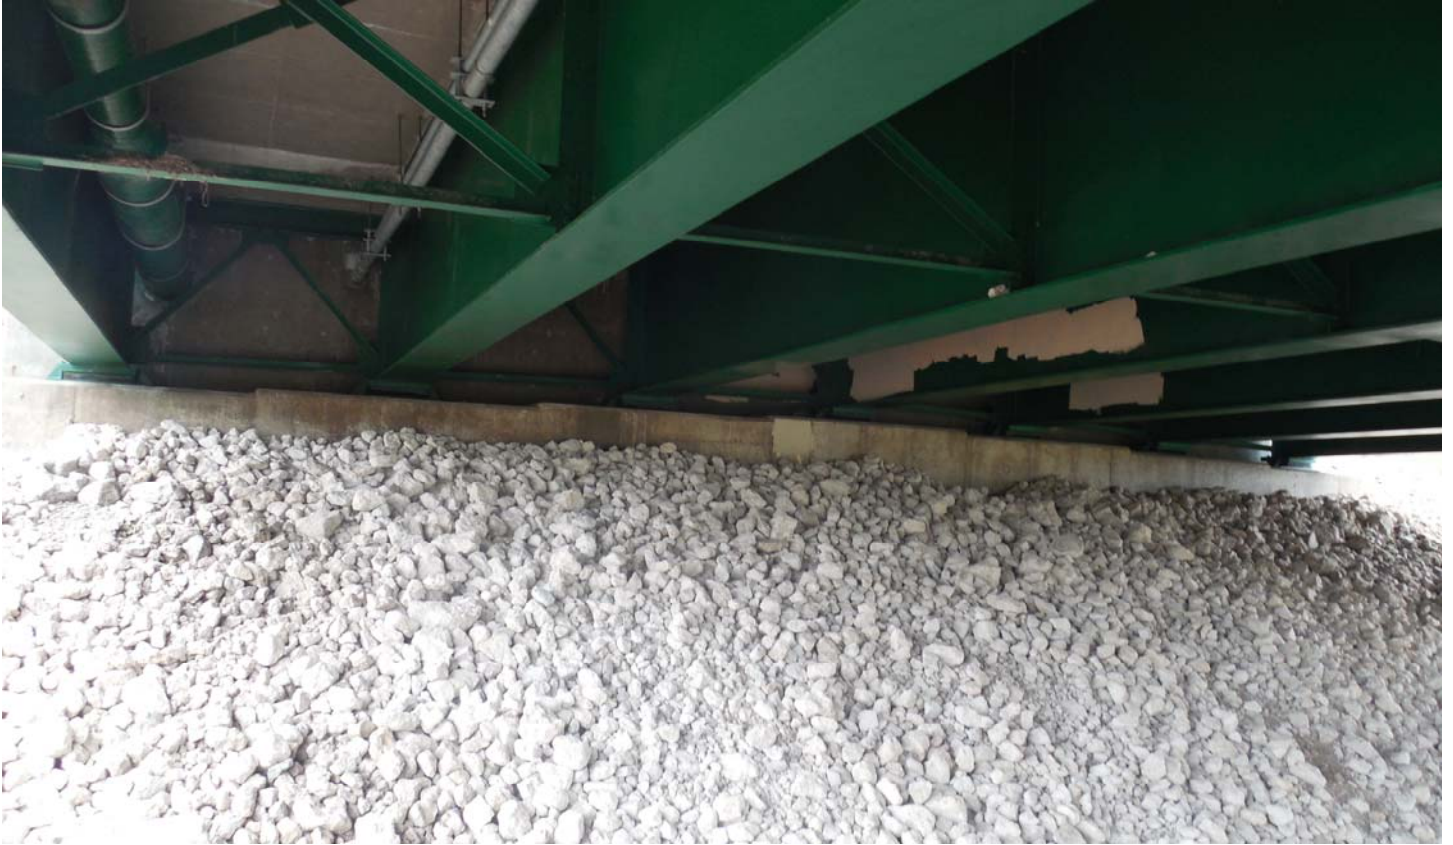
- The concrete abutments / wingwalls are smooth with no noticeable defects.

Photo 1 - East Abutment

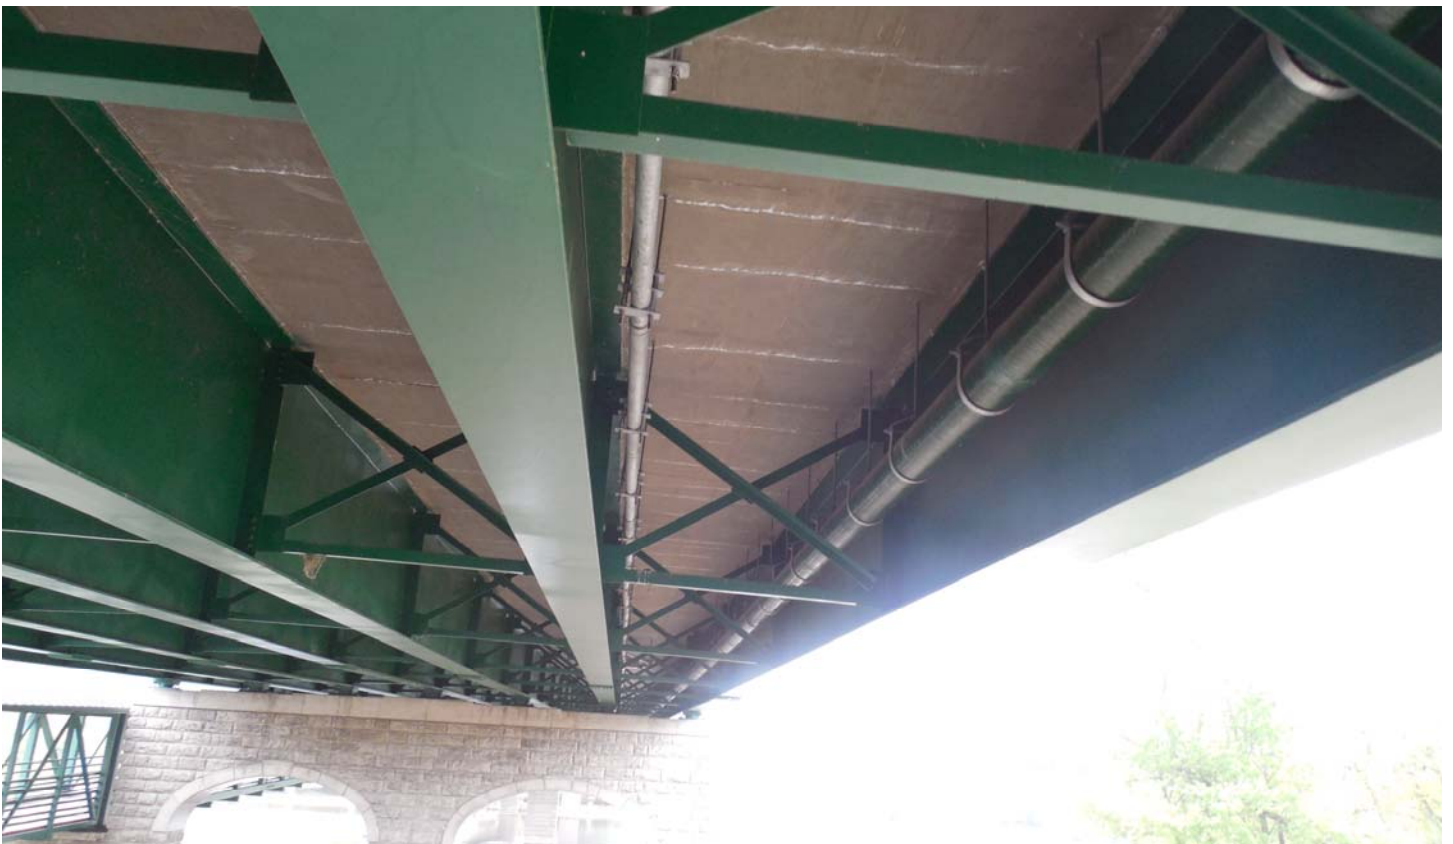
- The full depth transverse cracks at 5' intervals are leaching underside of the deck.

Photo 2 - Underside of Deck - North Bay of Span 5

- Seal cracks in the bridge deck.

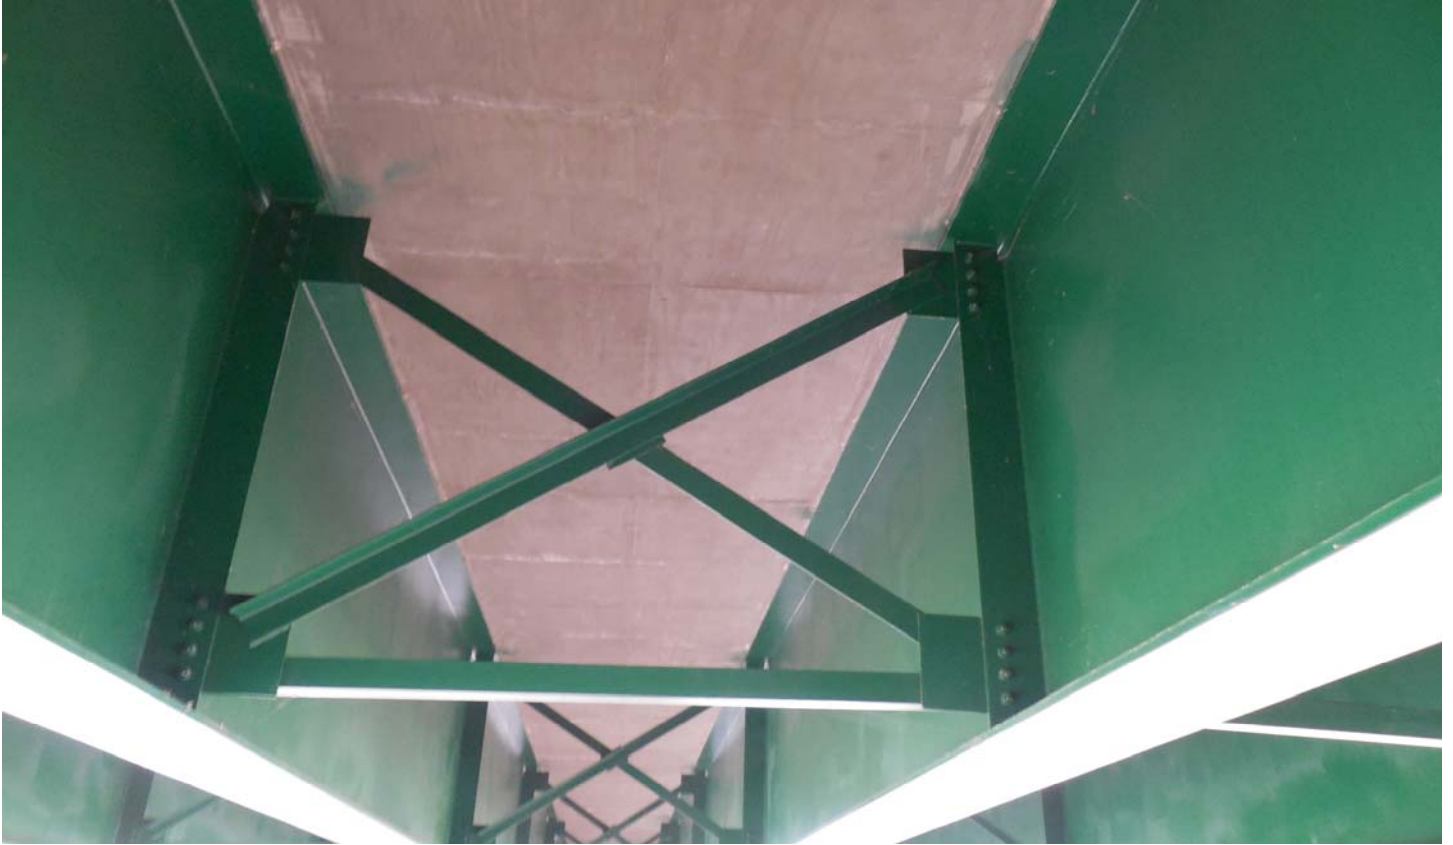
Photo 3 - Span 5 - Typical Diaphragm

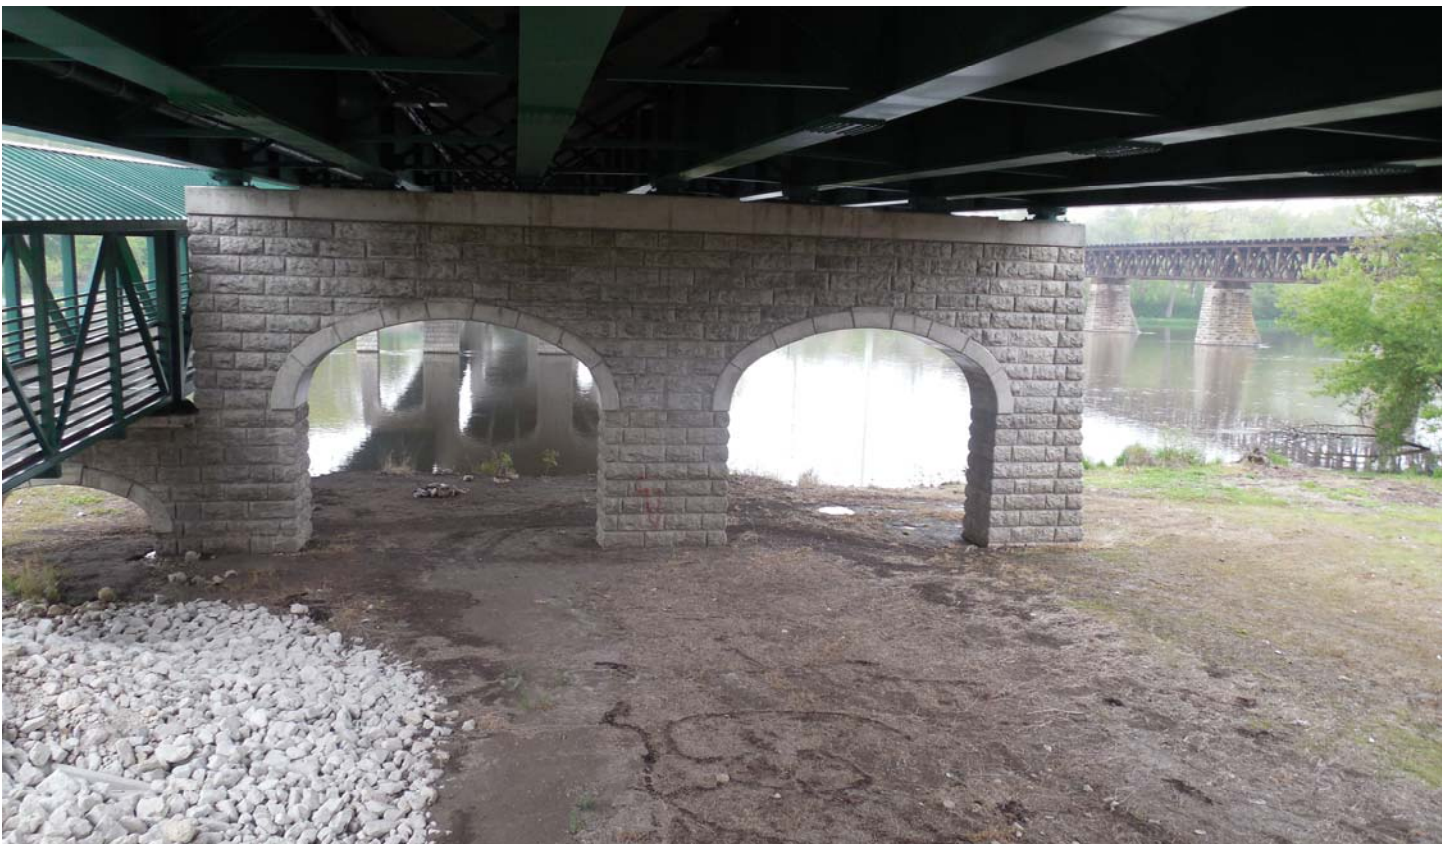
- The concrete piers with a decorative form liner have no noticeable defects.

Photo 4 - East Face of Pier 4

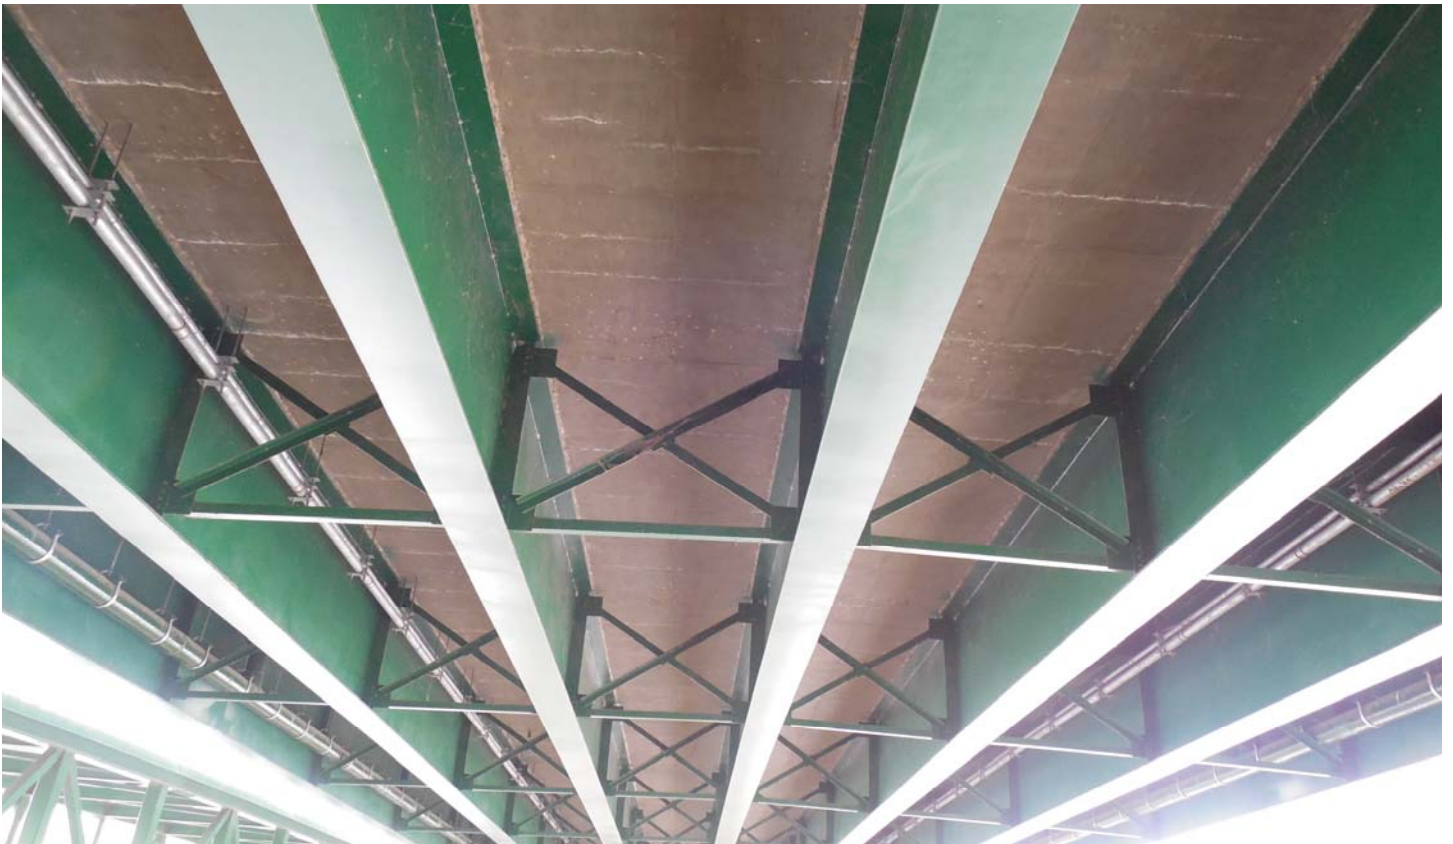
Photo 8 - Underside of Deck in Span 4

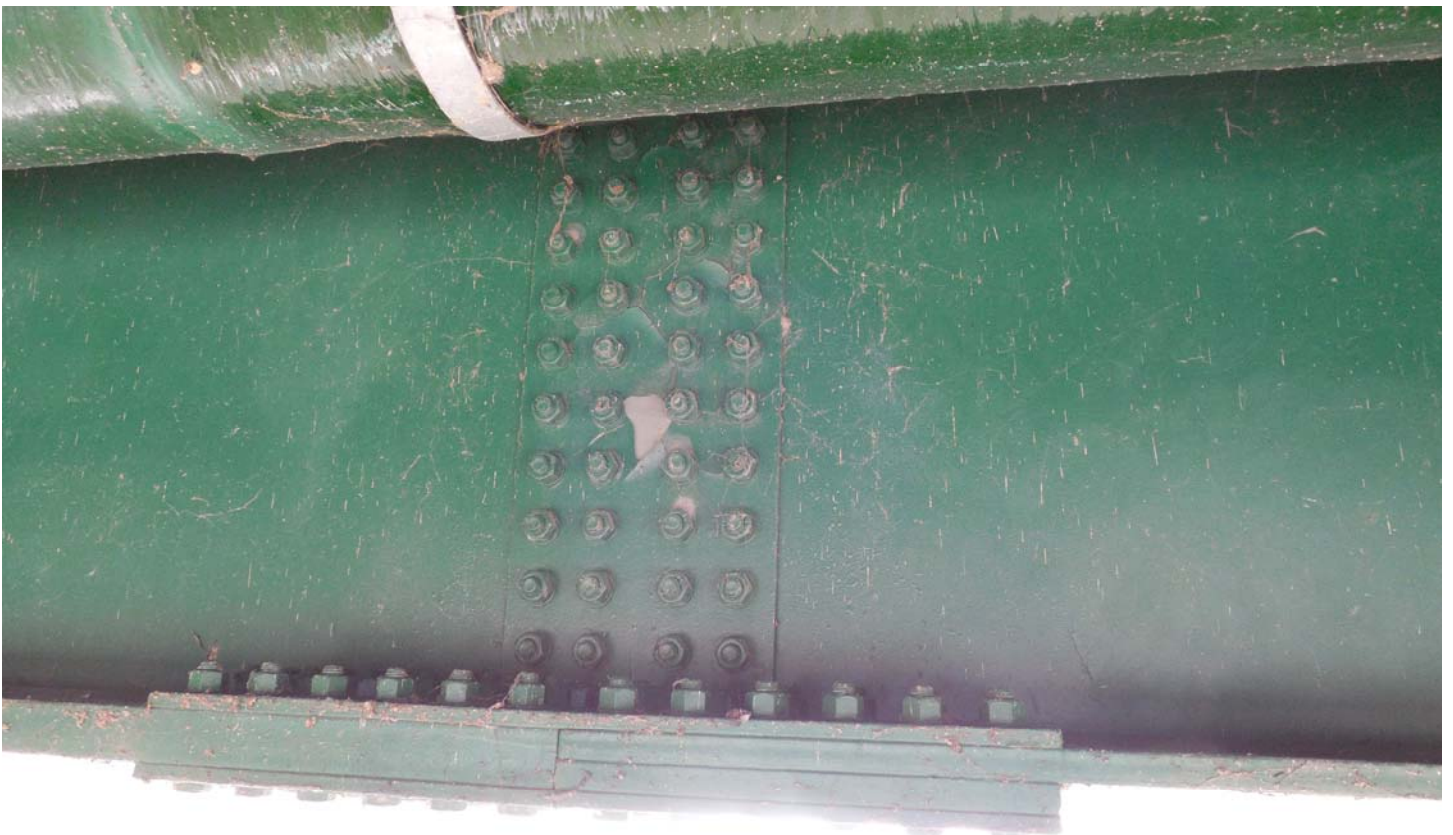
- There are a few small localized areas of paint coating flaking on the interior girders with no surface corrosion of note.
- The deck drainage system collects in two 12" diameter pipes suspended in the north and south superstructure bays.
- The south drain is leaking approximately 10 feet from the east abutment. (See Photo No. 72).

Photo 14 - Span 4 - Paint Failure on Splice Plate

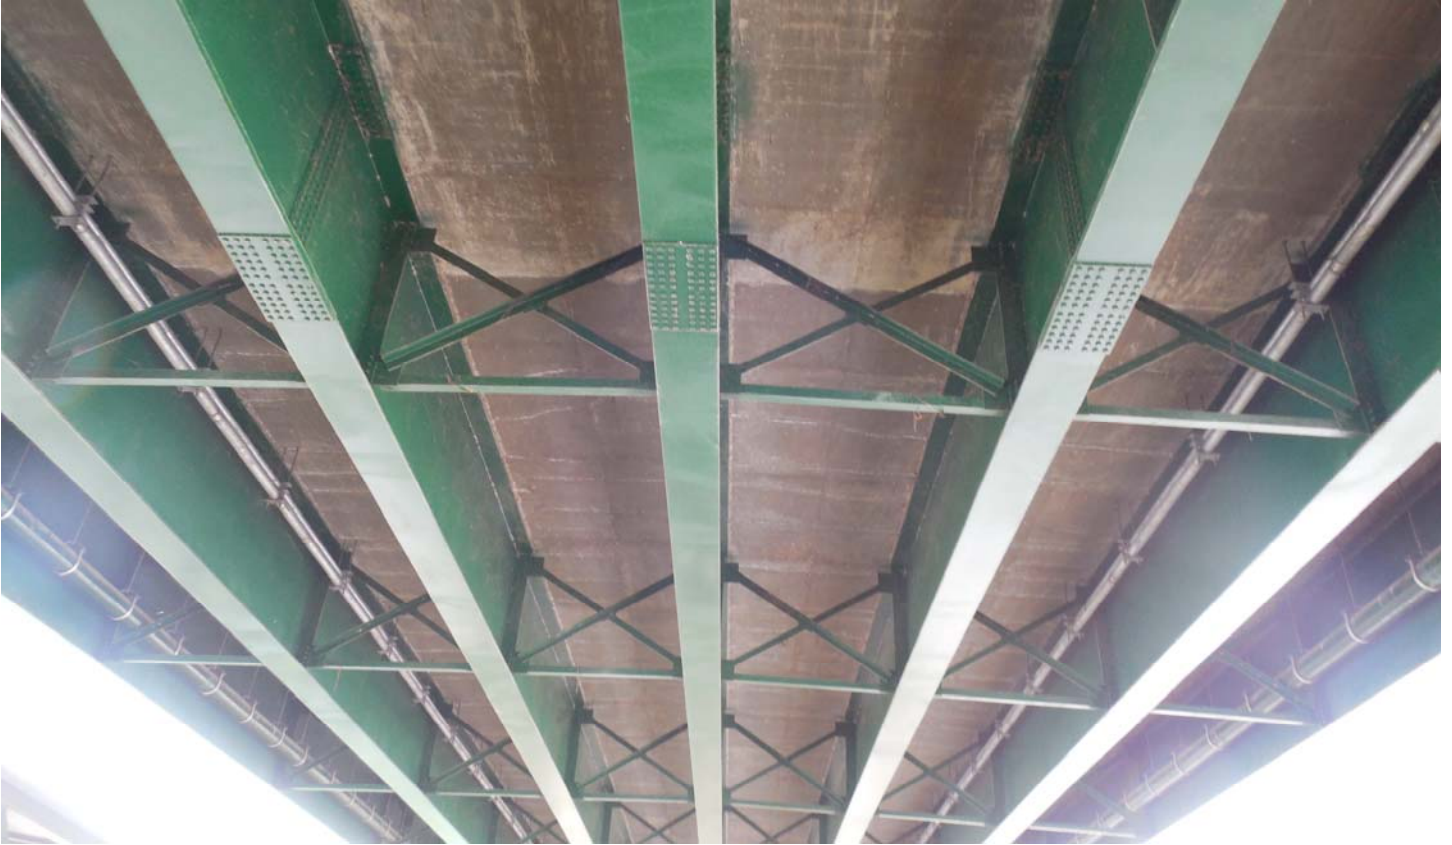
Photo 17 - Underside of Deck in Span 3 Looking West

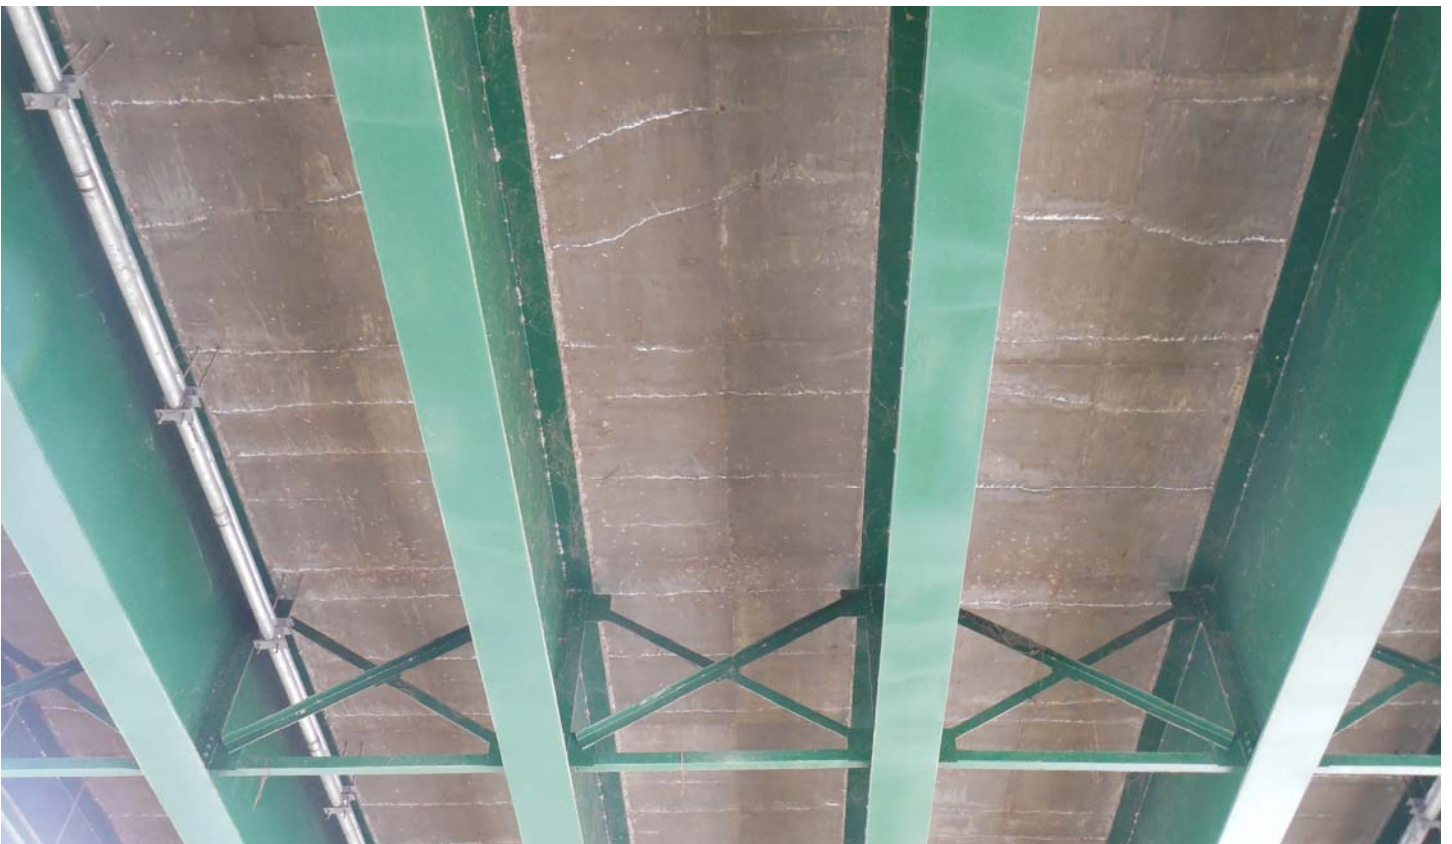
Photo 18 - Underside of Deck in Span 3

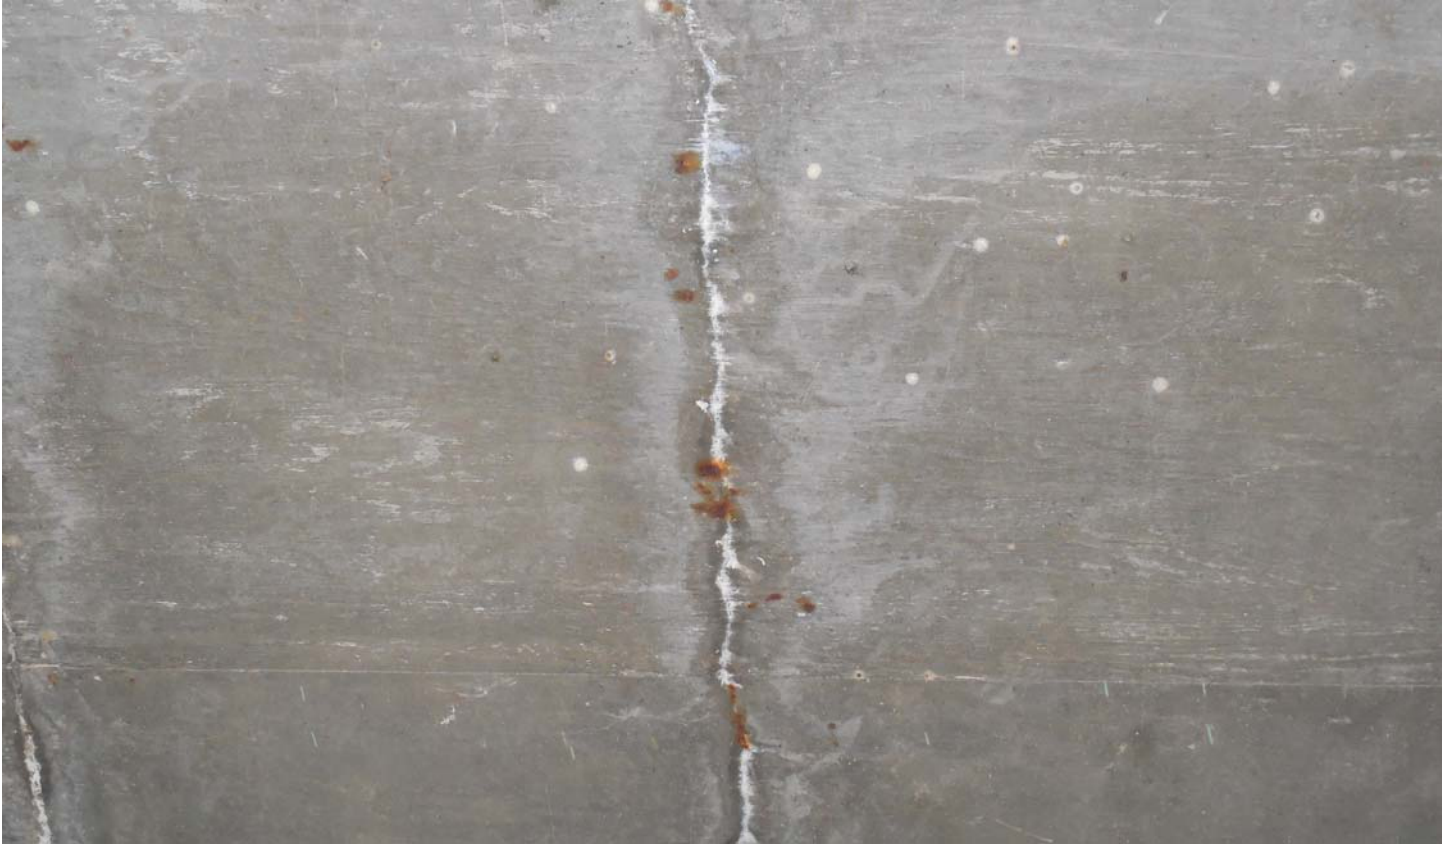
Photo 19 - Underside of Deck - Span 3 Bay 3 Rust Staining

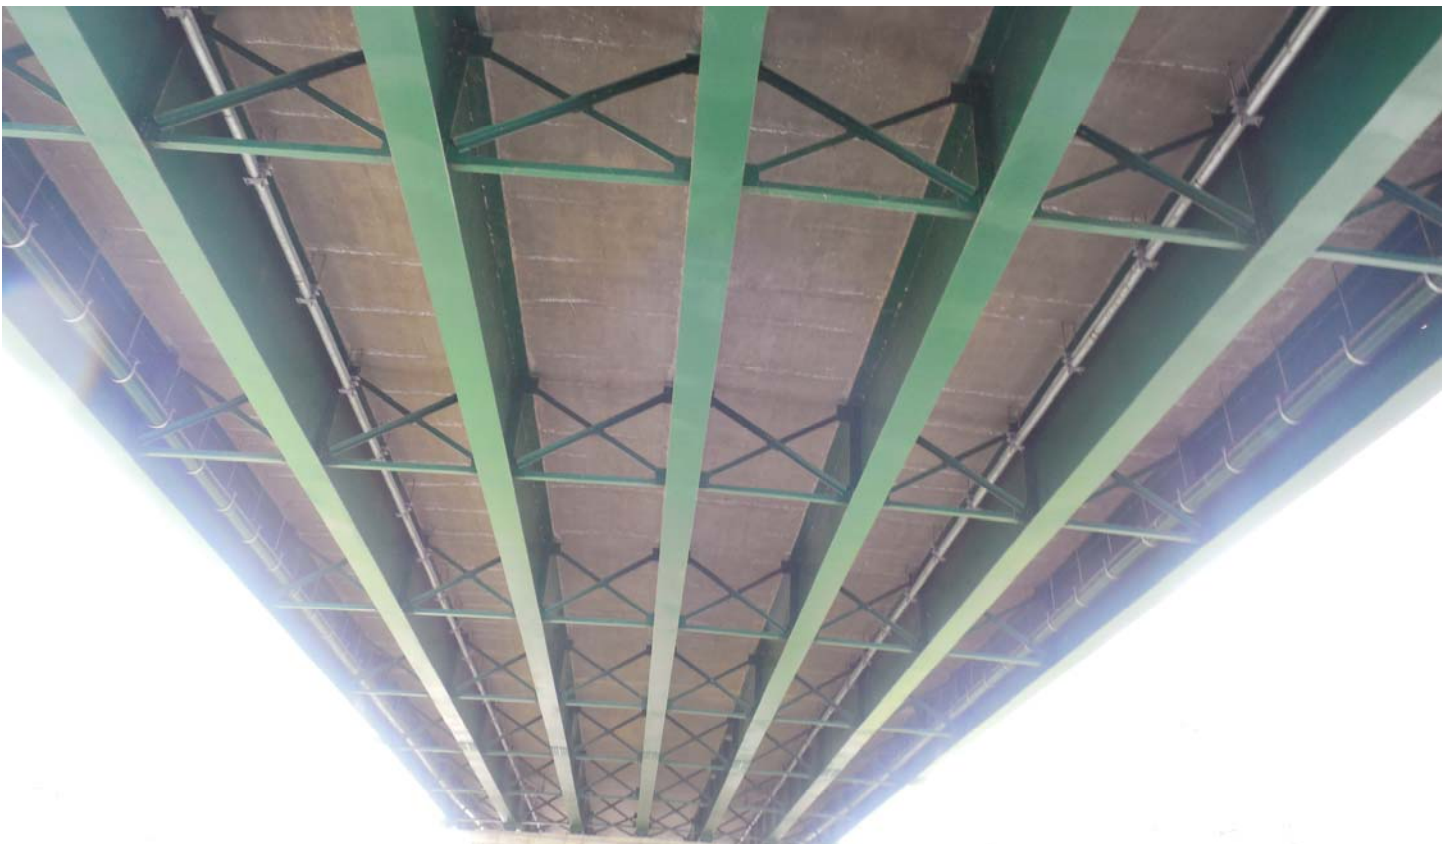
Photo 26 - Underside of Deck in Span 2

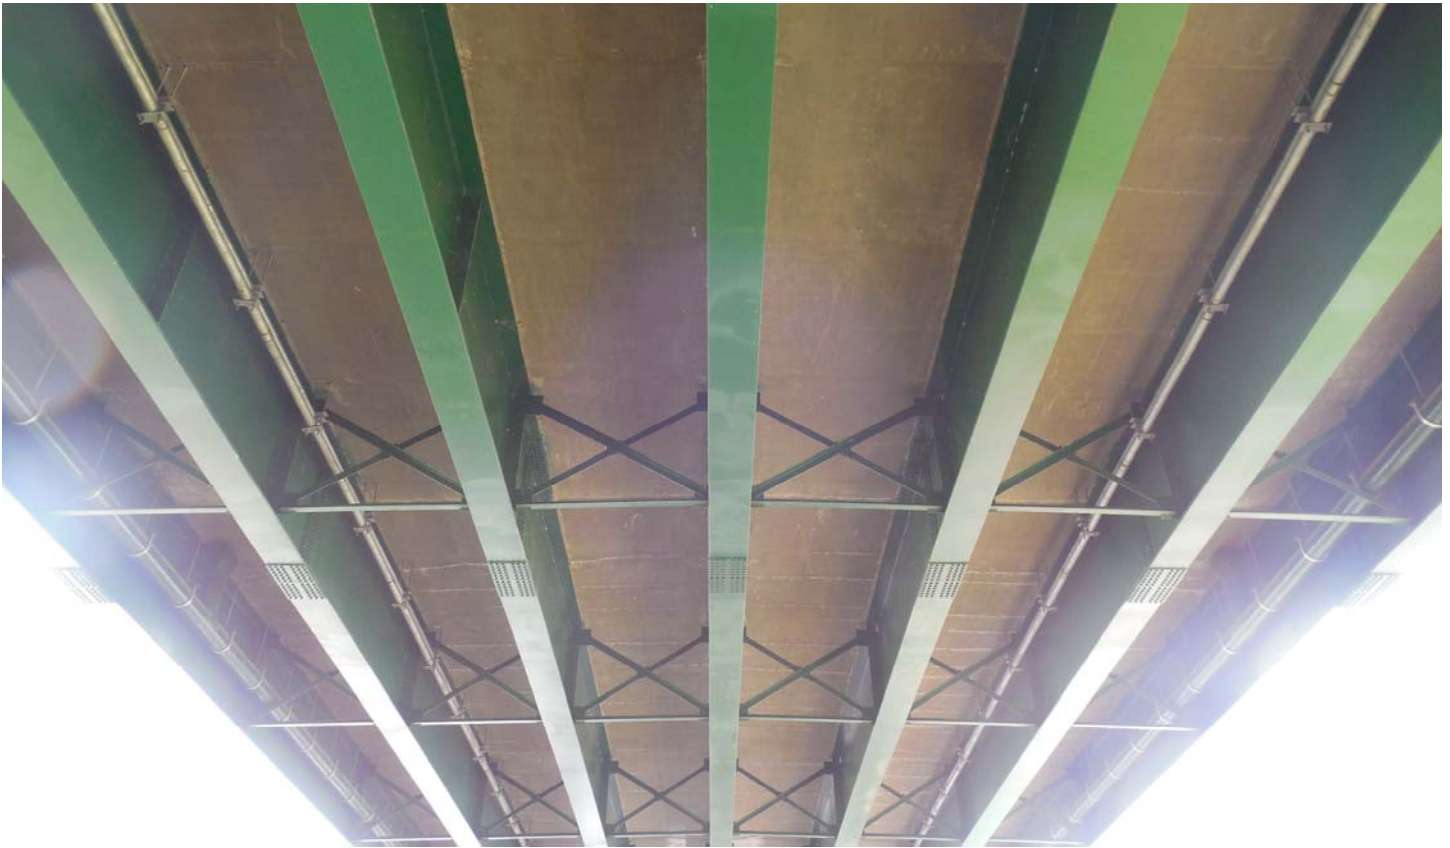
Photo 35 - Underside Deck in Span 2 from Pier 1

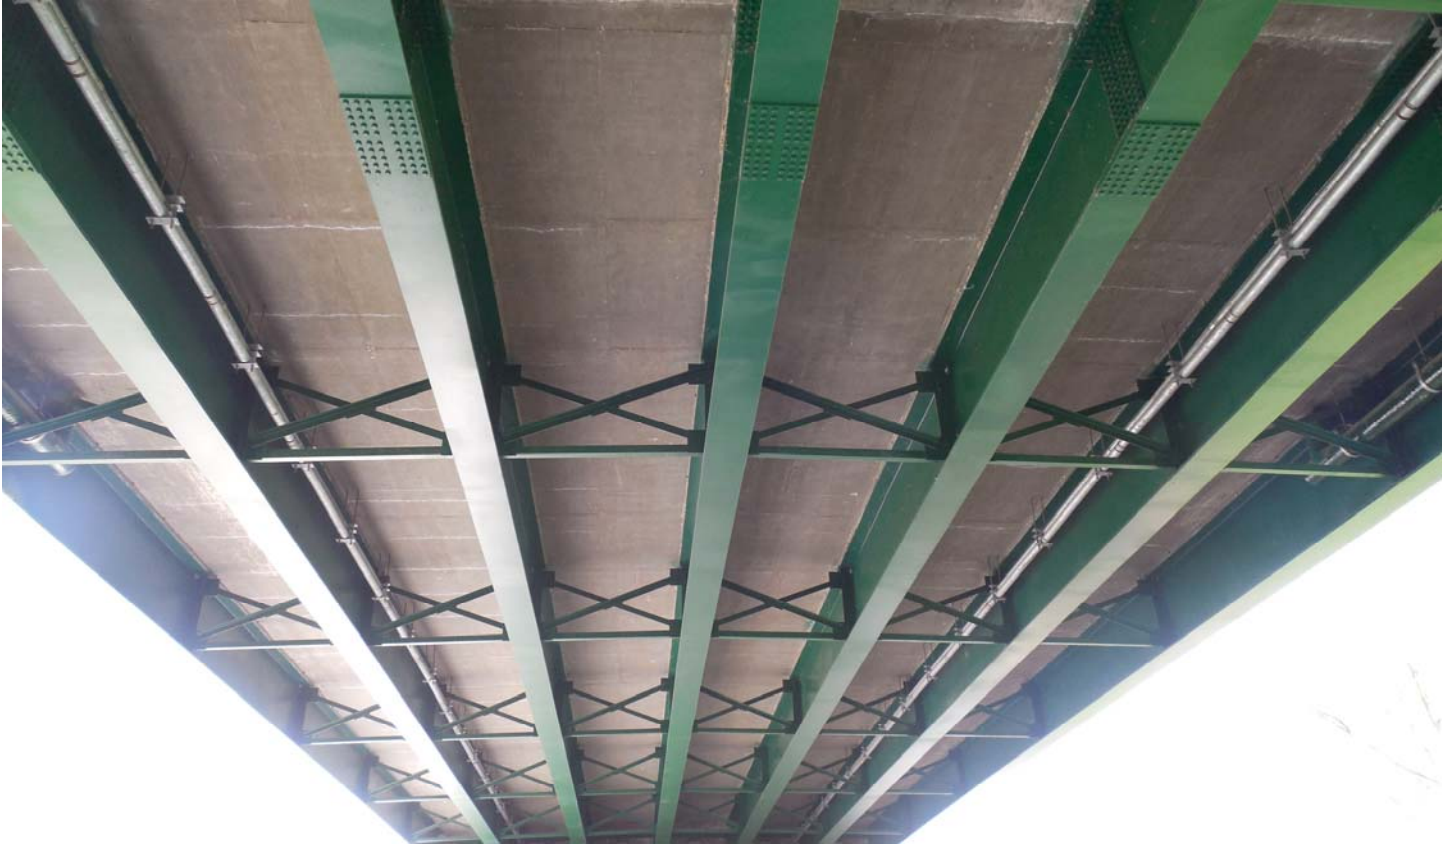
Photo 39 - Underside of Span 1 from Pier 1

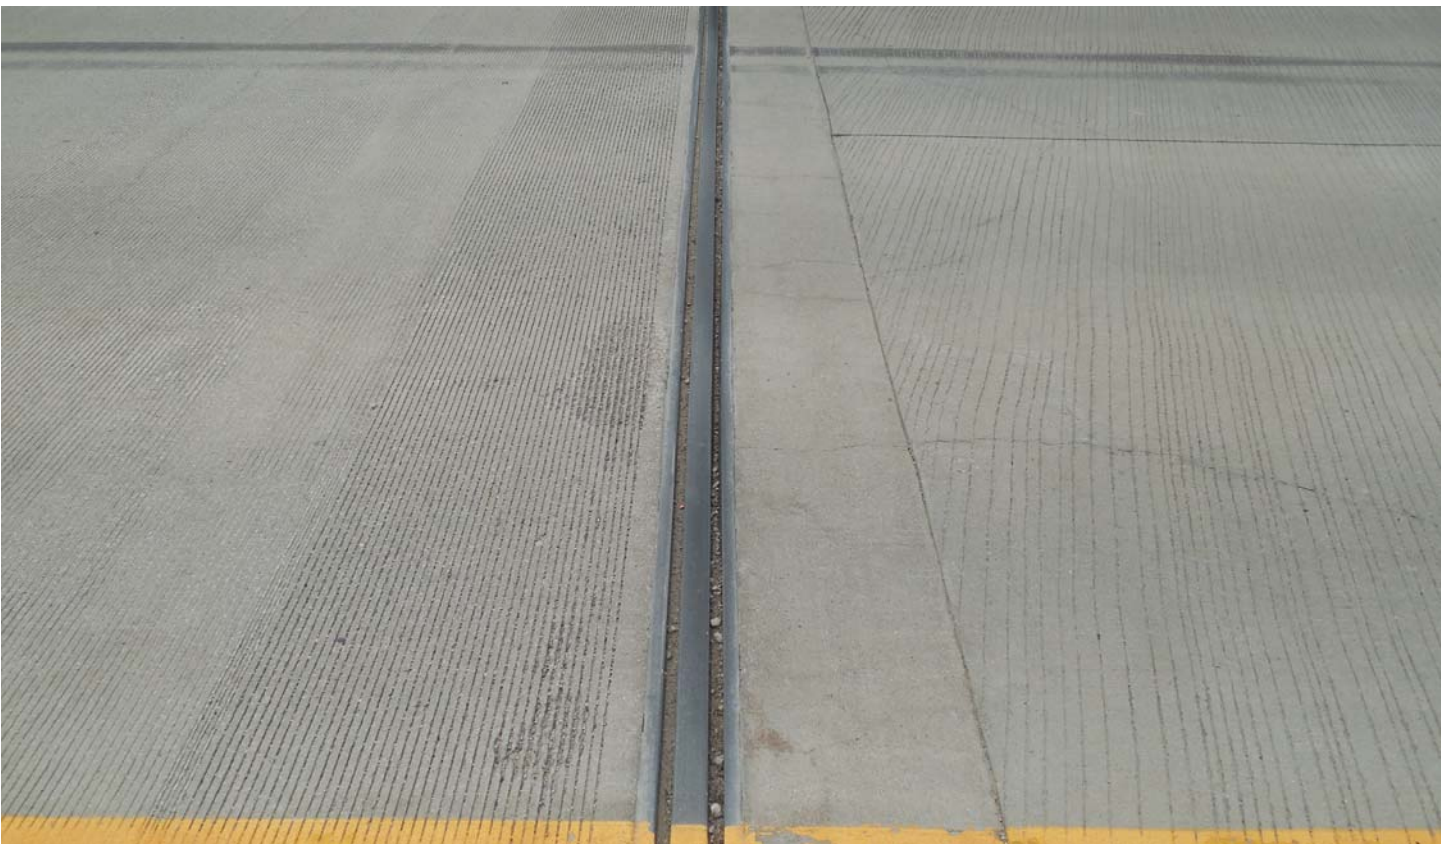
- There is a light buildup of debris at both expansion joints.
- The east and west abutment joints measured 8.5" and 5", respectively, at 70°F.

Photo 52 - Deck Joint at West Abutment in the Eastbound Lane Looking South

- Clean out the debris in deck drains for proper drainage.
- Clean debris from expansion joints.
- Fix drain pipe connection in Bay 6 to stop leakage

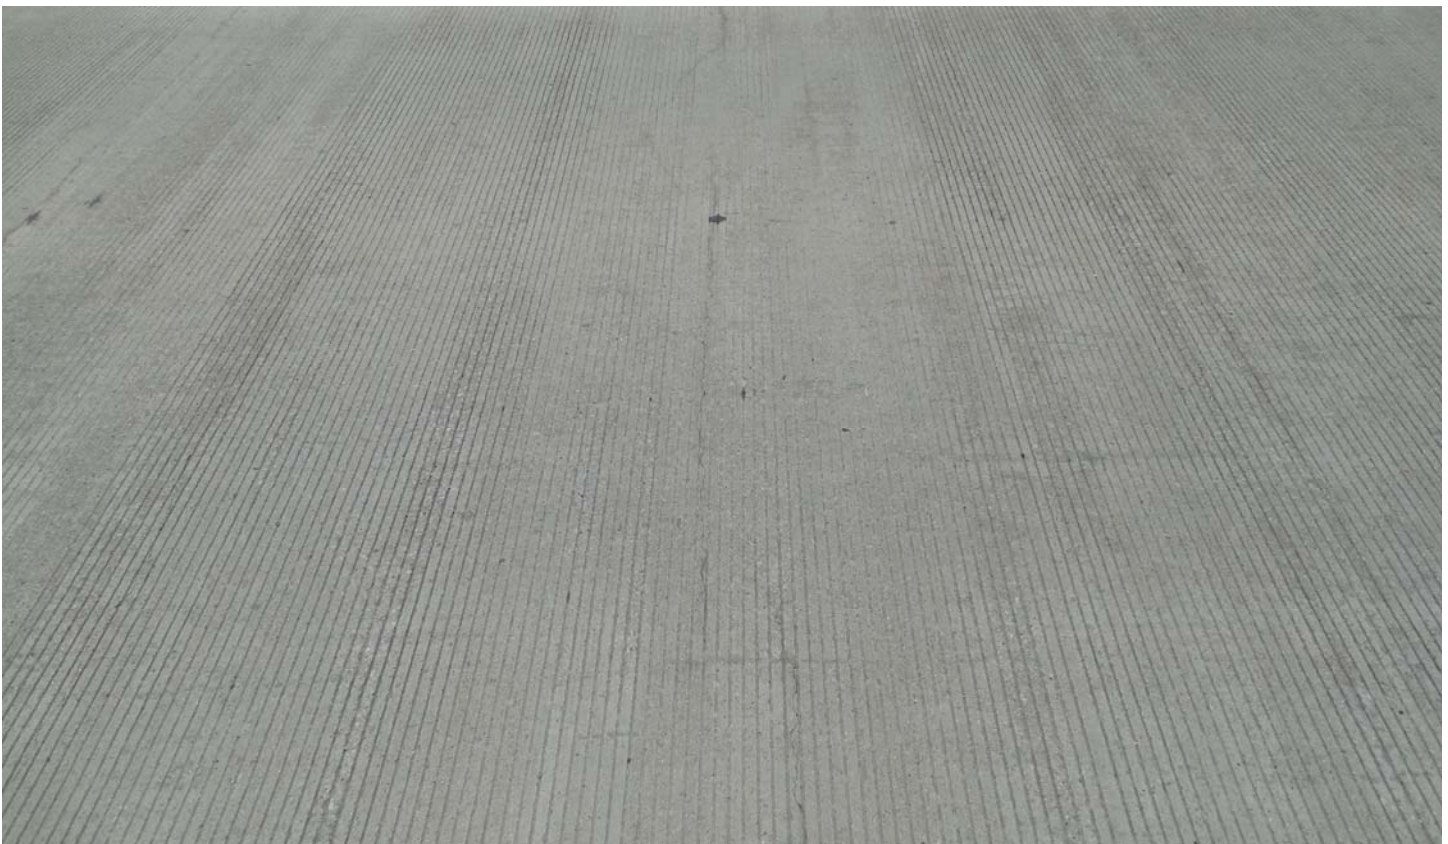
- There are full depth transverse cracks  $< 0.06''$  at 5' intervals over the majority of the deck.
- There are hairline vertical cracks on both side of the concrete median.
- Several of the deck drains have accumulated a minor amount of debris but seem to still be operational.

Photo 58 - Top of Deck - Typical Cracking in Span 1

- The transverse cracking in the deck should be sealed to limit the infiltration of water and de-icing salts through the bridge deck.

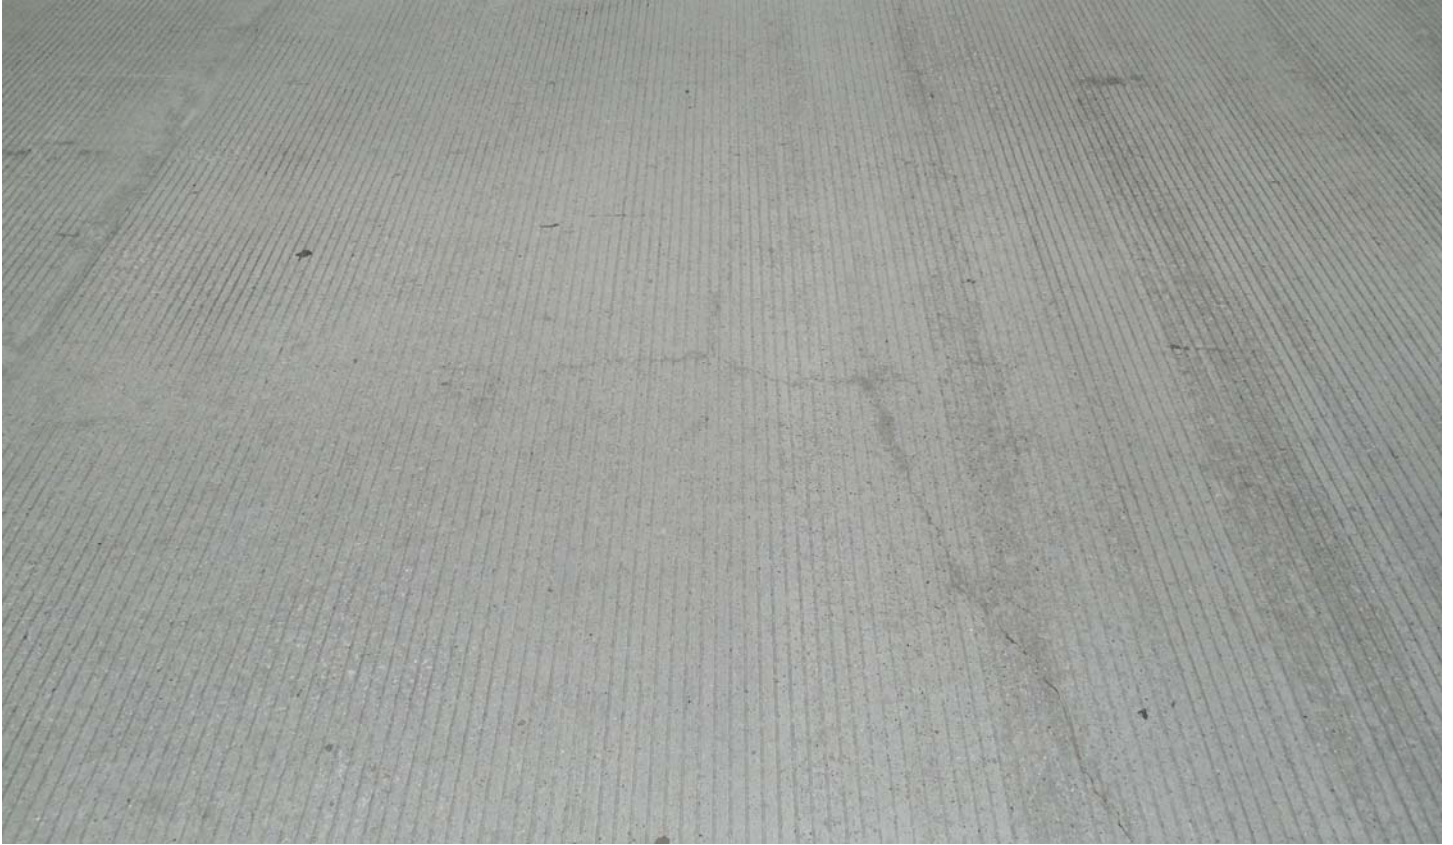
Photo 59 - Top of Deck - Typical Cracking in Span 2
