**2018 QBS  
Request for Statement of Interest (SOI)  
Kane County Division of Transportation (KDOT)  
2019 Structure Inspections  
Section Number 18-00501-00-EG**

# Bridge Inspection Report

## STRUCTURE NO. 045-3166

Stearns Road / FAP 361 over Fox River

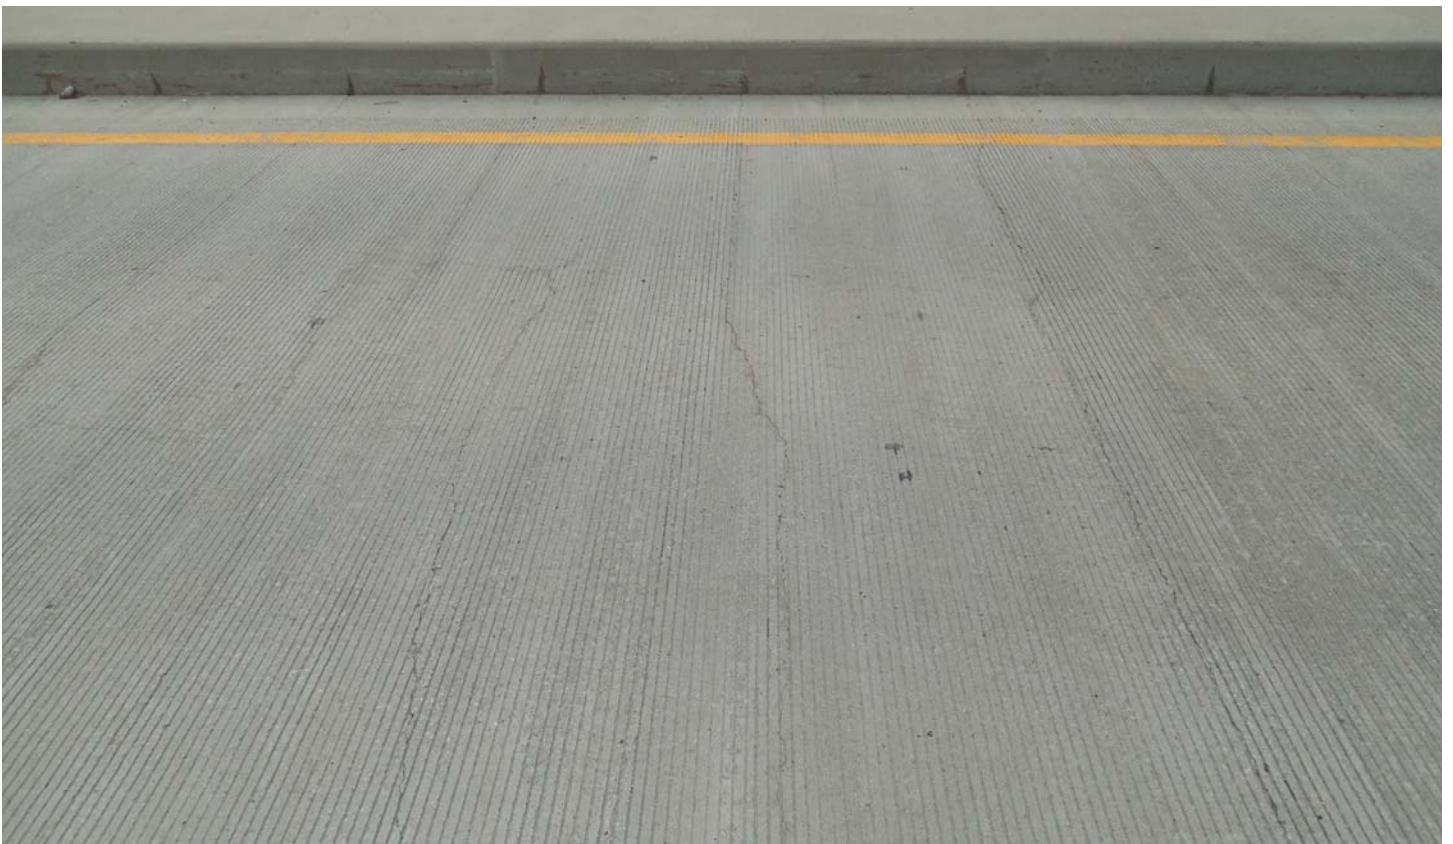
- There are full depth transverse cracks  $< 0.06''$  at 5' intervals over the majority of the deck.
- There are hairline vertical cracks on both side of the concrete median.
- Several of the deck drains have accumulated a minor amount of debris but seem to still be operational.

Photo 60 - Top of Deck - Typical Cracking in Span 3

- The transverse cracking in the deck should be sealed to limit the infiltration of water and de-icing salts through the bridge deck.

- Seal cracks in the bridge deck.

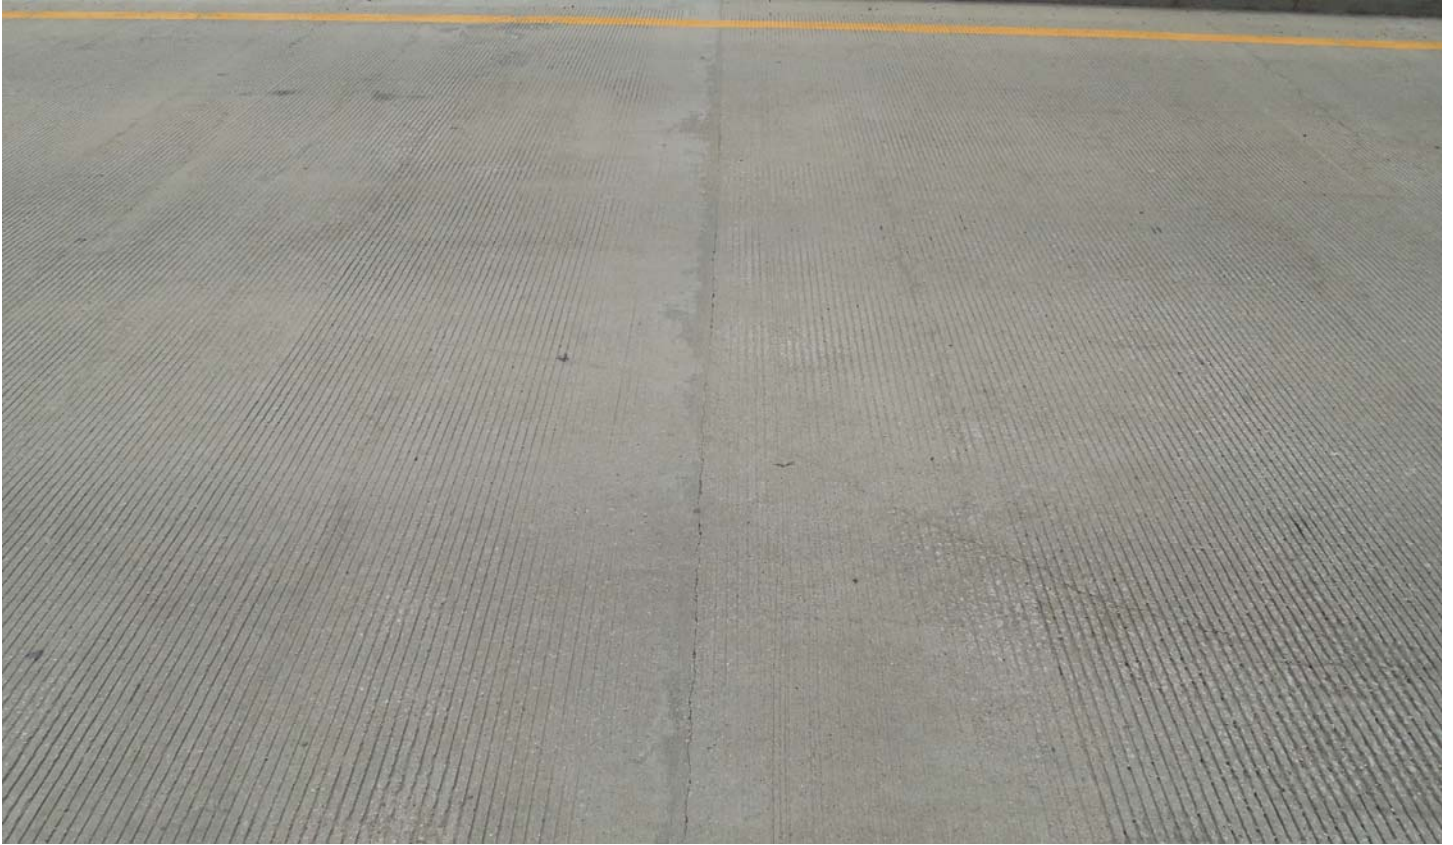
Photo 61 - Top of Deck in Span 4 - Cold Joint

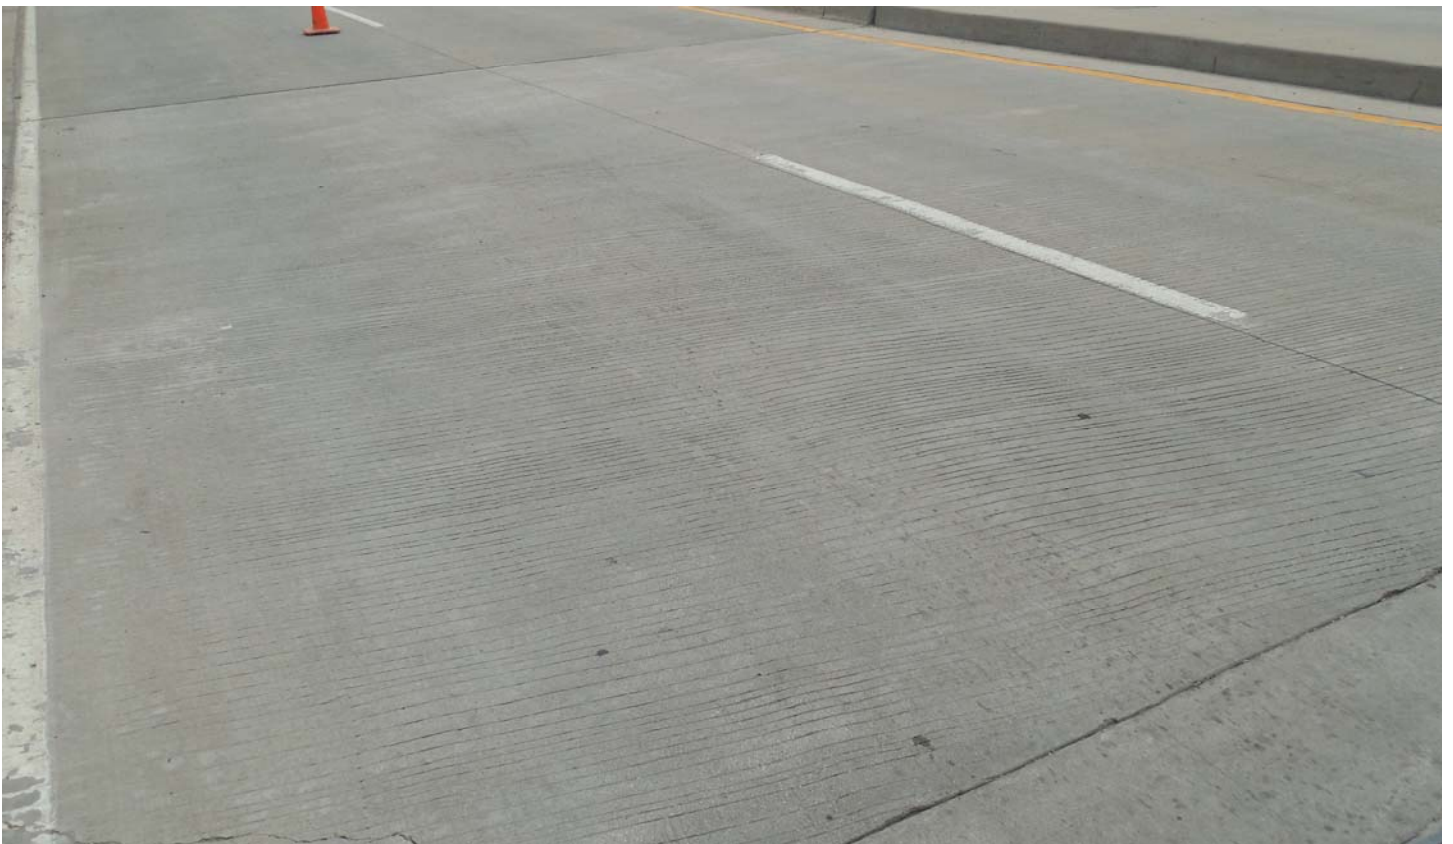
The concrete approach roadway is in **good condition**.

- Diagonal cracking up to 1/8" with dispersed transverse and longitudinal cracking throughout in the approach slabs

Photo 62 - East Approach - Westbound Lanes

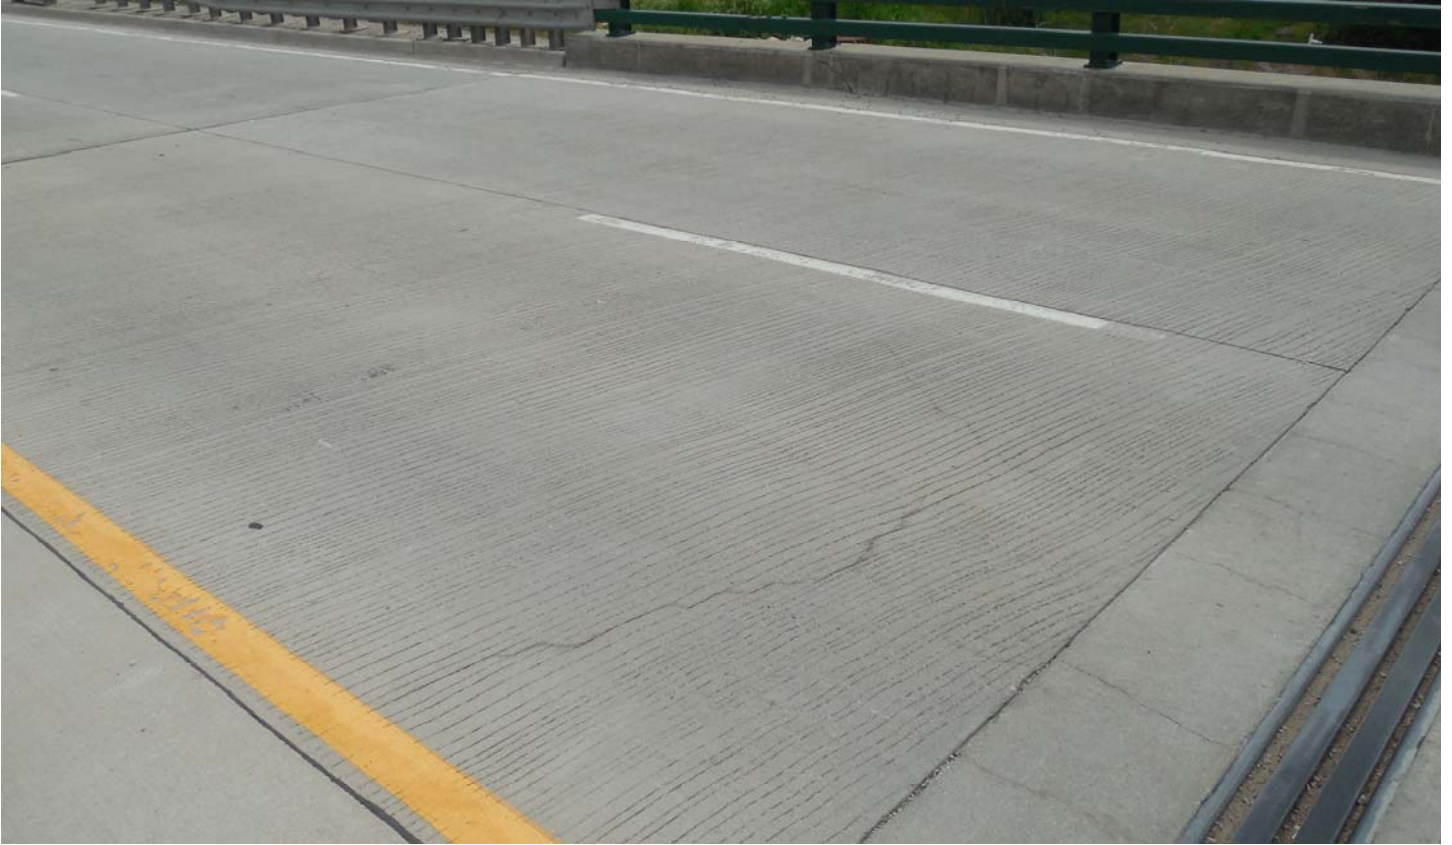
Photo 63 - East Approach - Eastbound Lanes

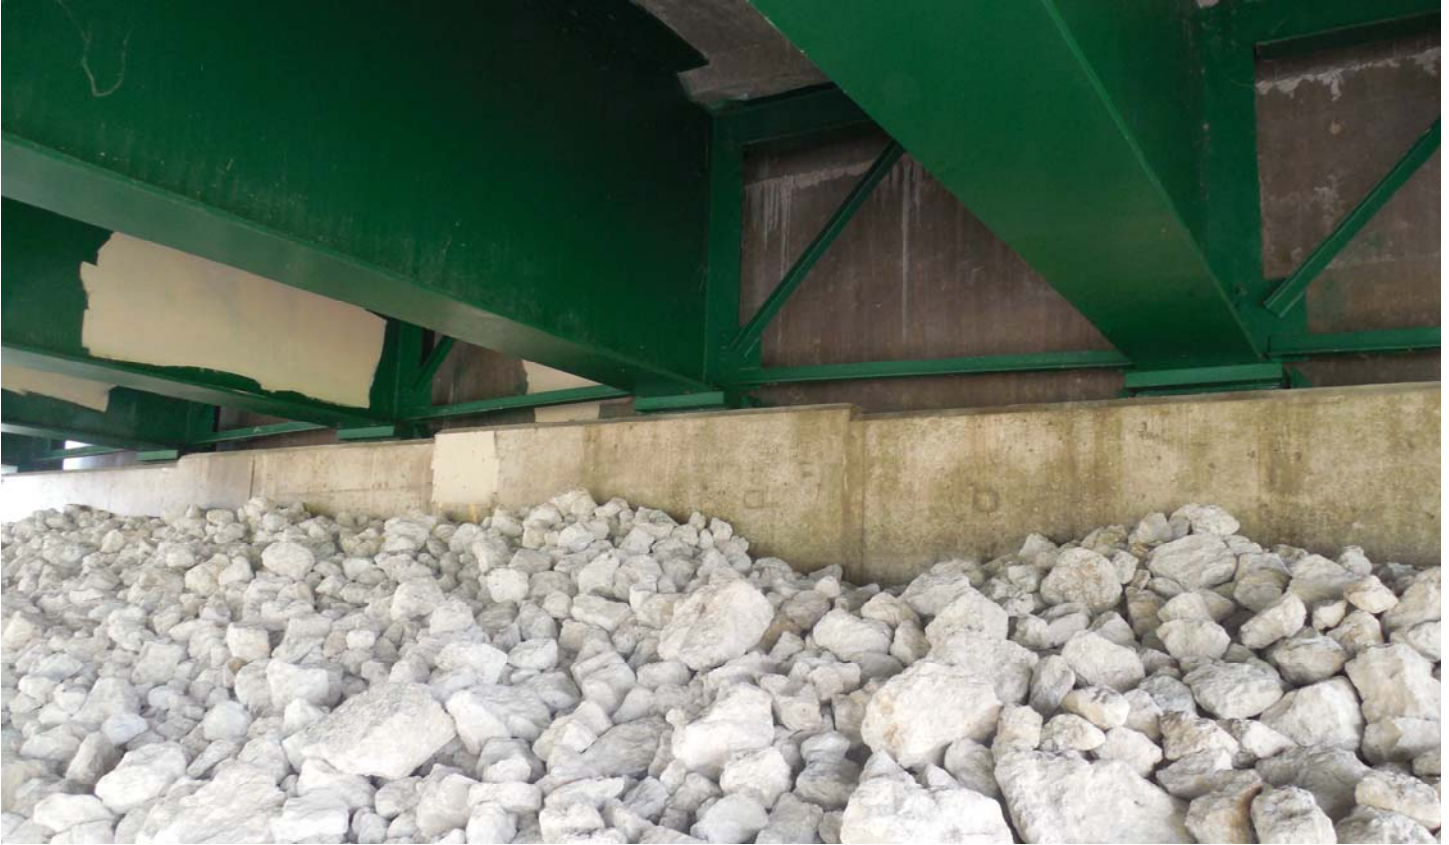
- The concrete abutments / wingwalls are smooth with no noticeable defects.

Photo 71 - East Abutment Cap and Backwall
