2019 QBS
Request for Statement of Interest (SOI)
Kane County Division of Transportation (KDOT)
Harter Road Culvert Replacement
Section Number 19-00509-00-BR

Bridge Inspection Report

Harter Road Culvert

INSPECTION TYPE: Routine
DATE: May 24th, 2017

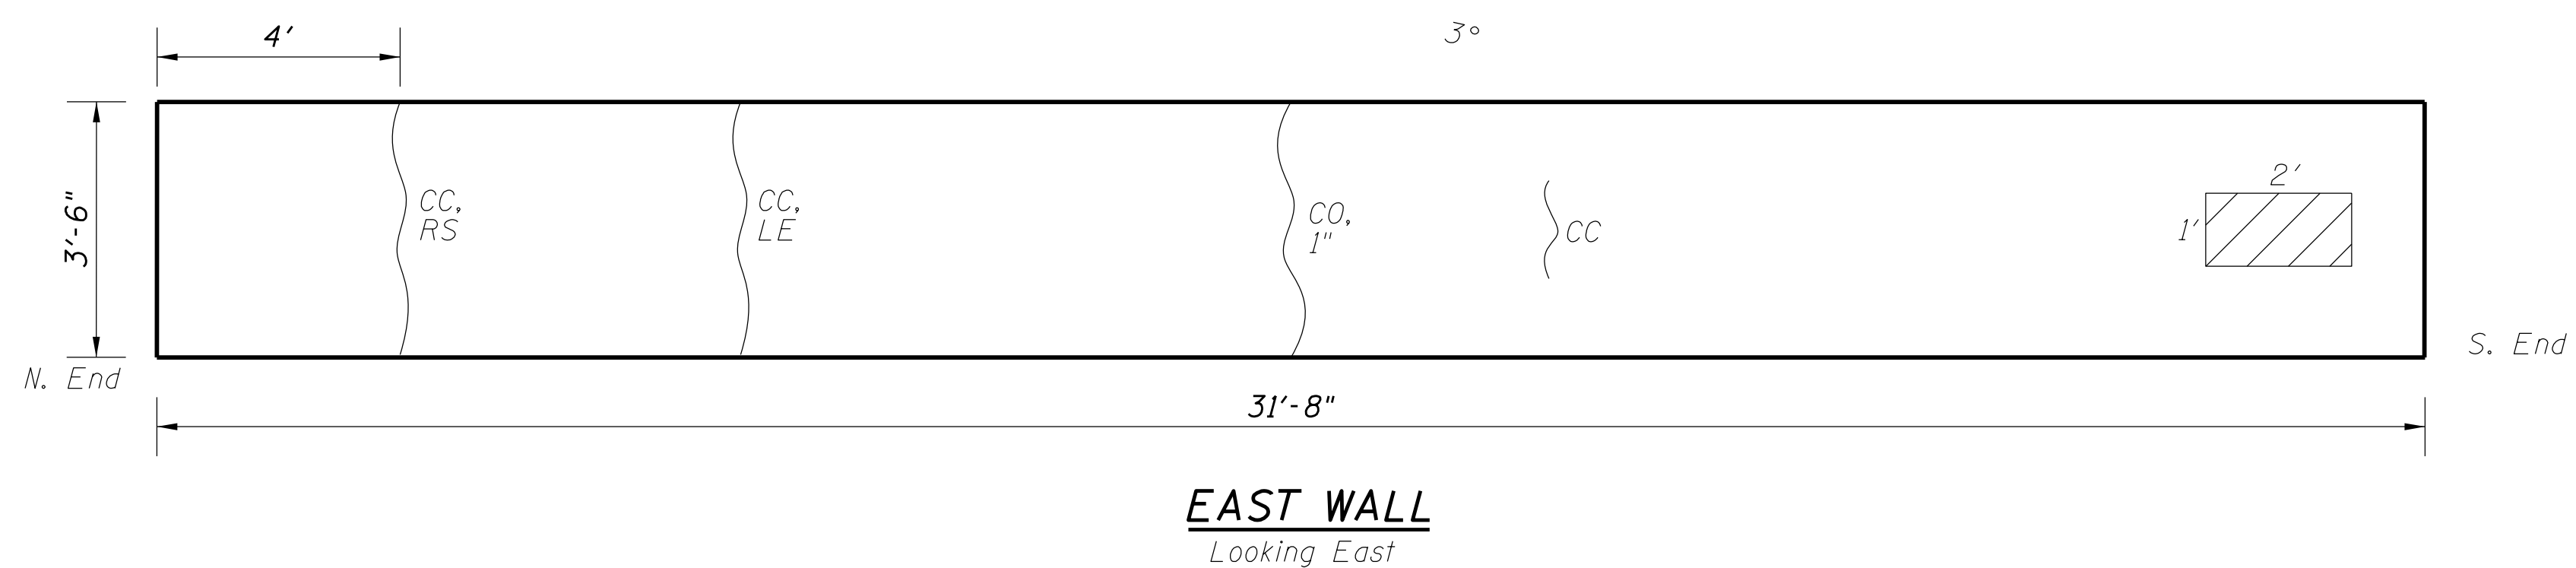
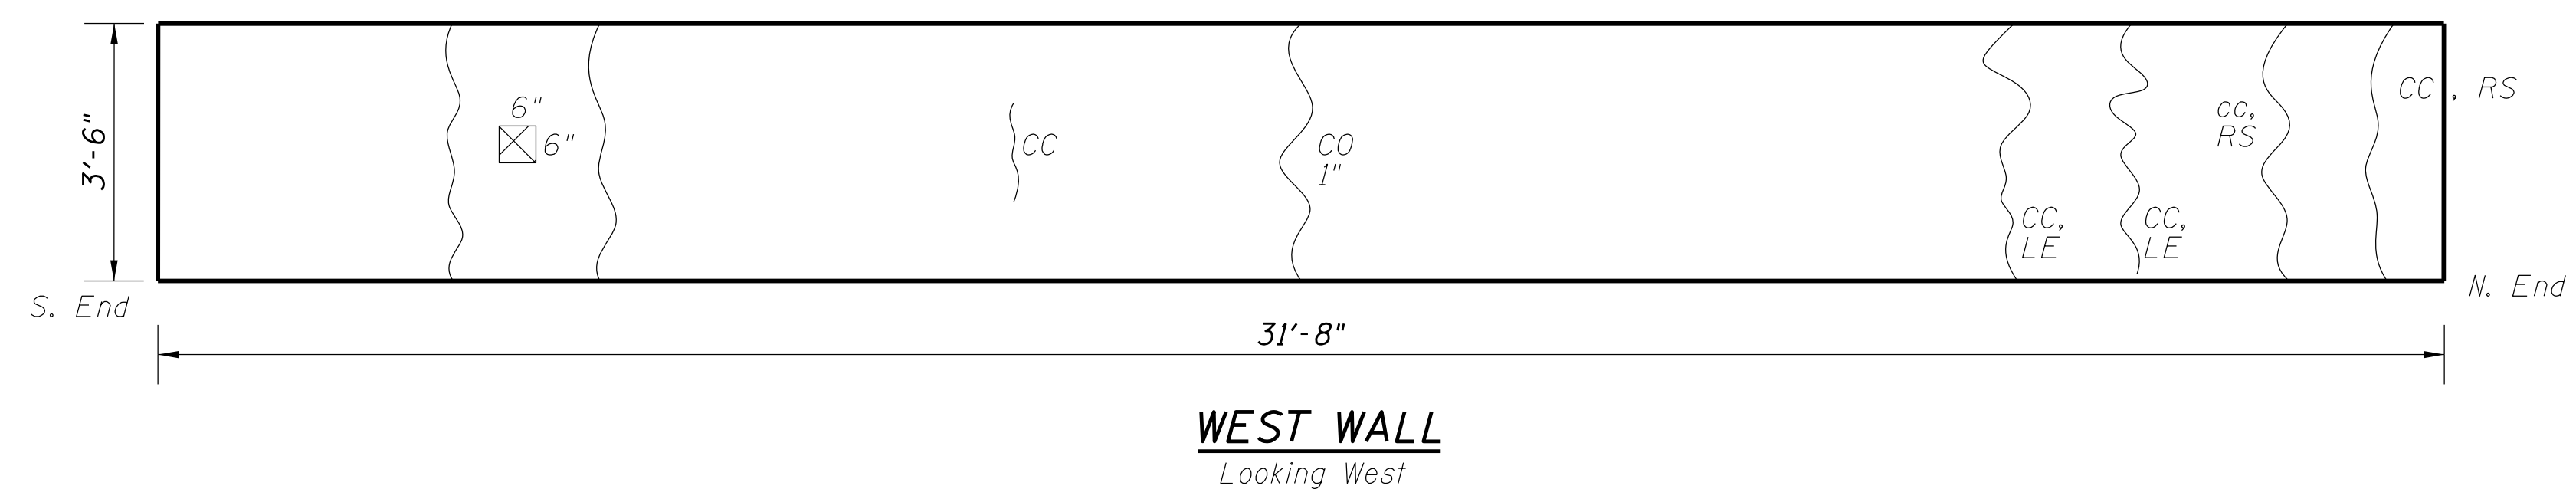
NOTES:
Dimensions are based on field measurements. No existing plans.
Center span 1" crack in walls is full depth. No reinforcement indicated

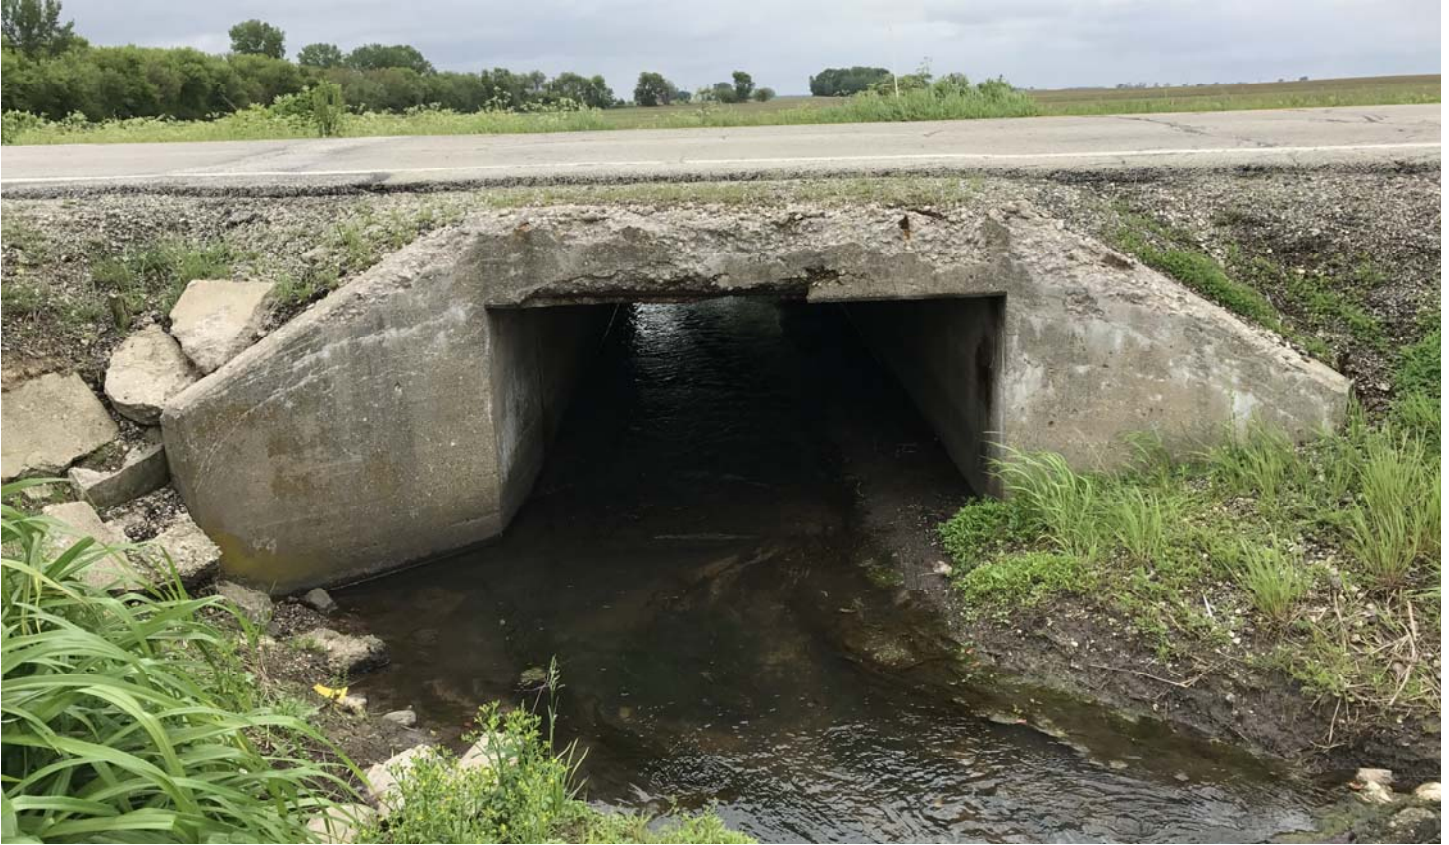
Photo 1 - Upstream, Looking South

- There is a 6 inch by 12 inch spall on the south headwall at the southeast corner.
- Minor cracks with efflorescence are present on the north wing walls with a spalling on the north headwall. (See Photo No. 1)

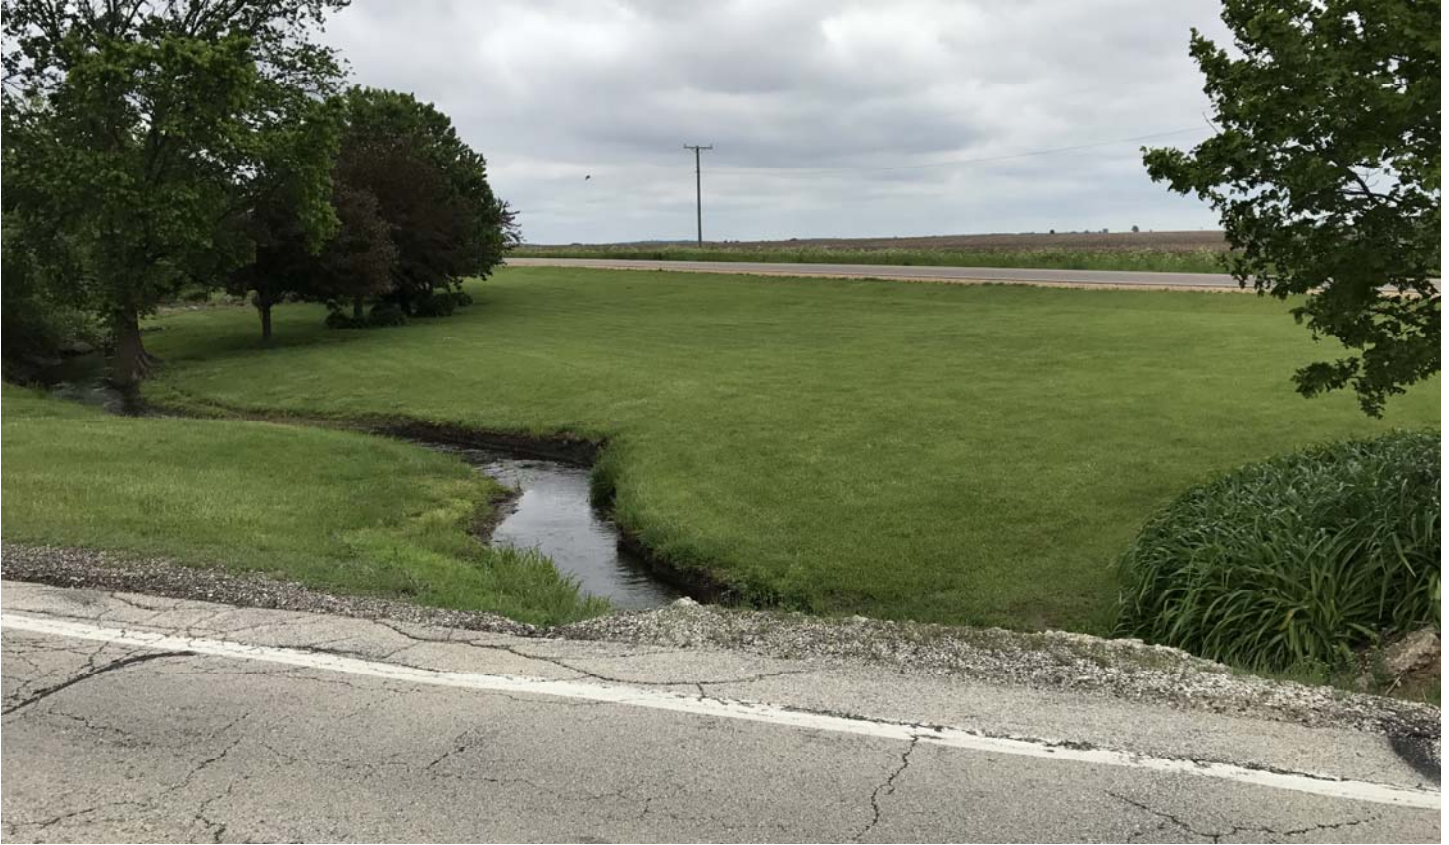
Photo 3 - From Harter Rd, Looking North

The slope and channel appear to be in **Fair** condition. Erosion is present on the creek banks, along with 1 inch of siltation along the bottom of the culvert. No bank protection is existing at this location. (See Photo No. 3)

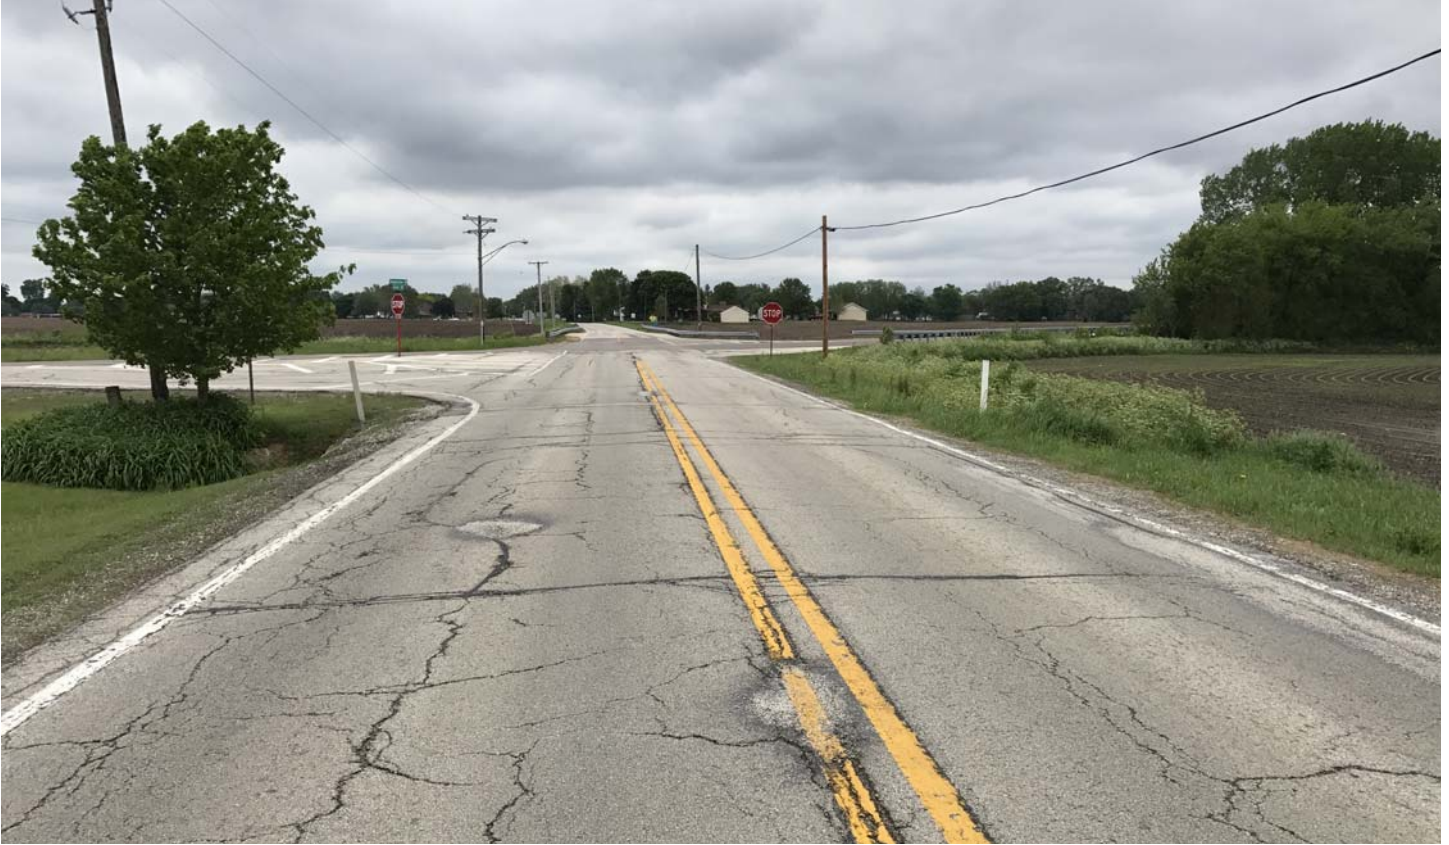
Photo 5 - Looking East along Harter Rd

The HMA pavement is in **Fair** condition.

- There is cracking along the roadway with a larger crack running vertically along the center of the road. (See Photo Nos. 5 & 6)

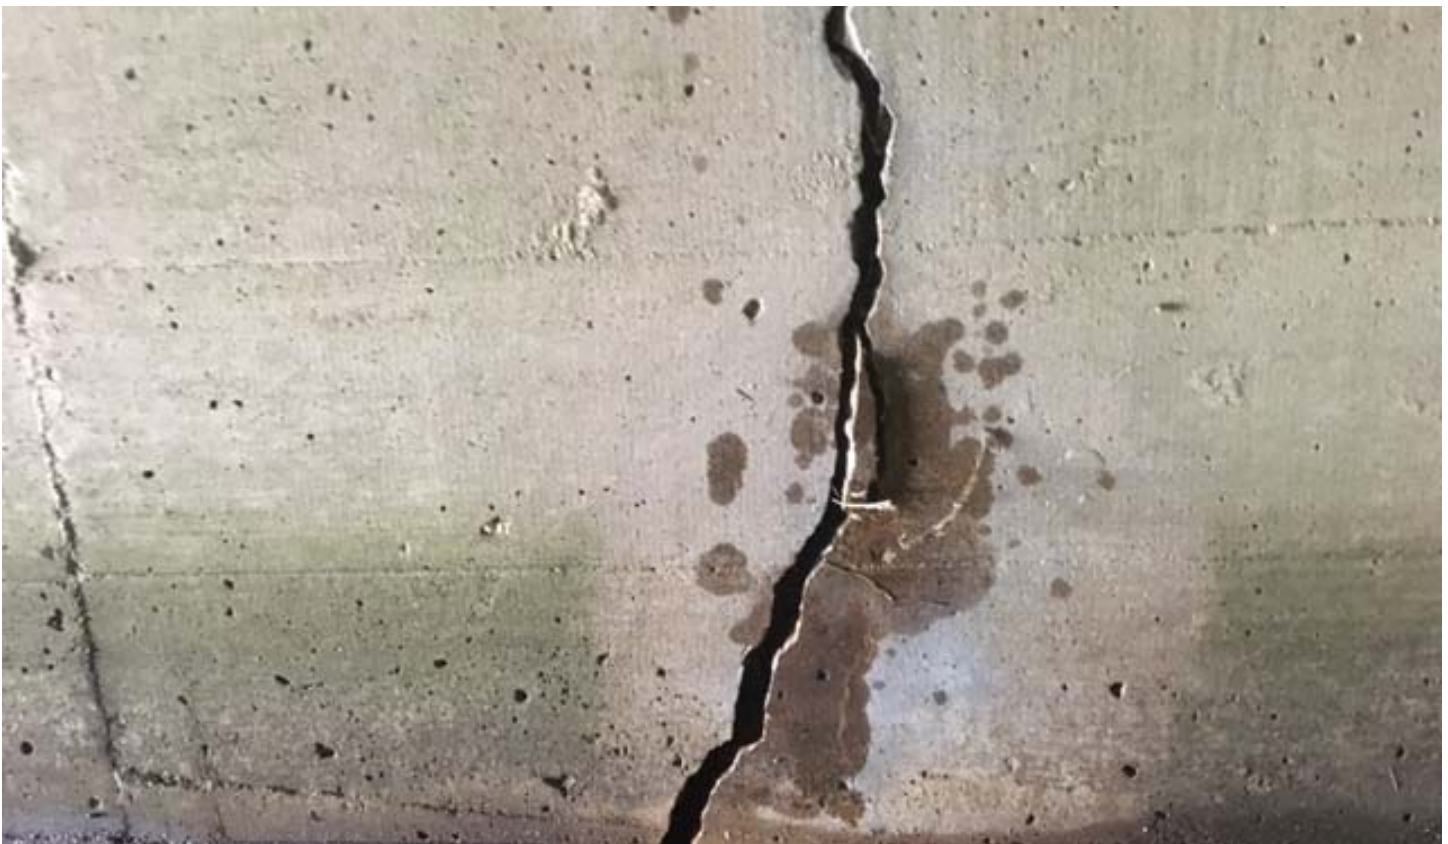
- At the center of the culvert, there is a 0.8-1.0 inch crack in each wall. The existing walls appear to be 8" thick from inspection and no reinforcement was encountered in the entire height of the crack. (See Photo No. 8 & 9)
- Multiple spalls, delaminations, and cracks occur throughout the culvert. (See Photo No. 11, 12, & 13)

The culvert is in overall **Poor** condition. It appears as if the walls and bottom slab were not reinforced during construction. As such, the culvert has acted as a beam and separated in the middle from the vehicular loads. The existing structure life span is 5 years.

Photo 8 - East Wall Mid Span Crack

- Replace culvert. It is recommended to review the culvert skew during design. The existing skew is 90°. However, the upstream channel skew is at 45° and the downstream skew is 90°.

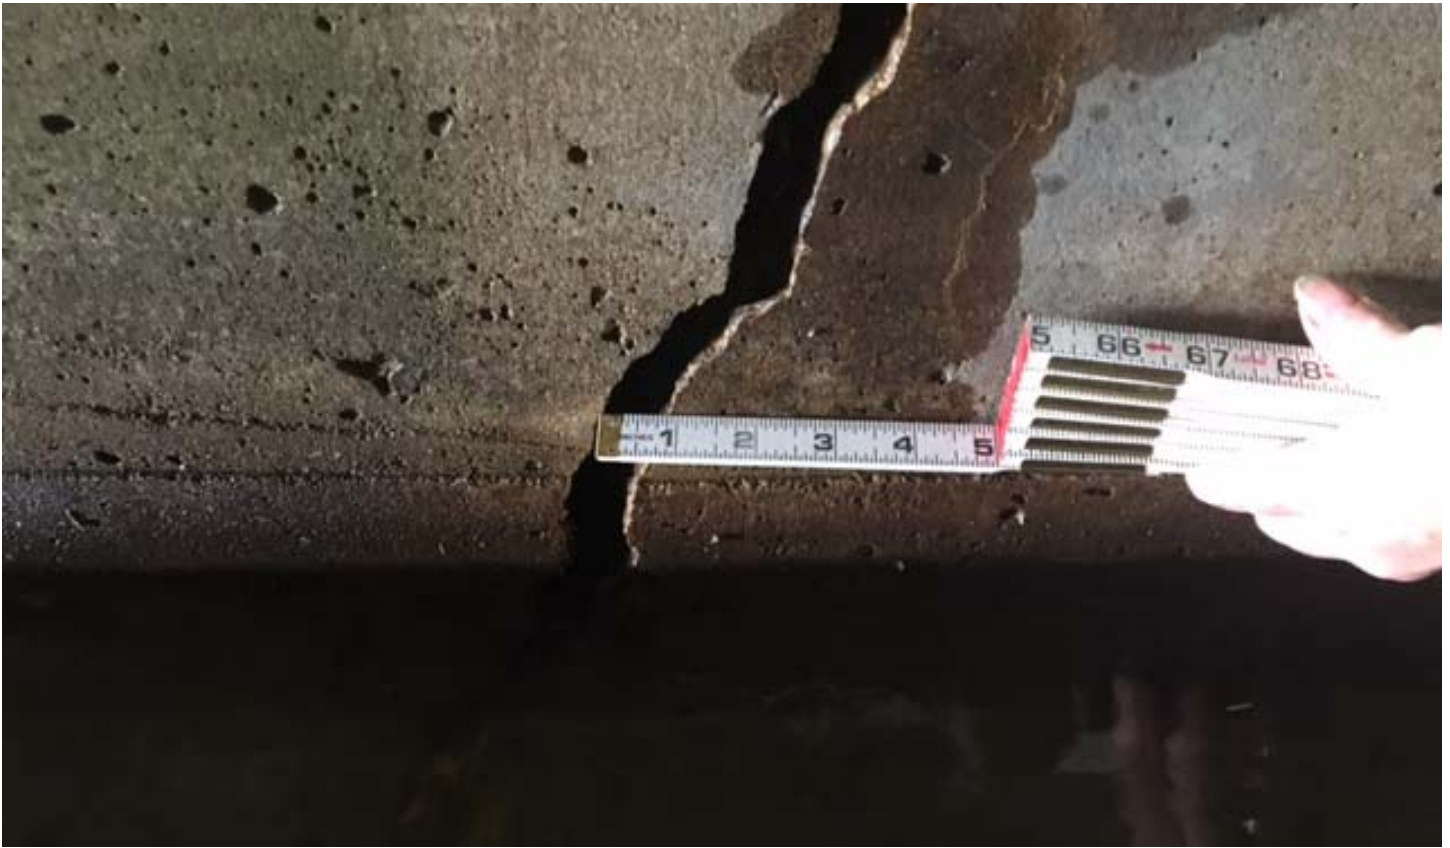
Photo 9 - East Wall Crack Closeup

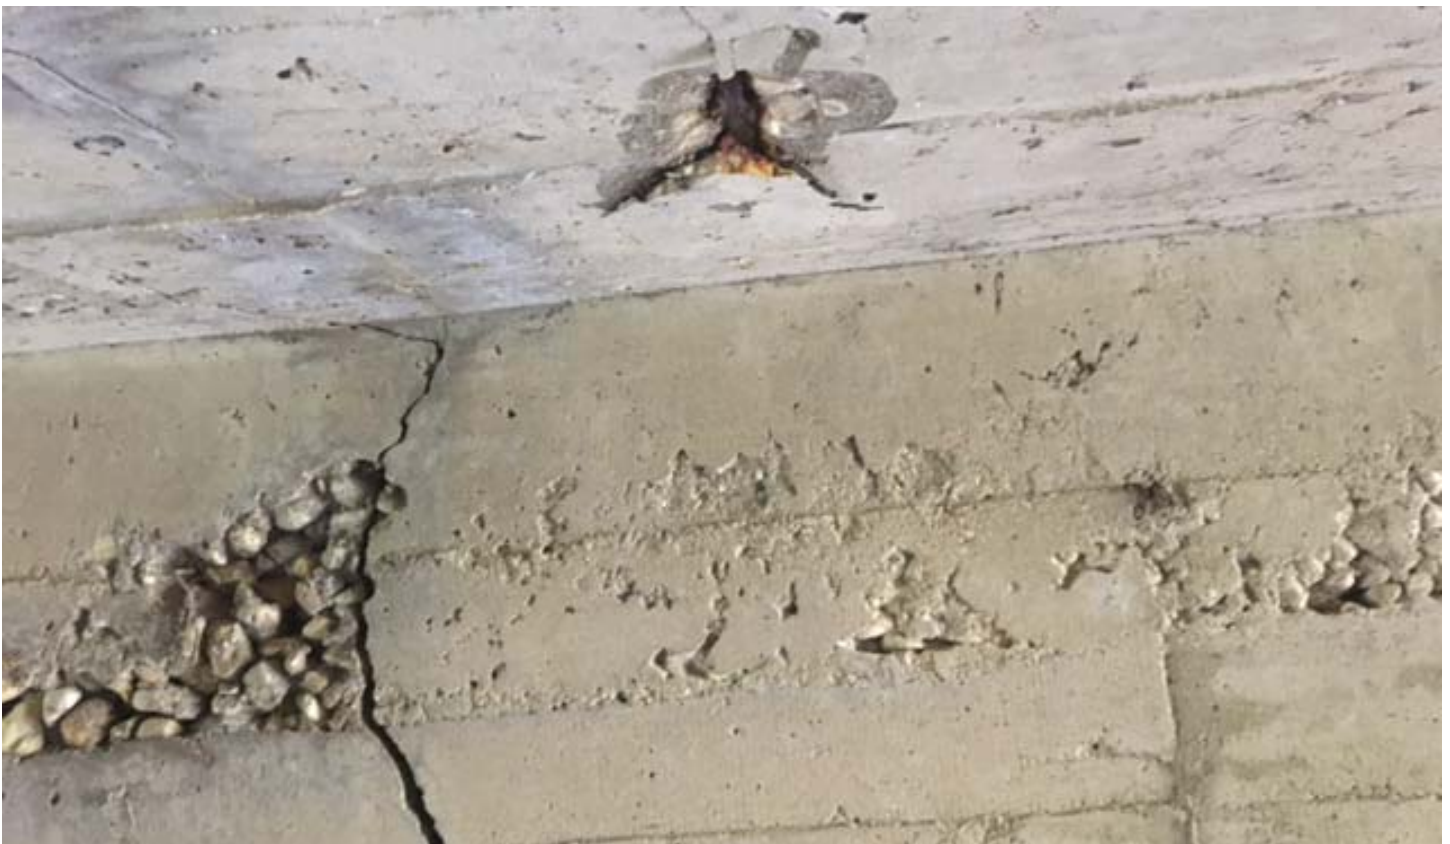
- At the north end of the culvert, a 1 foot spall across the culvert exists with exposed and dangling reinforcement. (See Photo Nos. 15 & 16)
- Multiple spalls with exposed reinforcement and delaminated areas exist throughout the top slab. (See Photo Nos. 10 and 14)
- Minor cracking with efflorescence exists in the northernmost 10'. (See Photo No. 14)

Photo 10 - Top Slab Spall near Mid Span Crack

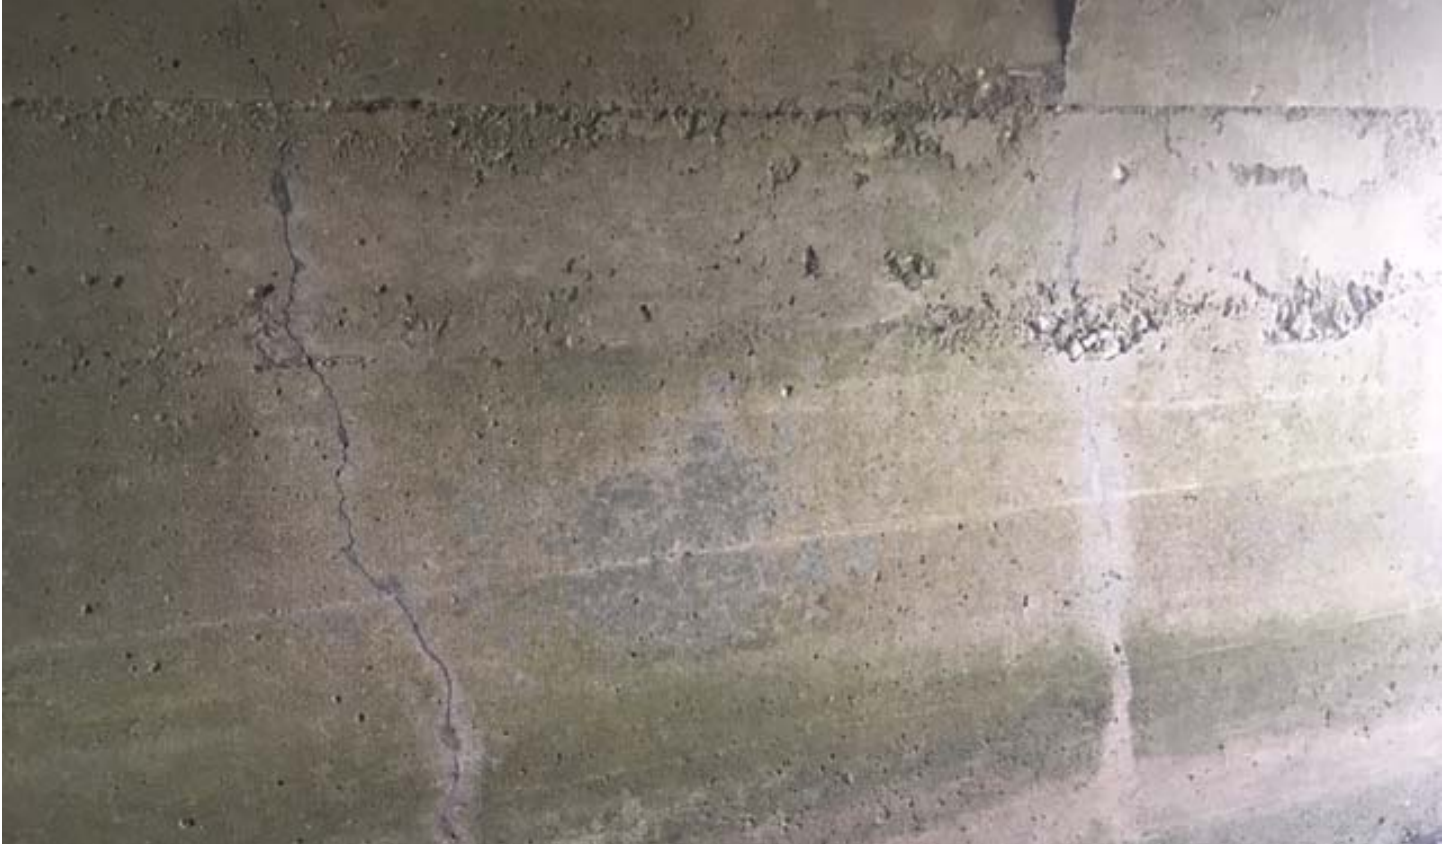
Photo 11 - West Wall North End Cracks

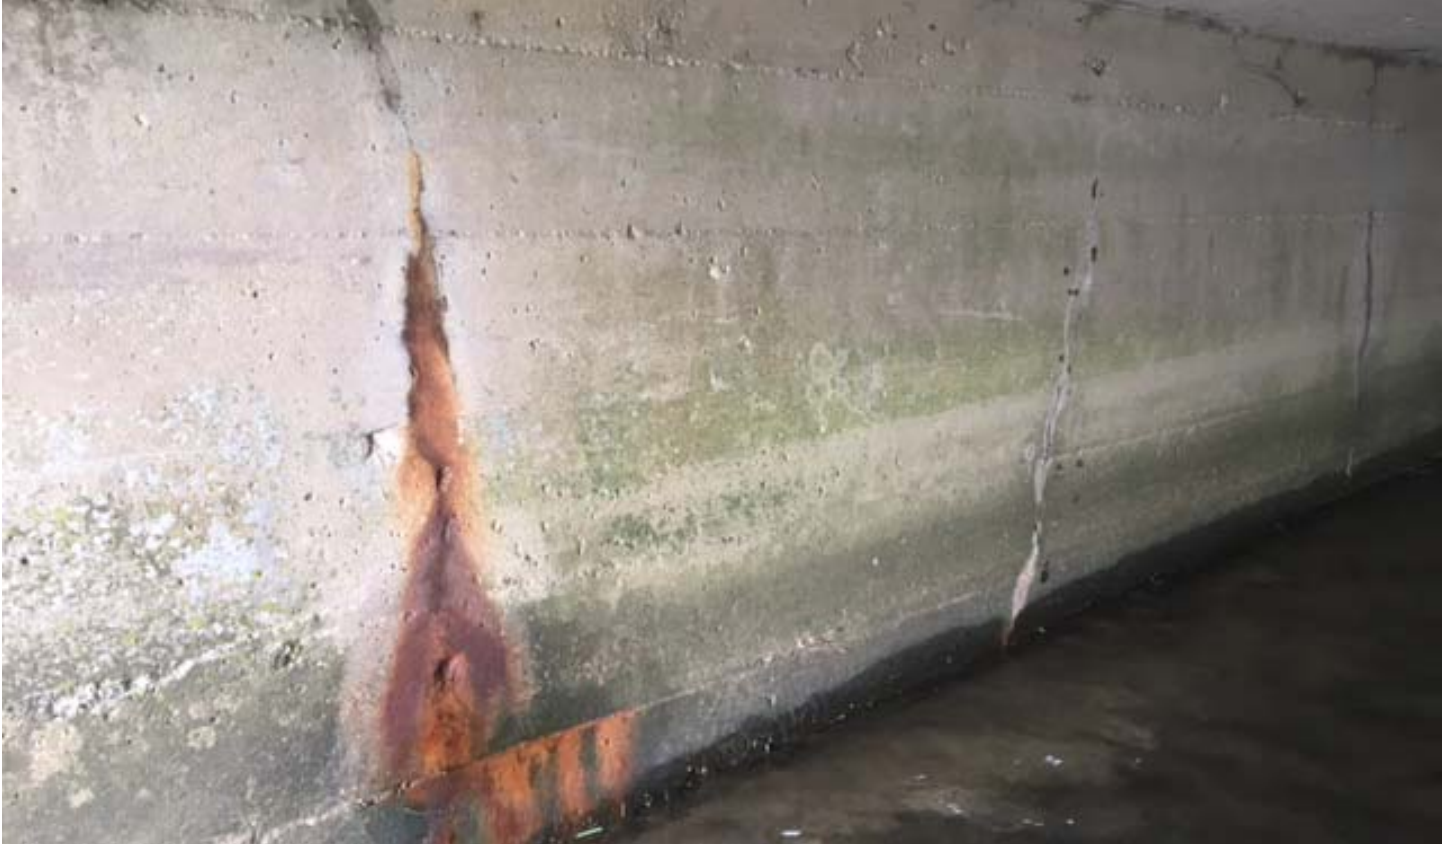
Photo 13 - East Wall North End Cracks

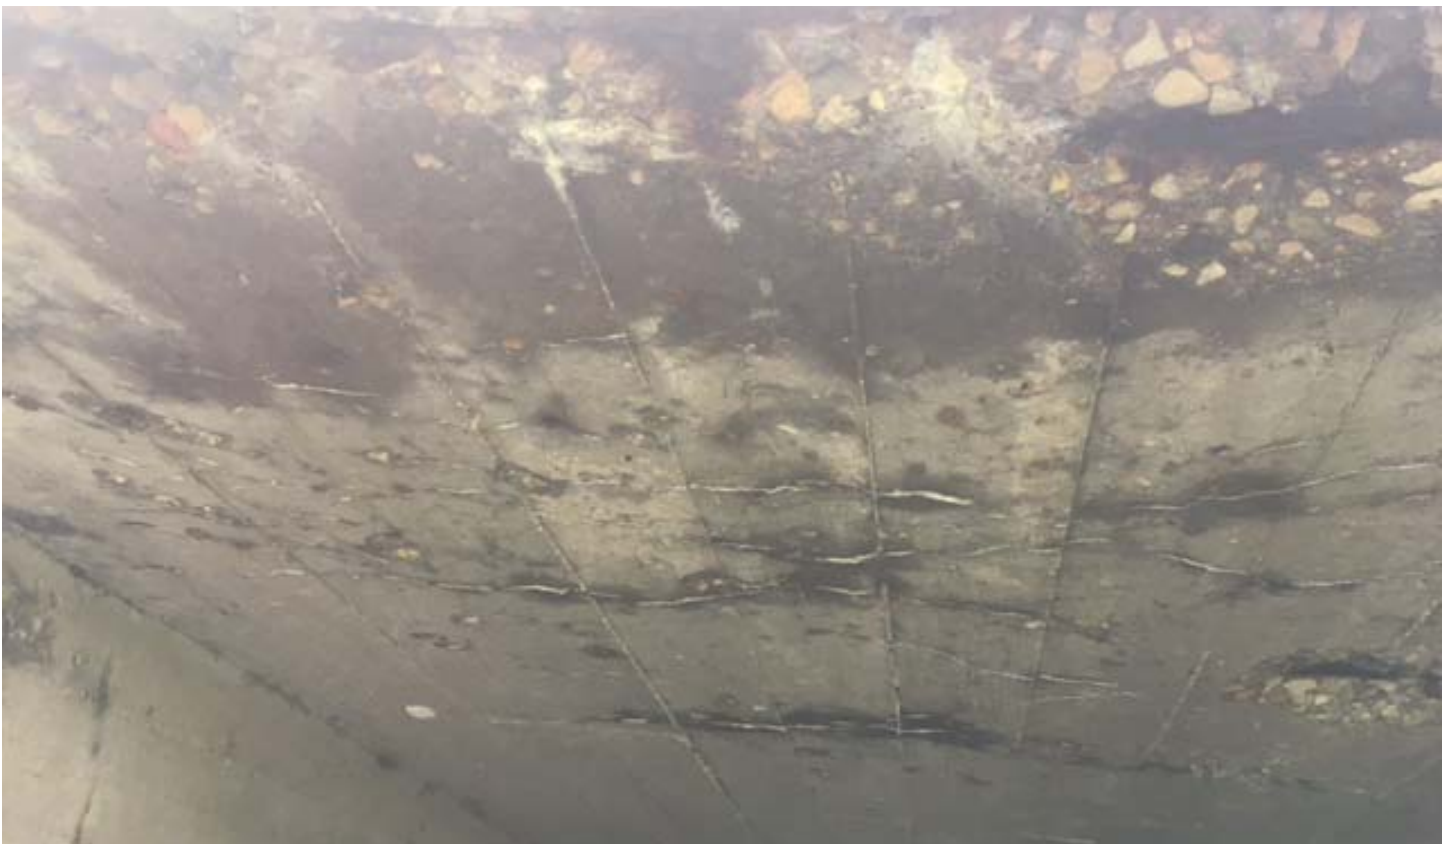
Photo 14 - Top Slab Map Cracking at North End

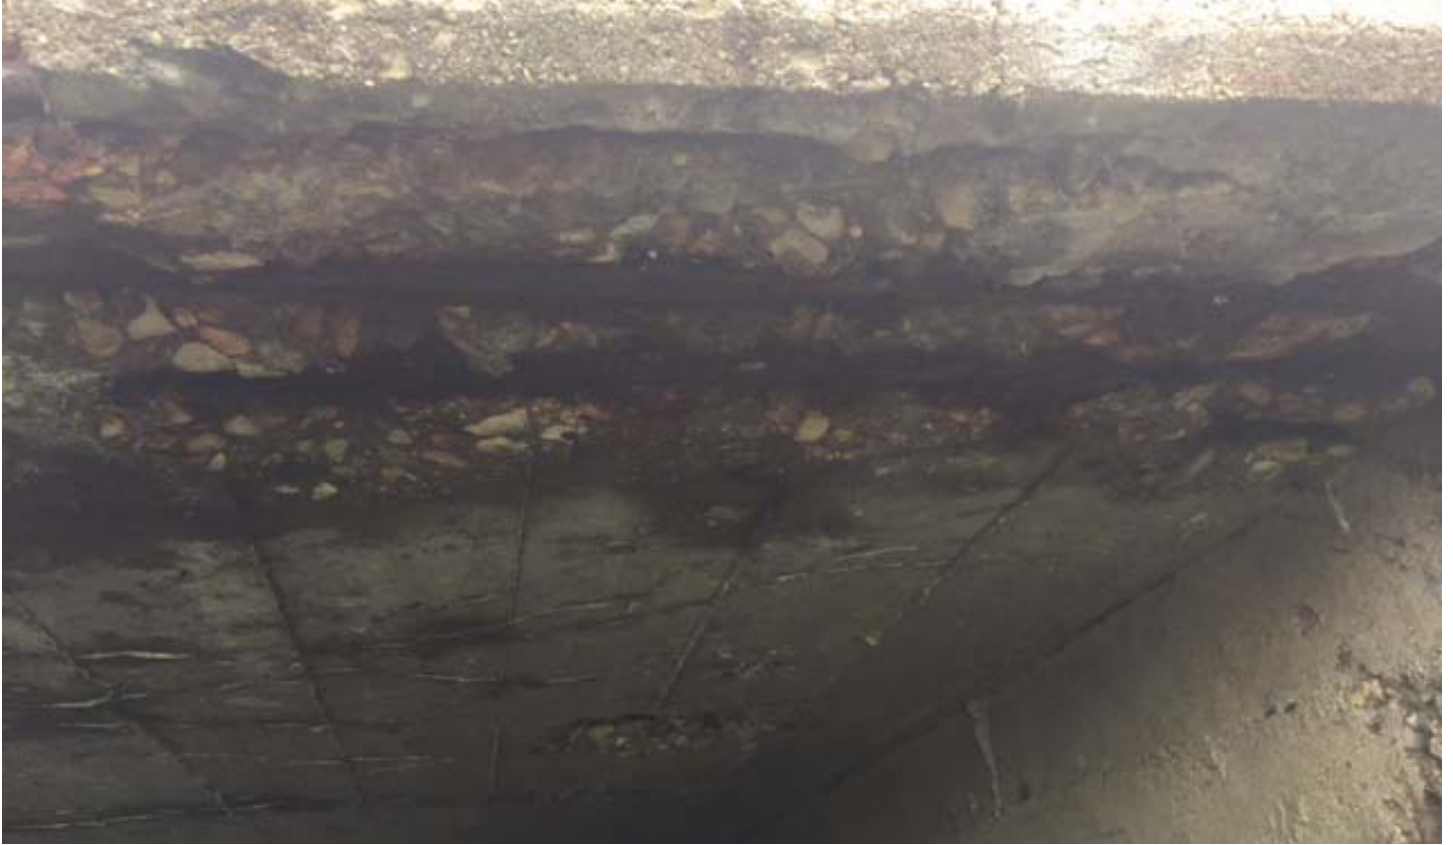
Photo 15 - North Headwall Spalls with Reinforcement
