Randall Road at Red Gate Road
(Pace Route 801)

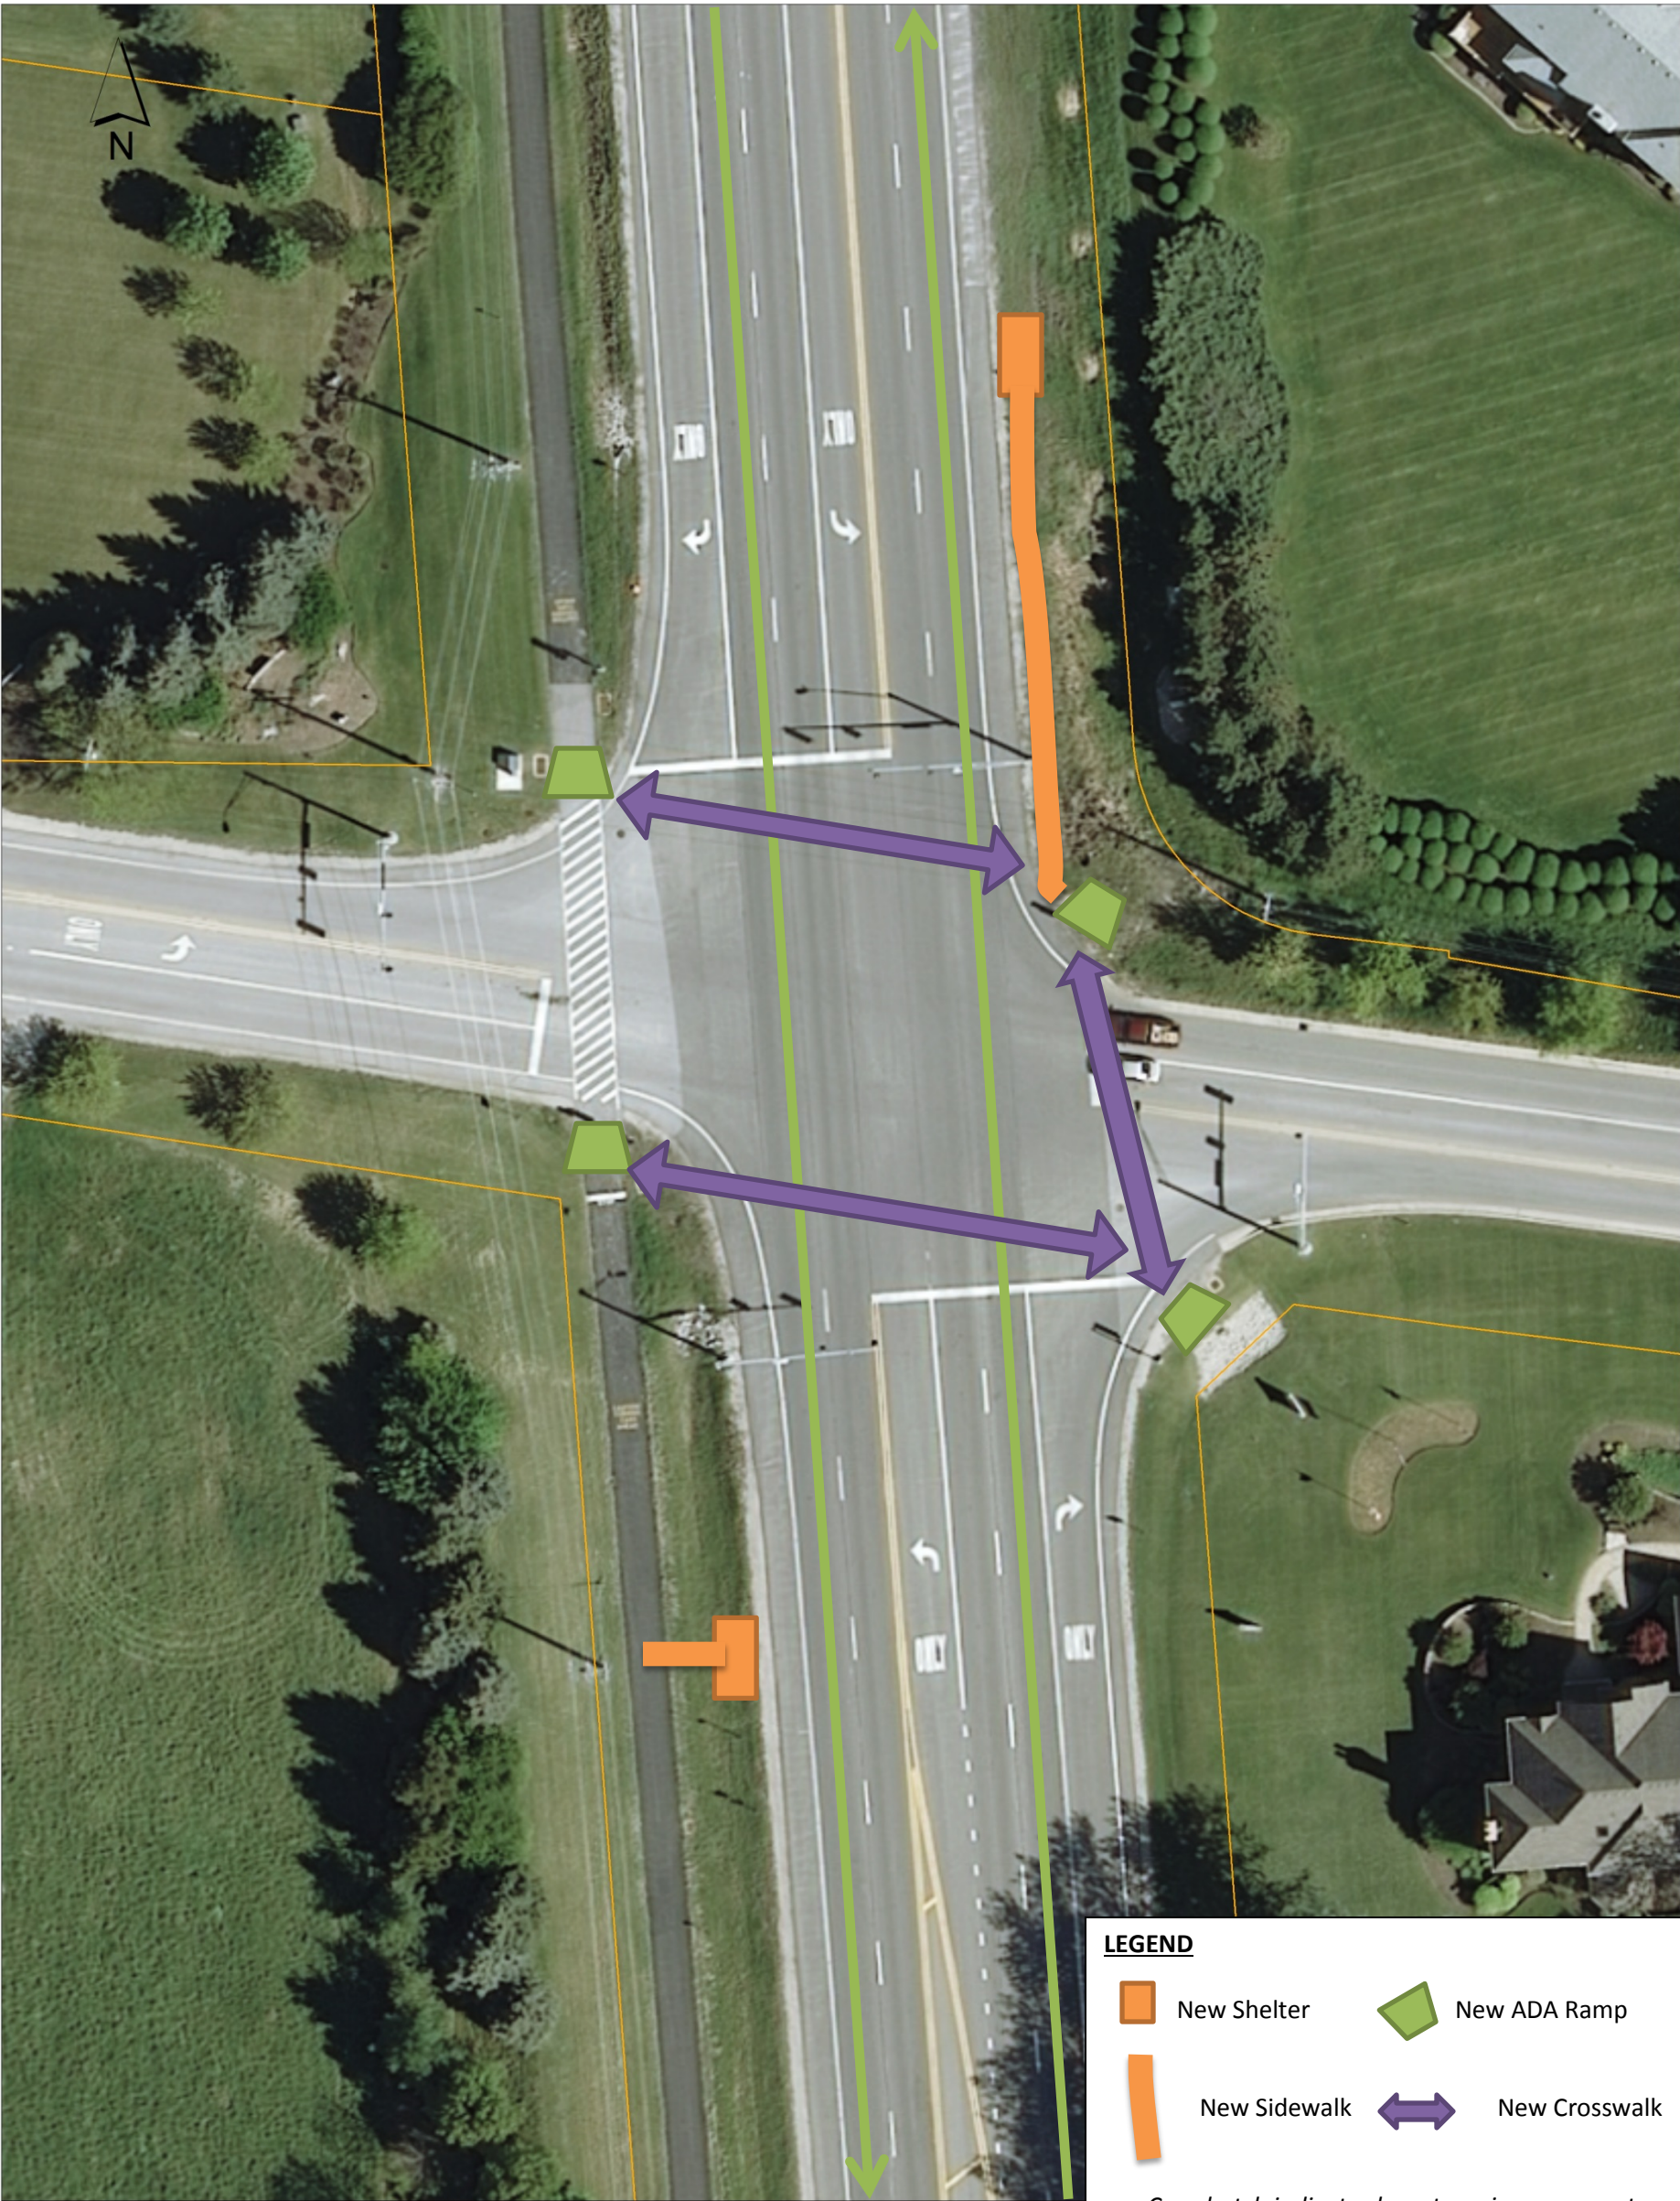
Existing Conditions	NE	NW	SW	SE	Notes: No boardings No alightings
Pedestrian signals	No	Yes	Yes	No	
ADA ramps	No	No	No	No	
Crosswalk	No	Yes	Yes	No	
Shelter possible	No	No	No	No	
Additional sidewalk needed	100 LF	No	30 LF	No

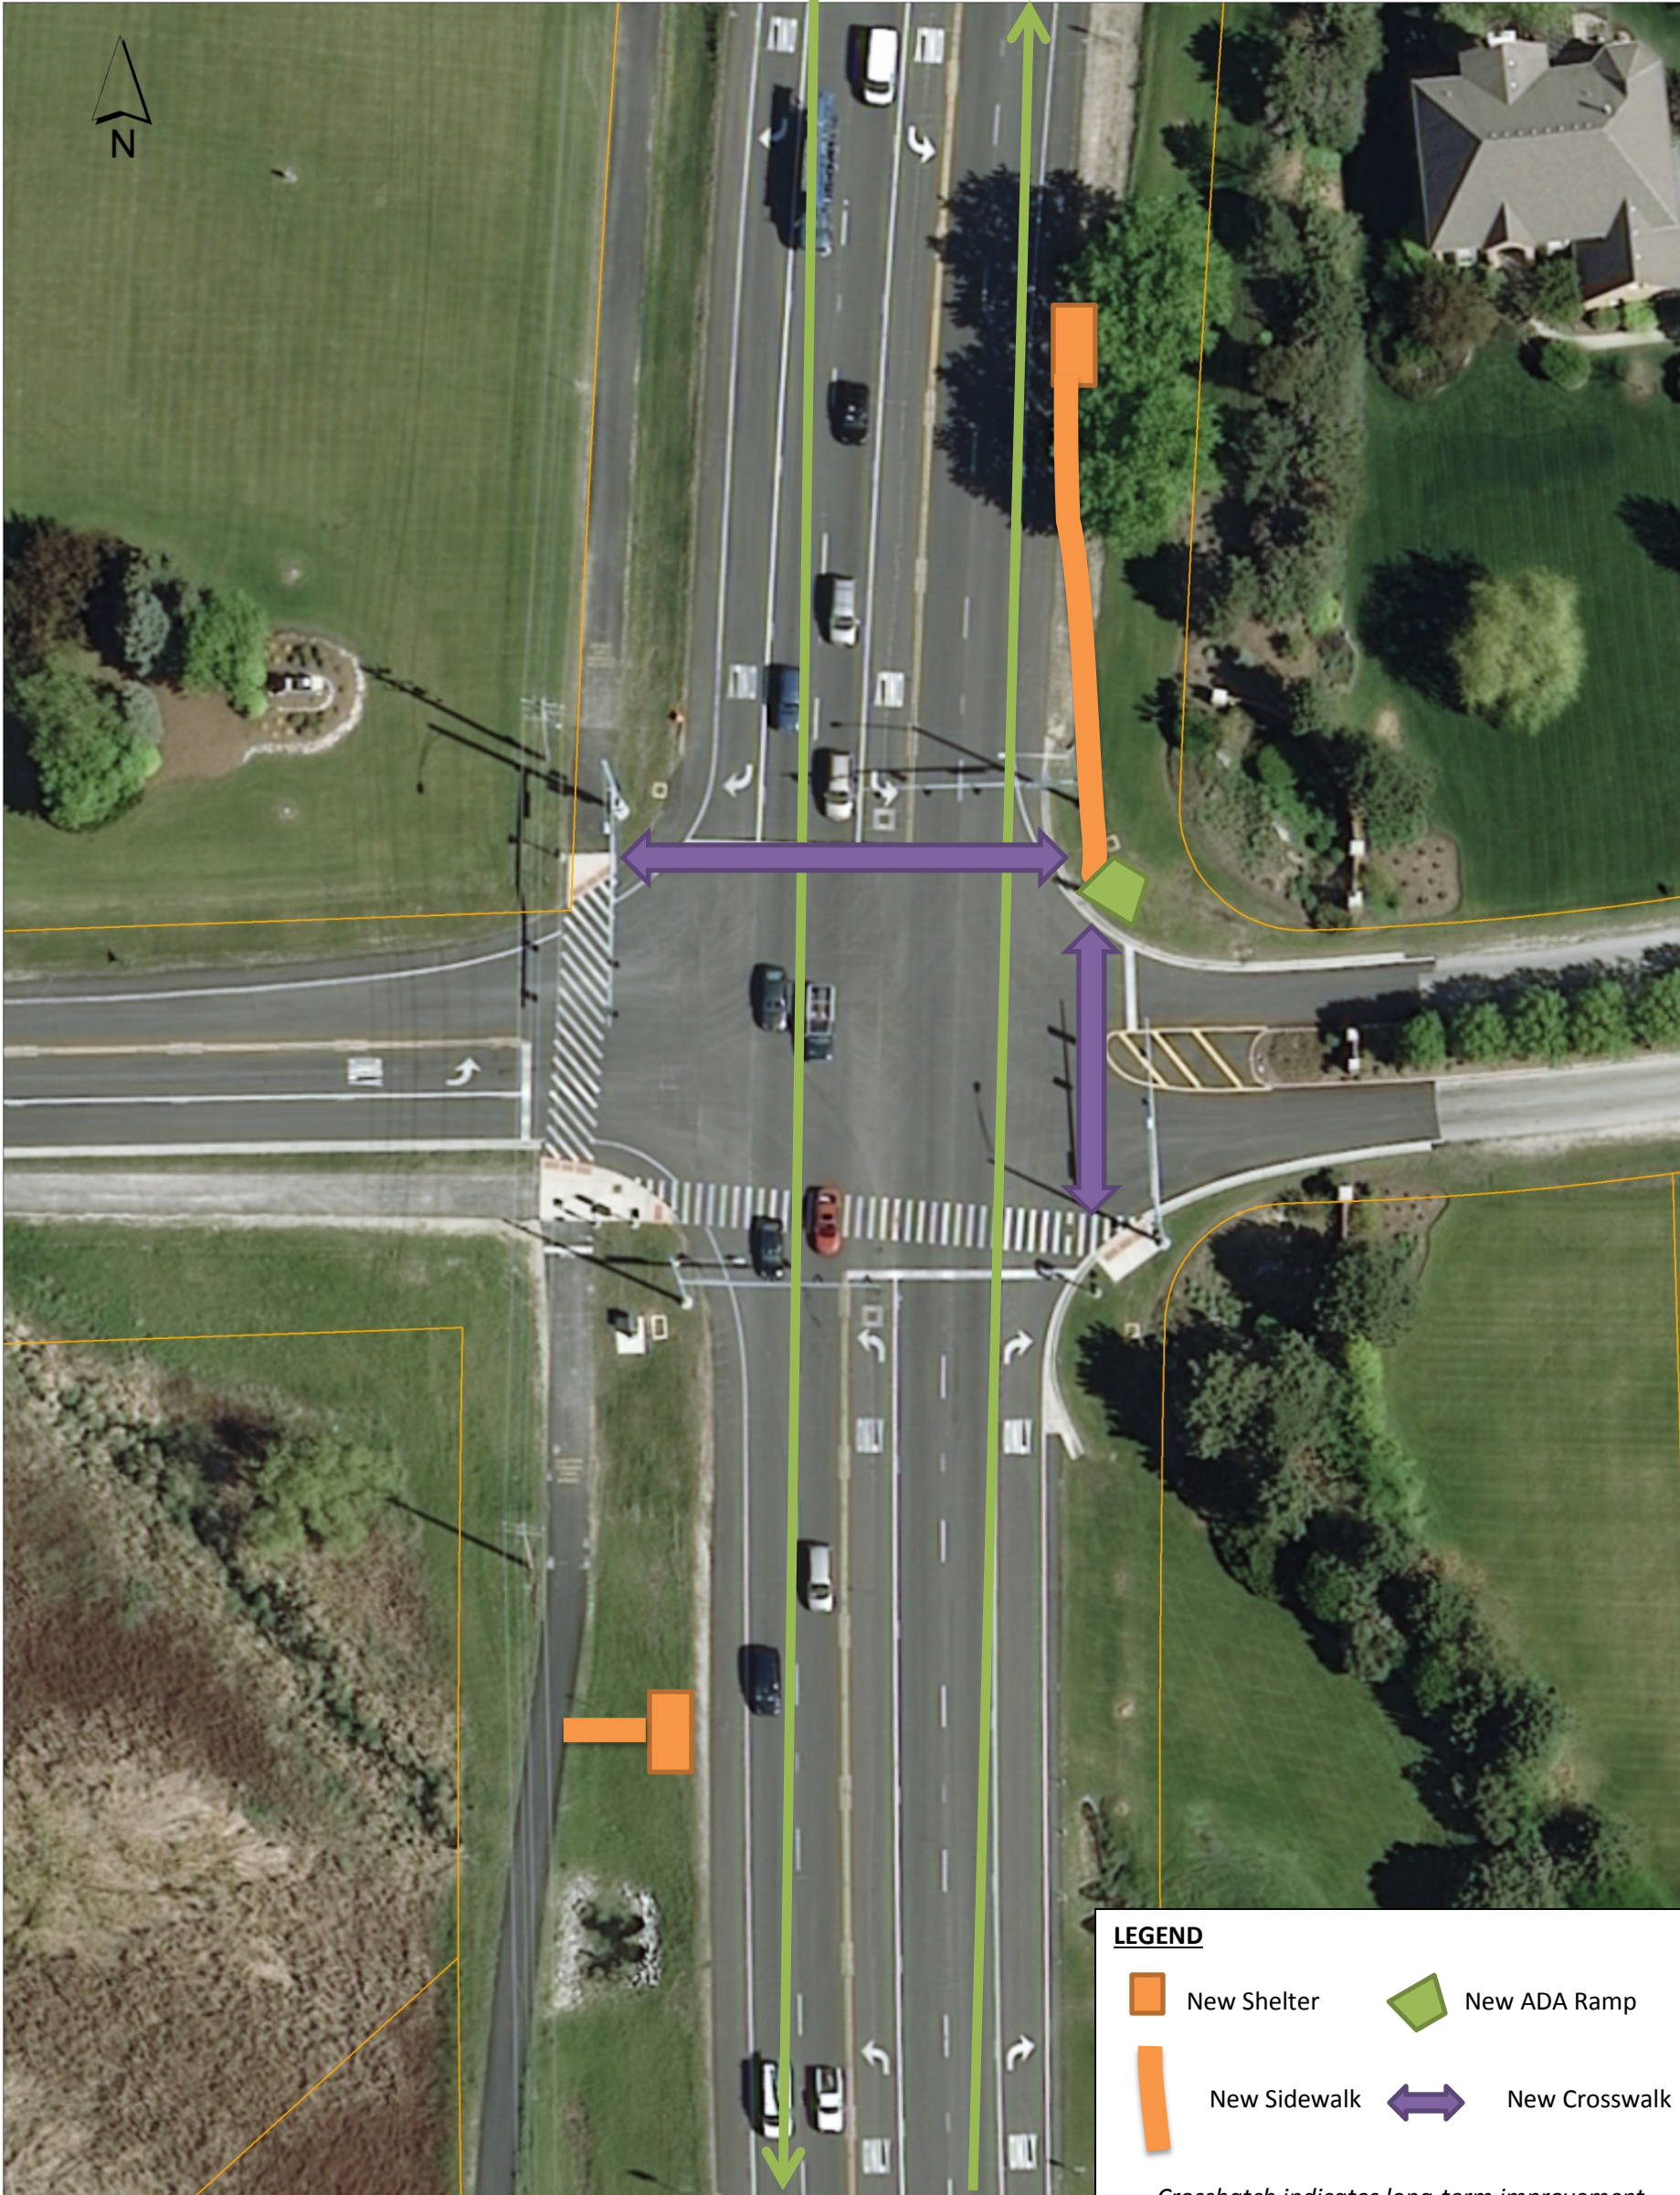
Randall Road at Bolcum Road
(Pace Route 801)

Existing Conditions	NE	NW	SW	SE	Notes: Culverts on northeast and southeast. Large grade different between pavement and bike path on northwest and southwest corners. Large church on northwest corner, with private school behind to the west. Dangerous mid-block stop about ½ mile north of this intersection.
Pedestrian signals	No	Yes	Yes	No	
ADA ramps	No	Yes	Yes	No	
Crosswalk	No	Yes	Yes	No	
Shelter possible	No	No	No	No	
Additional sidewalk needed	100 LF	No	30 LF	No	No boardings No alightings

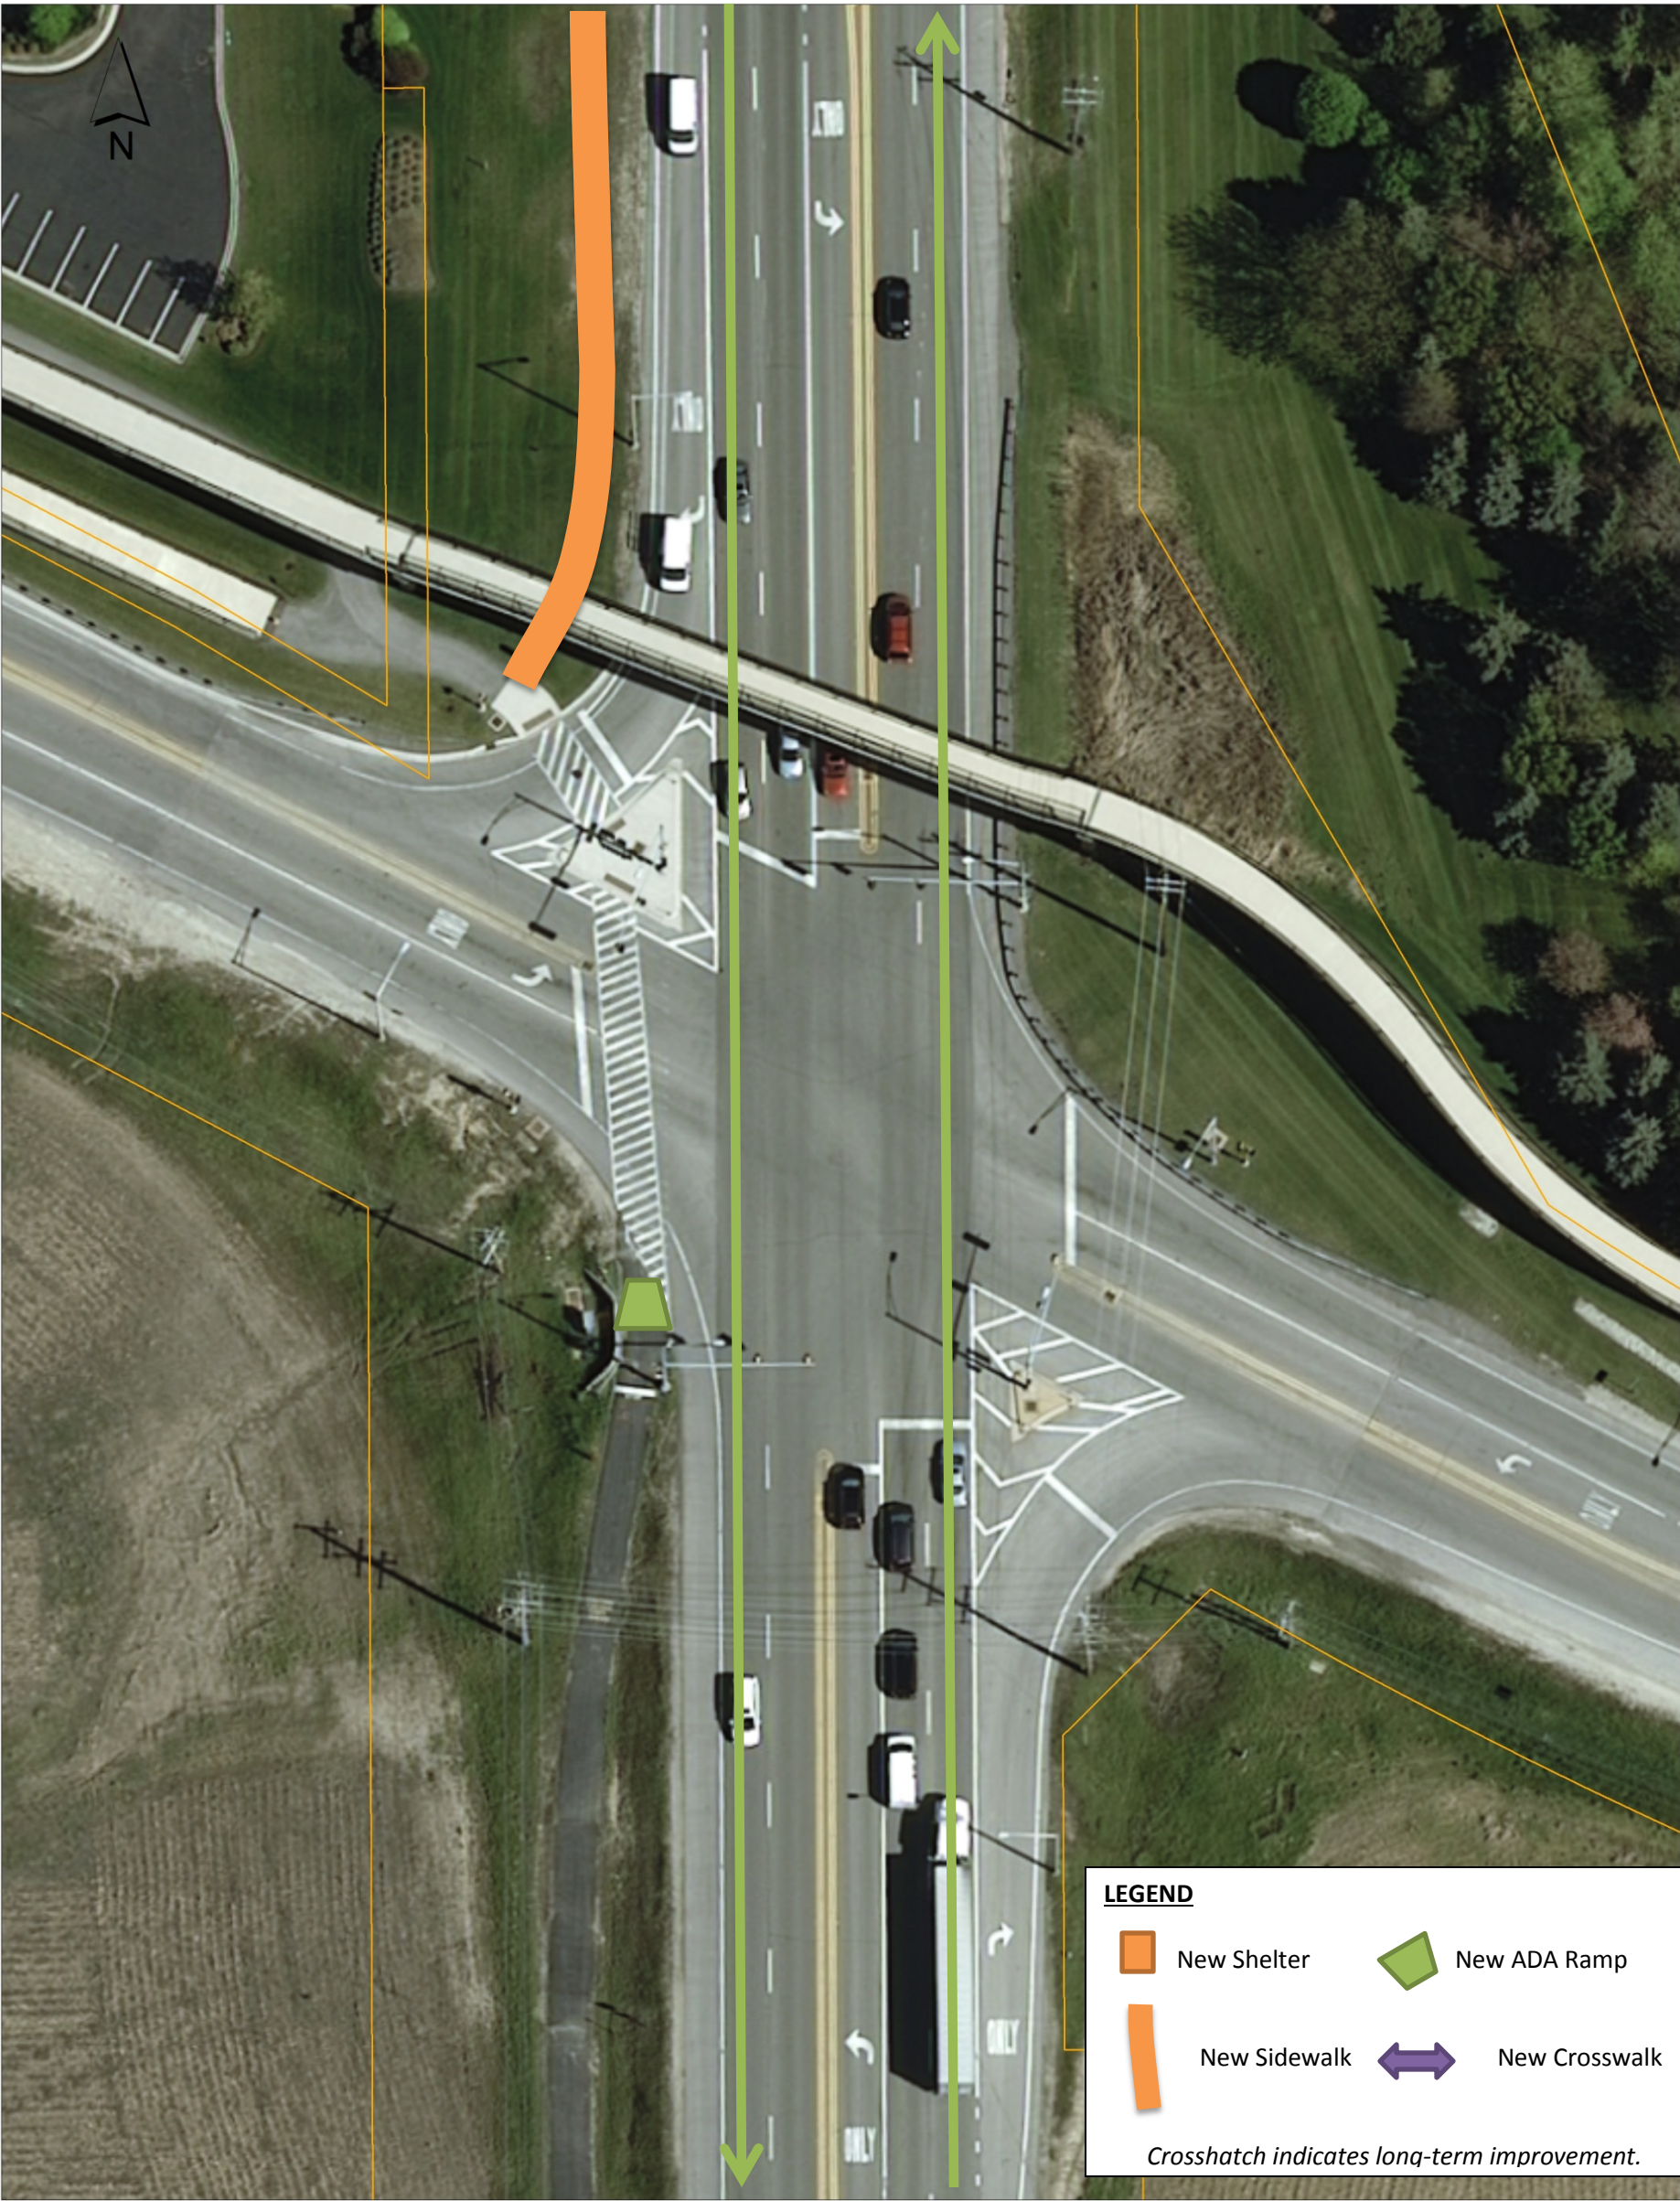
Randall Road at Silver Glen Road
(Pace Route 801)

Existing Conditions	NE	NW	SW	SE	Notes: Difficult shelter placement on northbound with overpass and culvert with barrier along ROW on the north side. Overpass acts as east/west pedestrian crossing. Dangerous mid-block stop about ½ mile south of intersection. <i>*New sidewalk/path on west side north to Thornwood.</i> No boardings No alightings
Pedestrian signals	See Note	Yes	Yes	No	
ADA ramps	See Note	Yes	No	No	
Crosswalk	See Note	Yes	Yes	No	
Shelter	No	No	No	No	
Additional sidewalk needed	*	No	20 LF	No

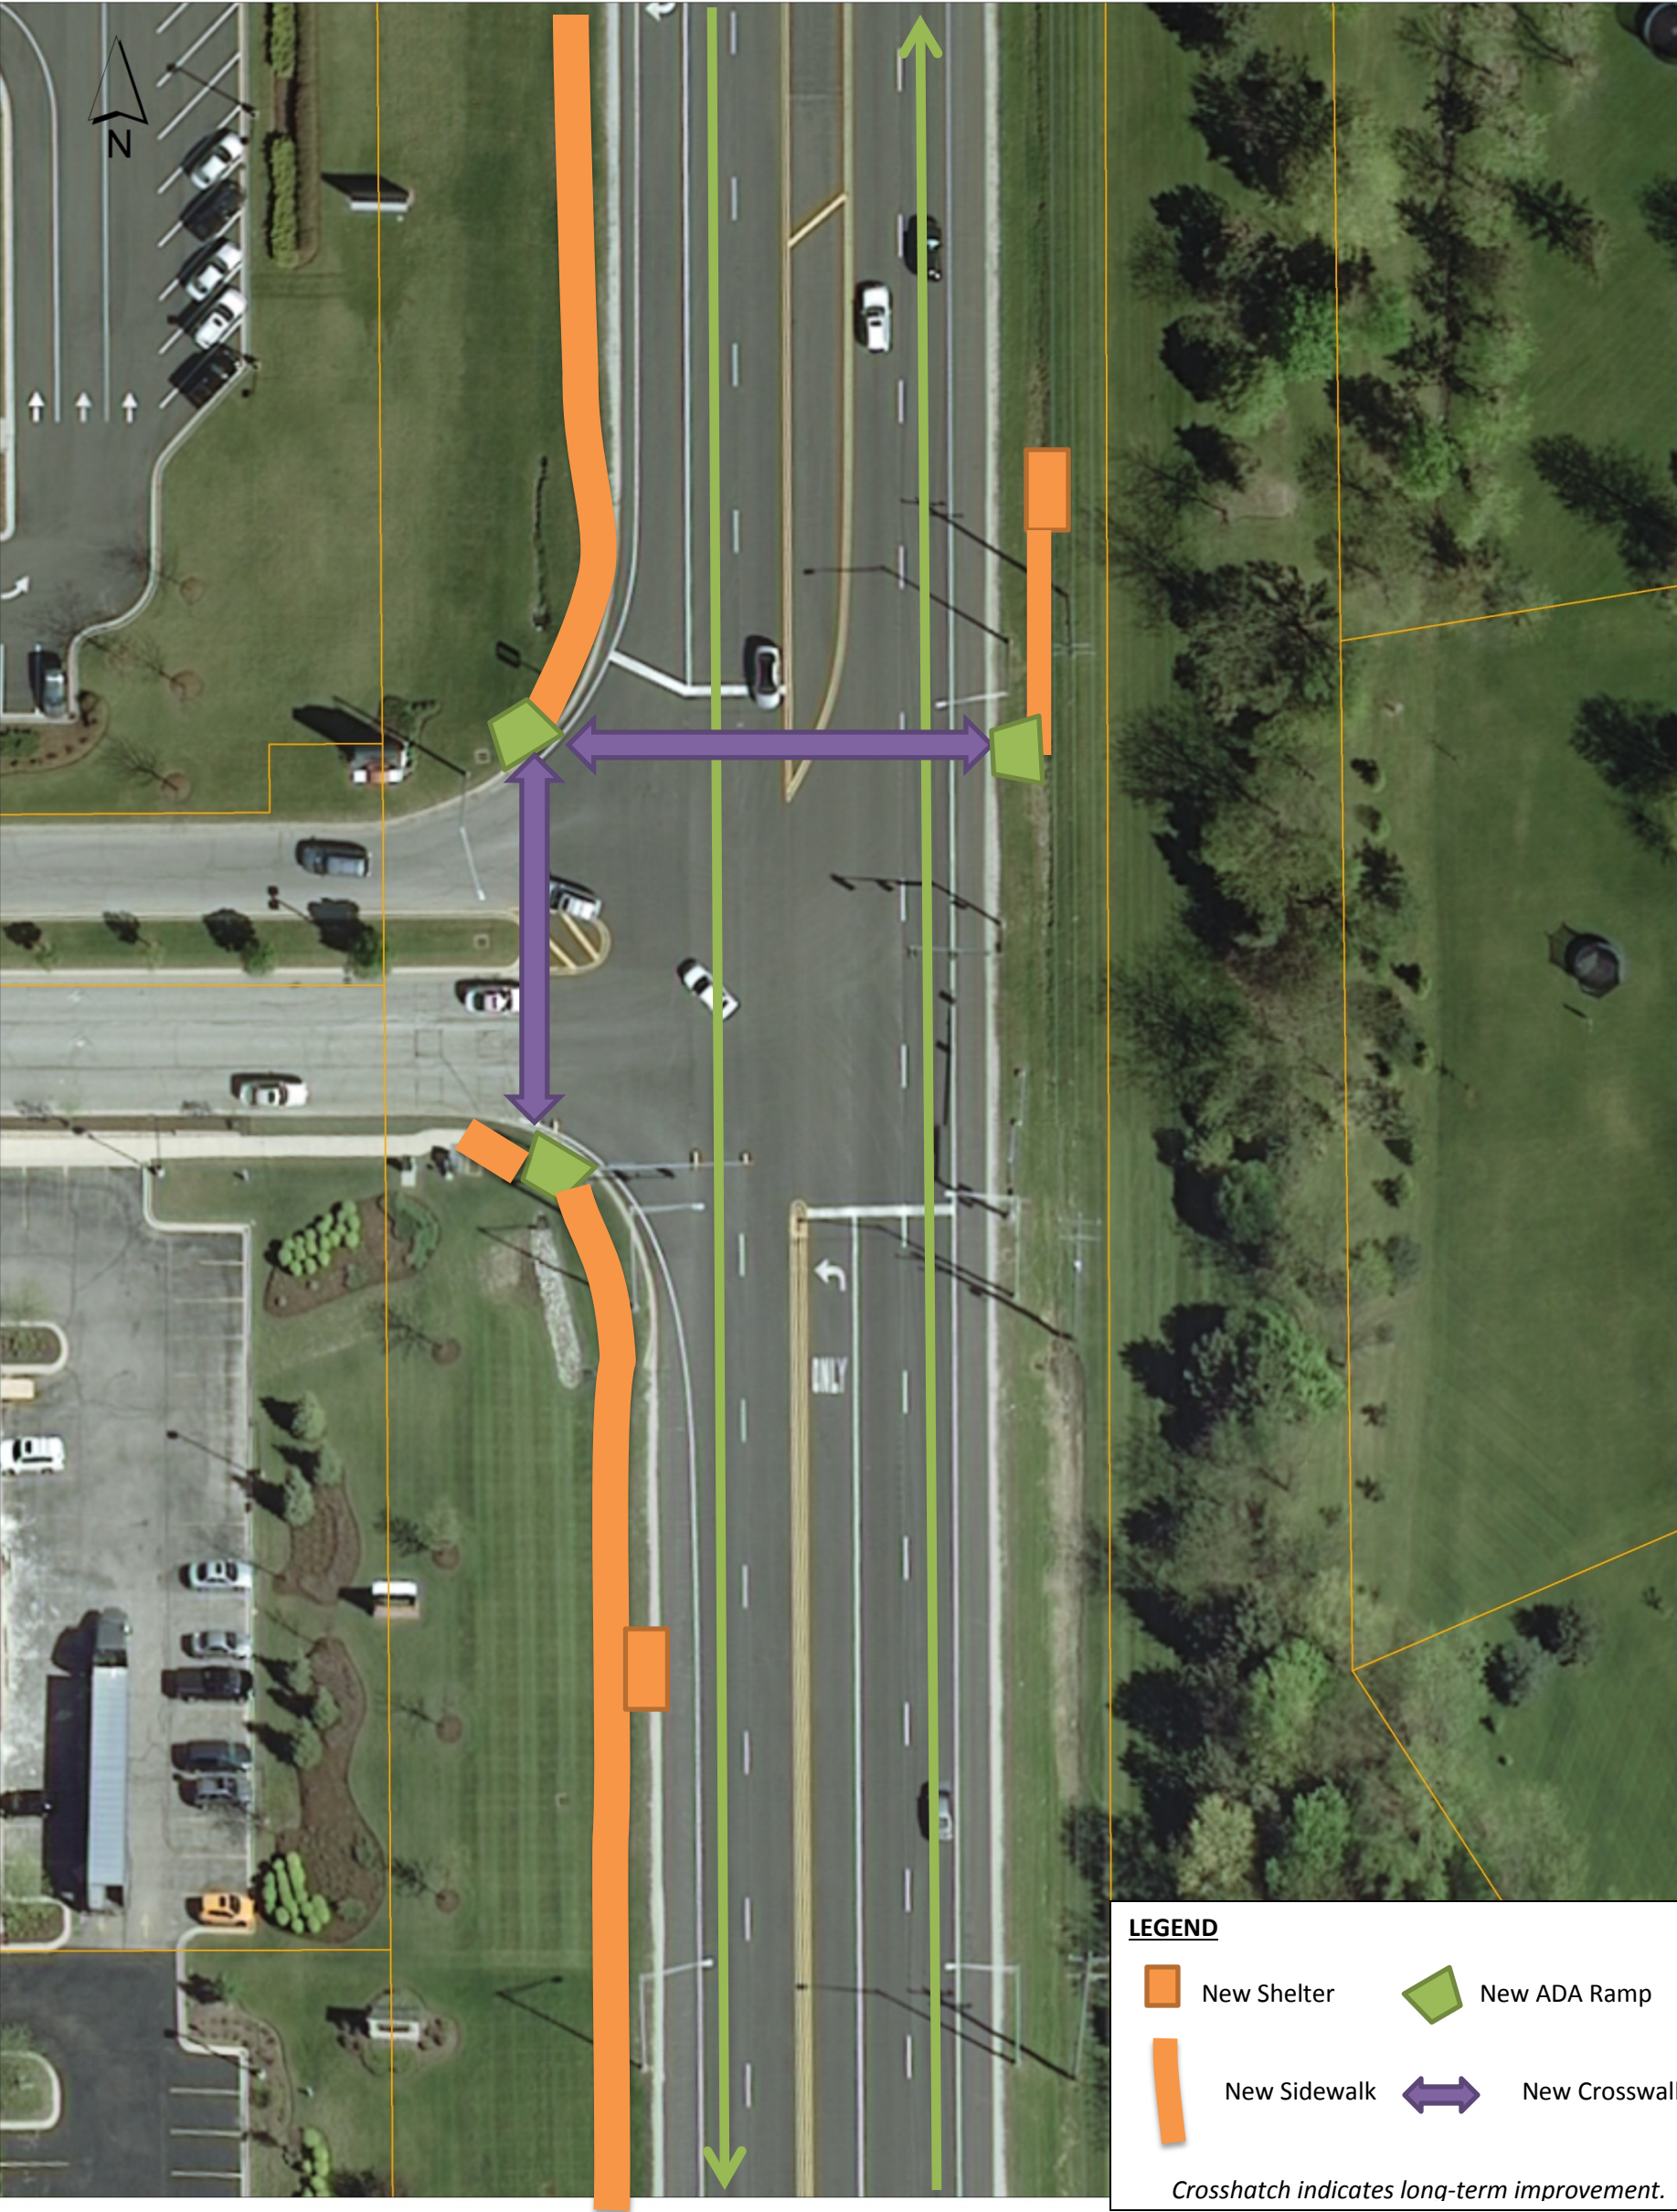
Randall Road at Pamela Road
(Pace Route 801)

Existing Conditions	NE	NW	SW	SE	Notes: <i>*New sidepath on west side north from Silver Glen to Thornwood.</i> No boardings 1 alighting
Pedestrian signals	No	No	No	No	
ADA ramps	No	No	No	No	
Crosswalk	No	No	No	No	
Shelter	No	No	No	No	
Additional sidewalk needed	No	*	*	No

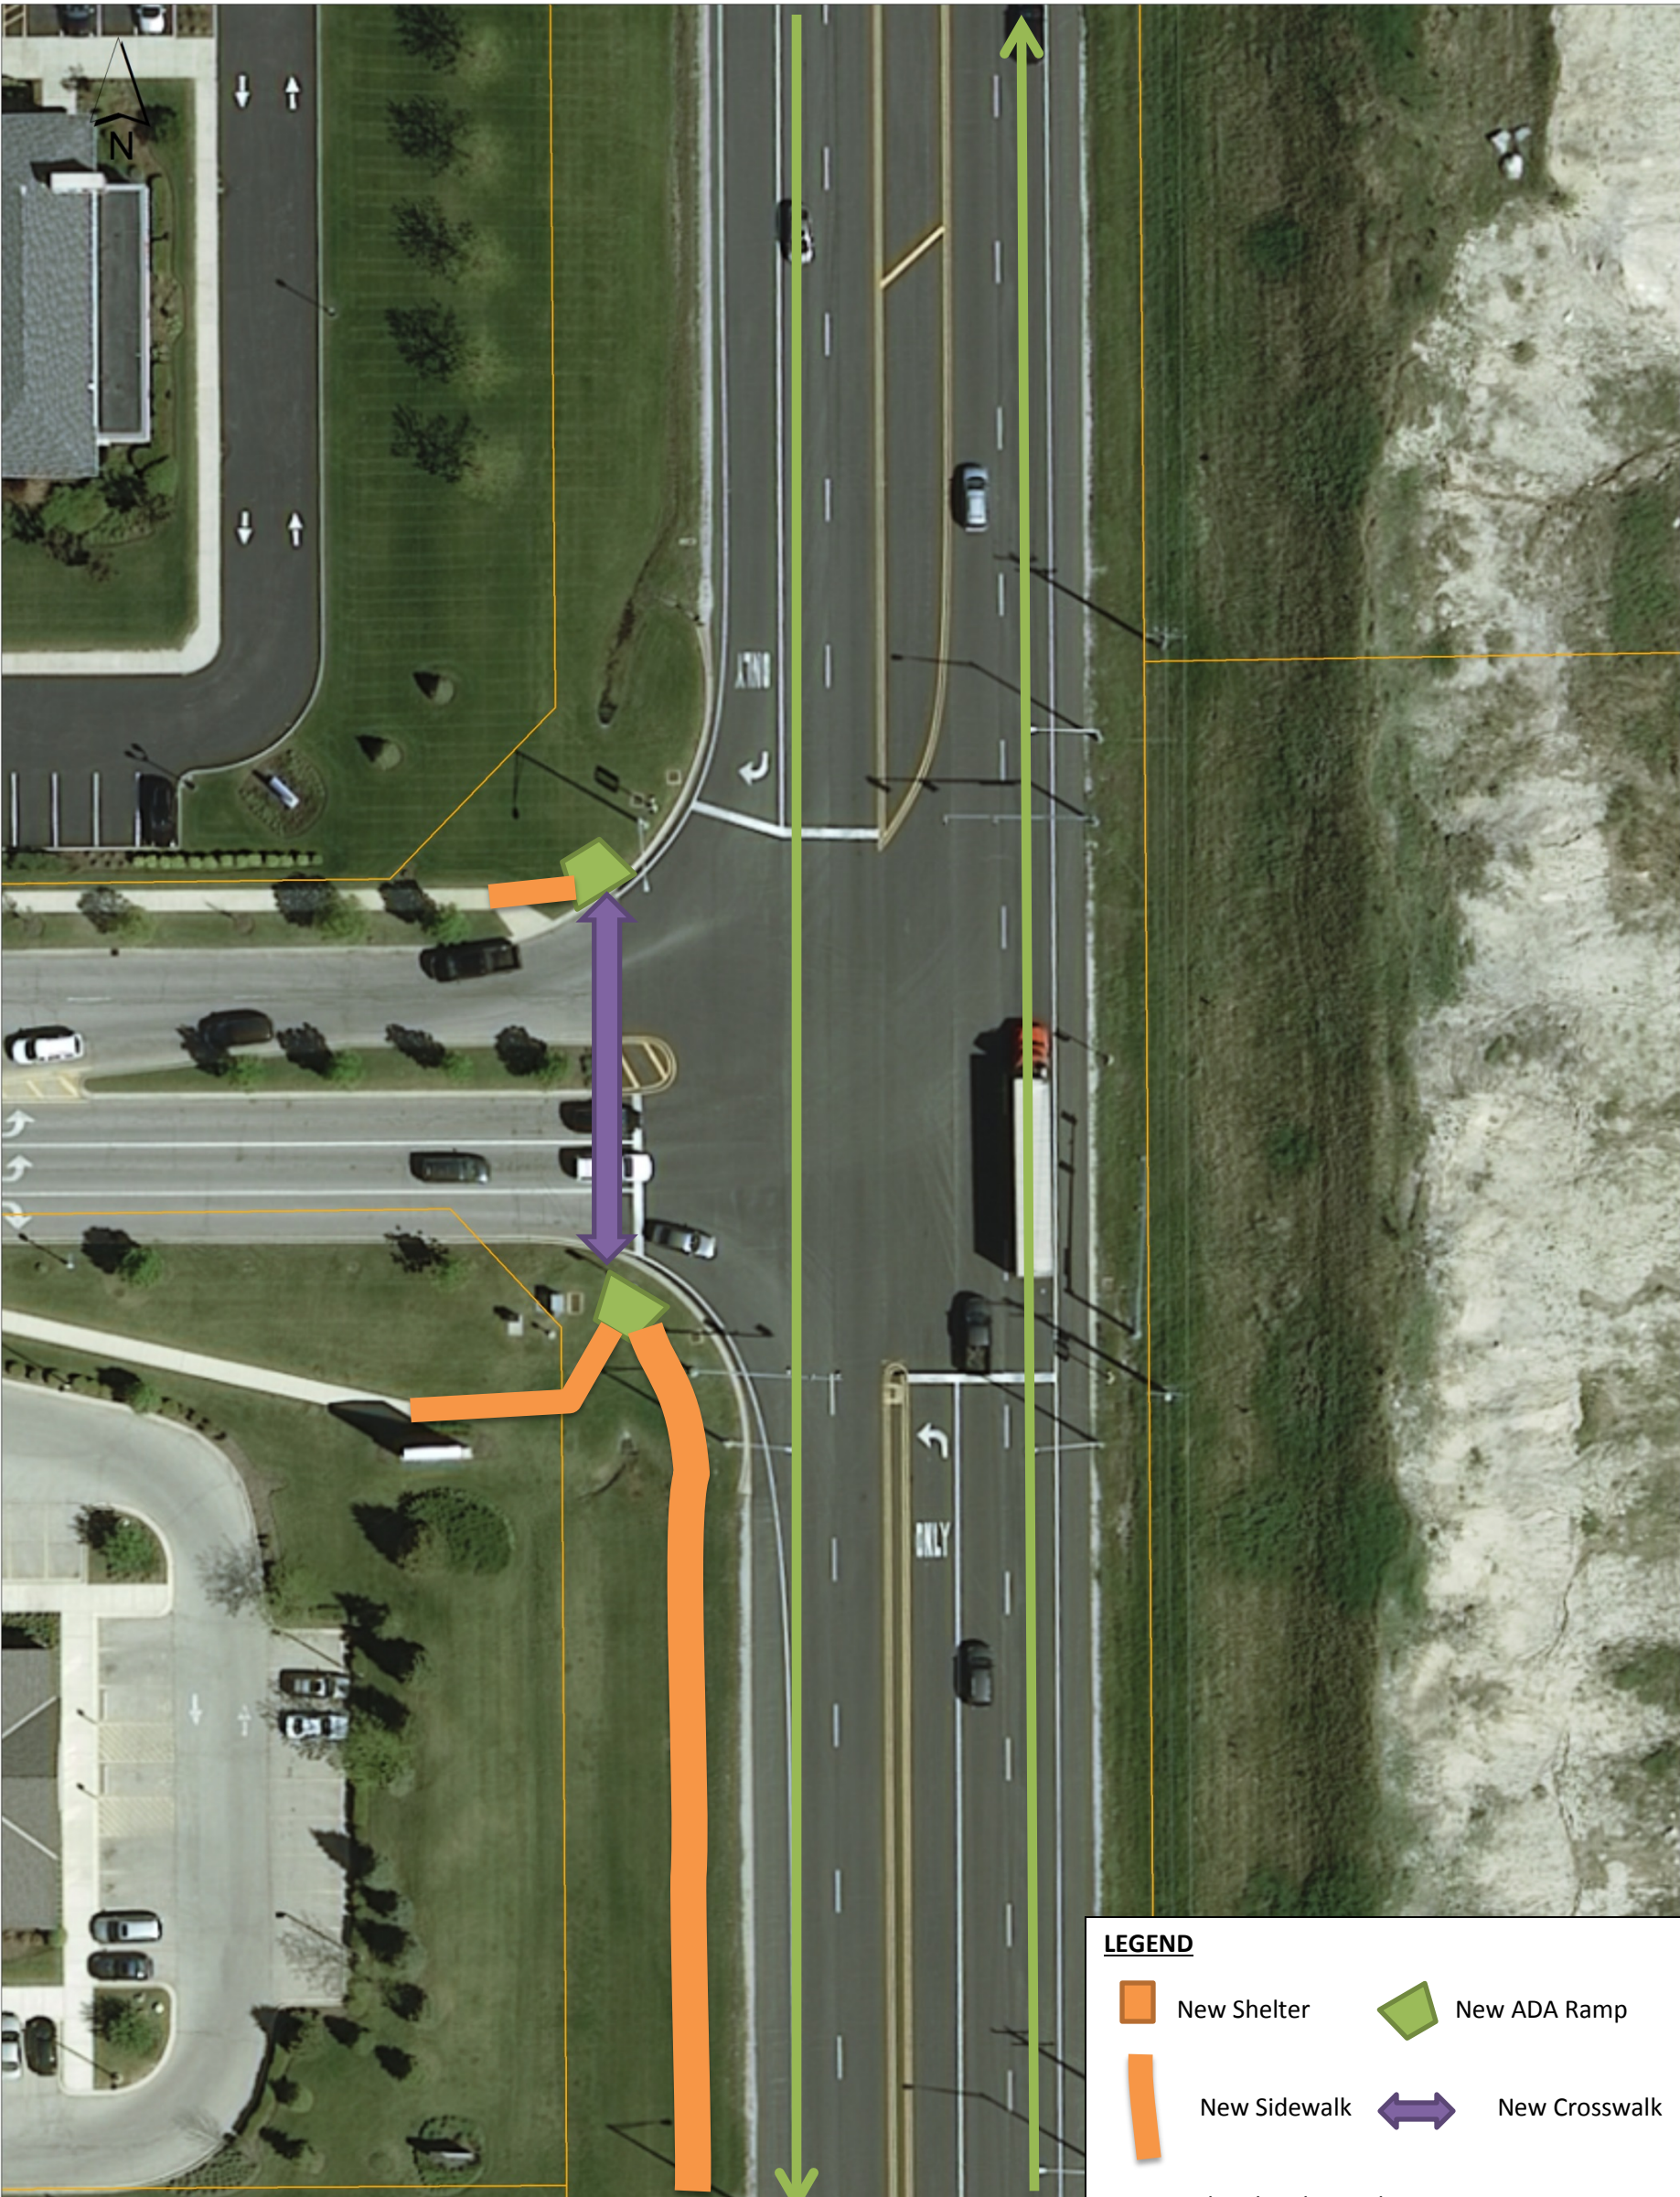
Randall Road at Thornwood
(Pace Route 801)

Existing Conditions	NE	NW	SW	SE	<div>Notes: Pace recently installed a shelter on the Southwest Corner at bus's turnout of shopping center going Southbound. To east, low density single family residential and a gravel pit.</div> <div>*New sidewalk/path on west side south to Silver Glen.</div> <div>No boardings</div> <div>No alightings</div>
Pedestrian signals	No	No	No	No	
ADA ramps	No	No	No	No	
Crosswalk	No	No	No	No	
Shelter	No	No	Yes	No	
Additional sidewalk needed	No	*	*	No

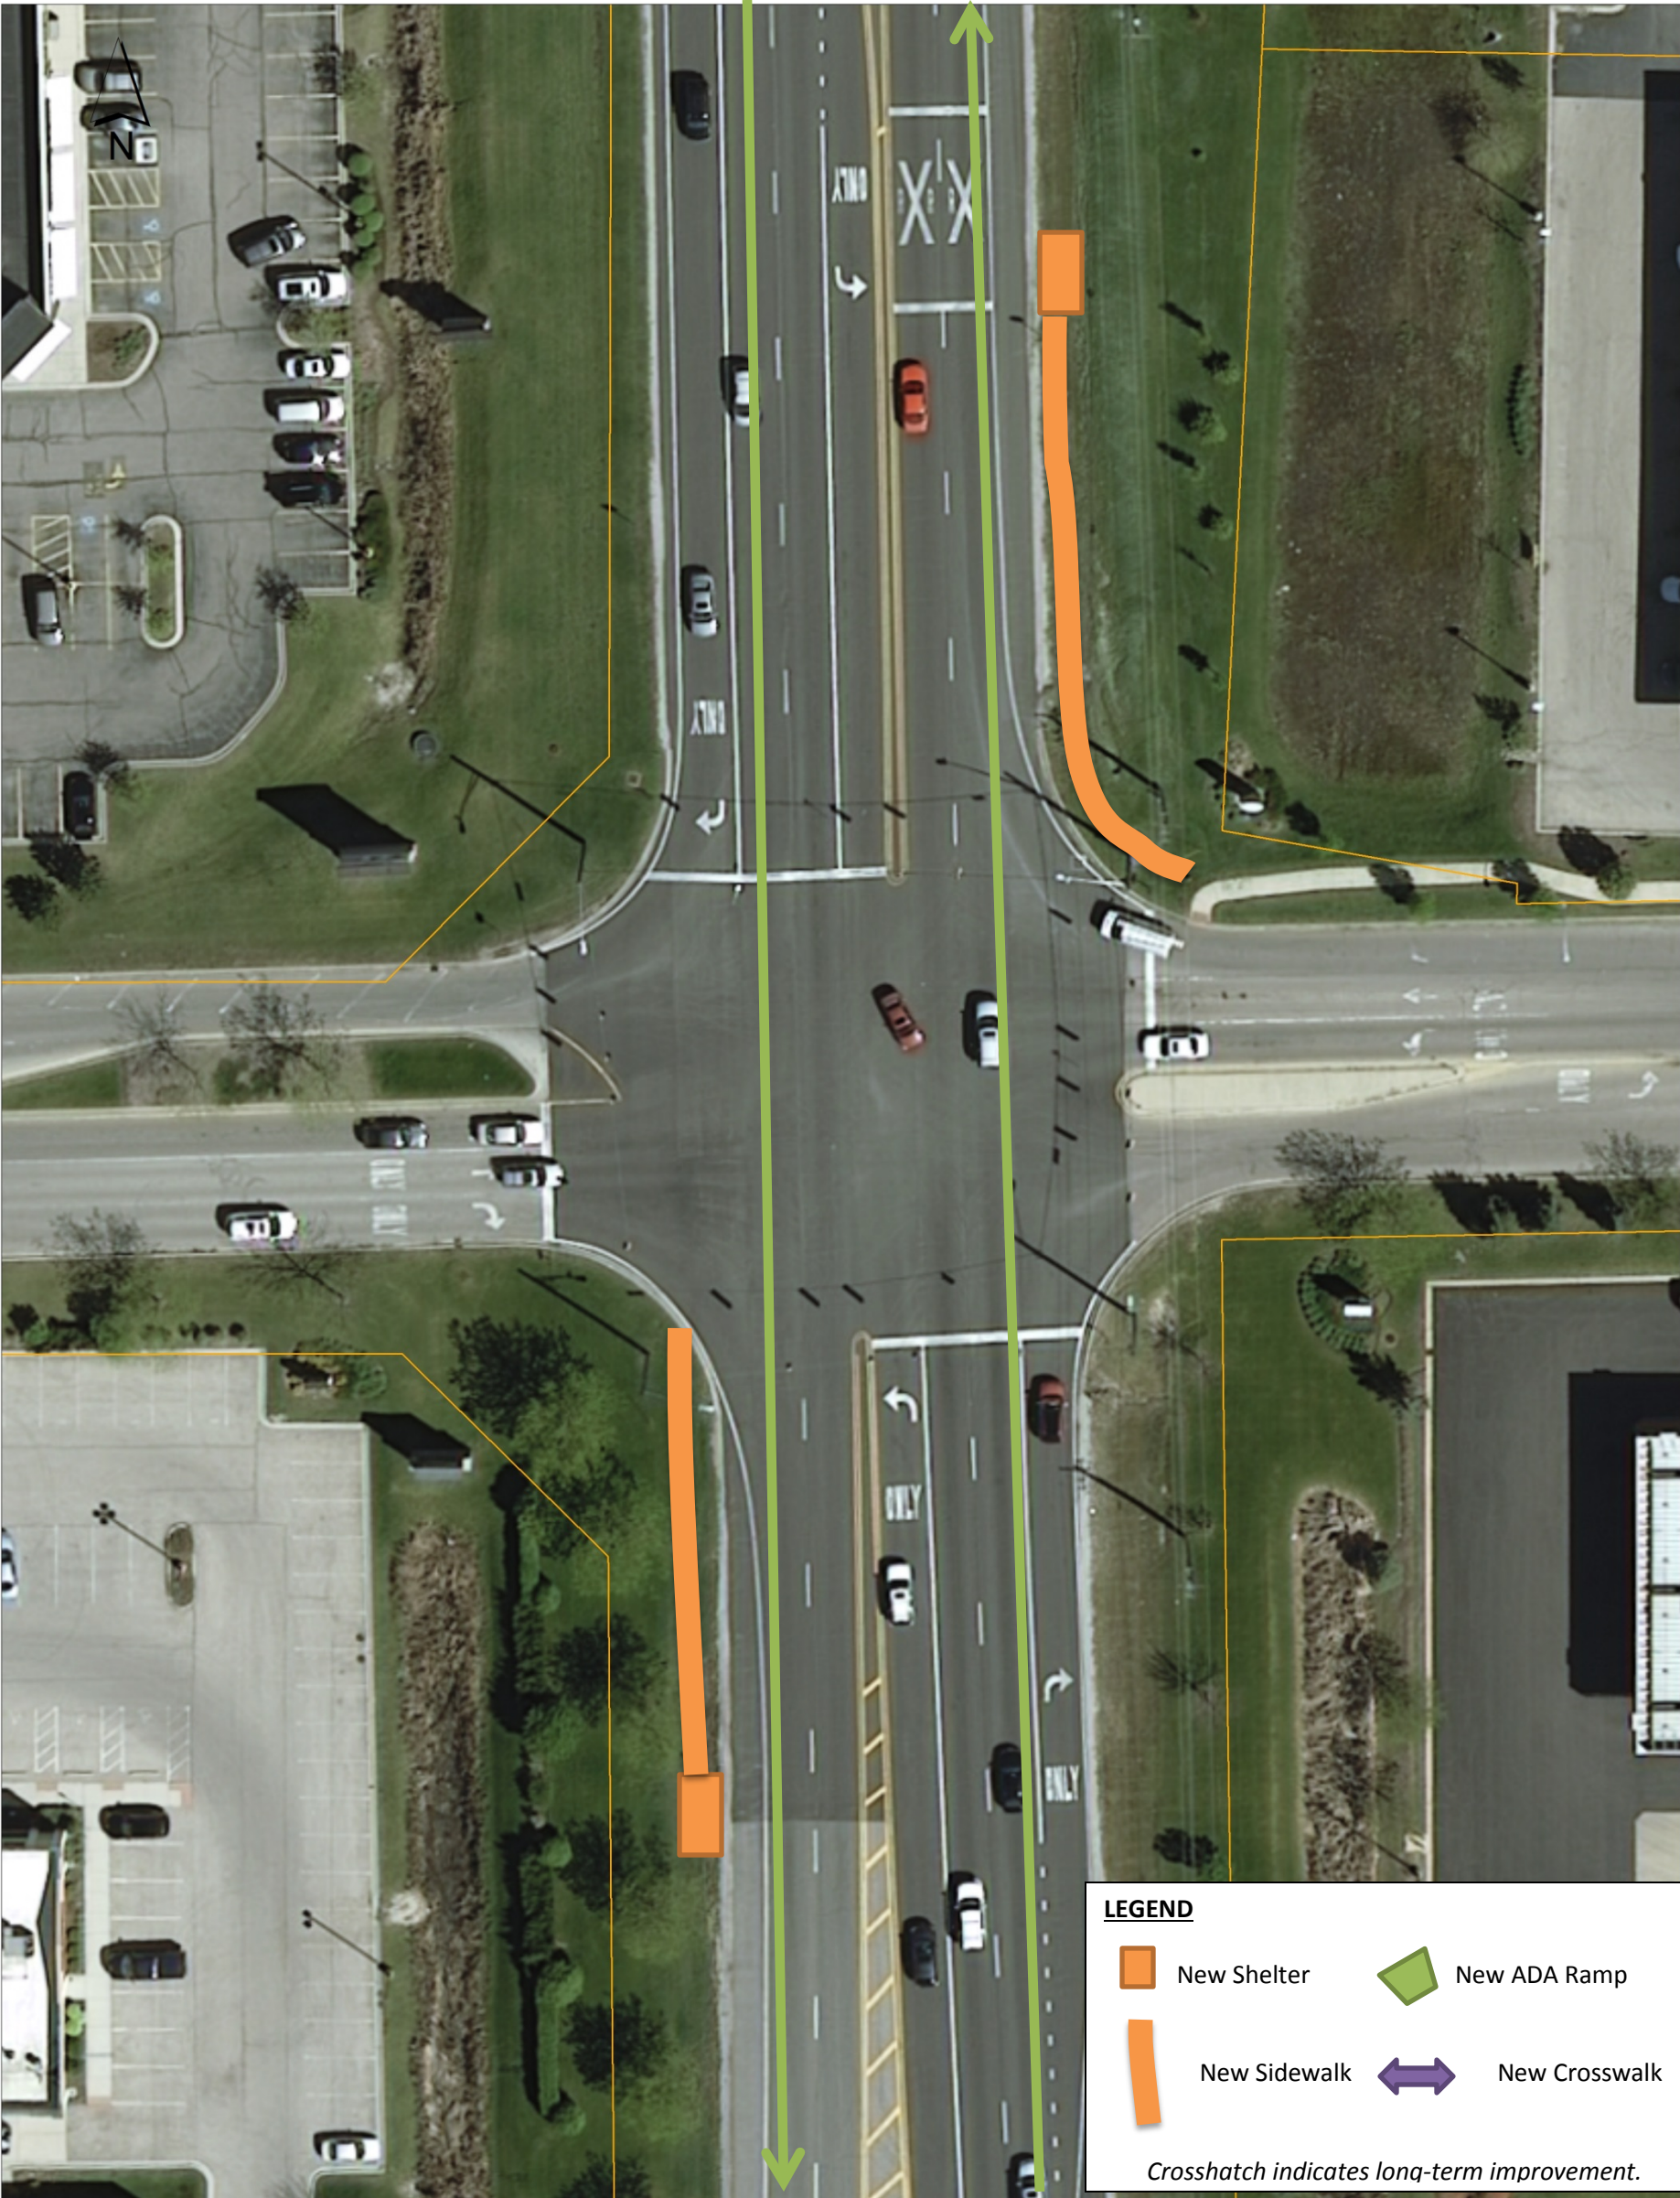
Randall Road at Gyorr Road
(Pace Route 801)

Existing Conditions	NE	NW	SW	SE	Notes: Kane County recently put in crosswalks and ADA ramps and Pace recently installed a shelter and sidewalk on the northeast corner for northbound riders. Sidewalk linkages are needed for the remaining legs. Goodwill, a major employer of handicapped persons, is located west of the intersection. 2 boardings 2 alightings
Pedestrian signals	Yes	Yes	Yes	Yes	
ADA ramps	Yes	Yes	Yes	Yes	
Crosswalk	Yes	Yes	Yes	Yes	
Shelter	See notes	No	No	No	
Additional sidewalk needed	130 LF	No	100 LF	No
