Randall Road at Red Gate Road
(Pace Route 801)

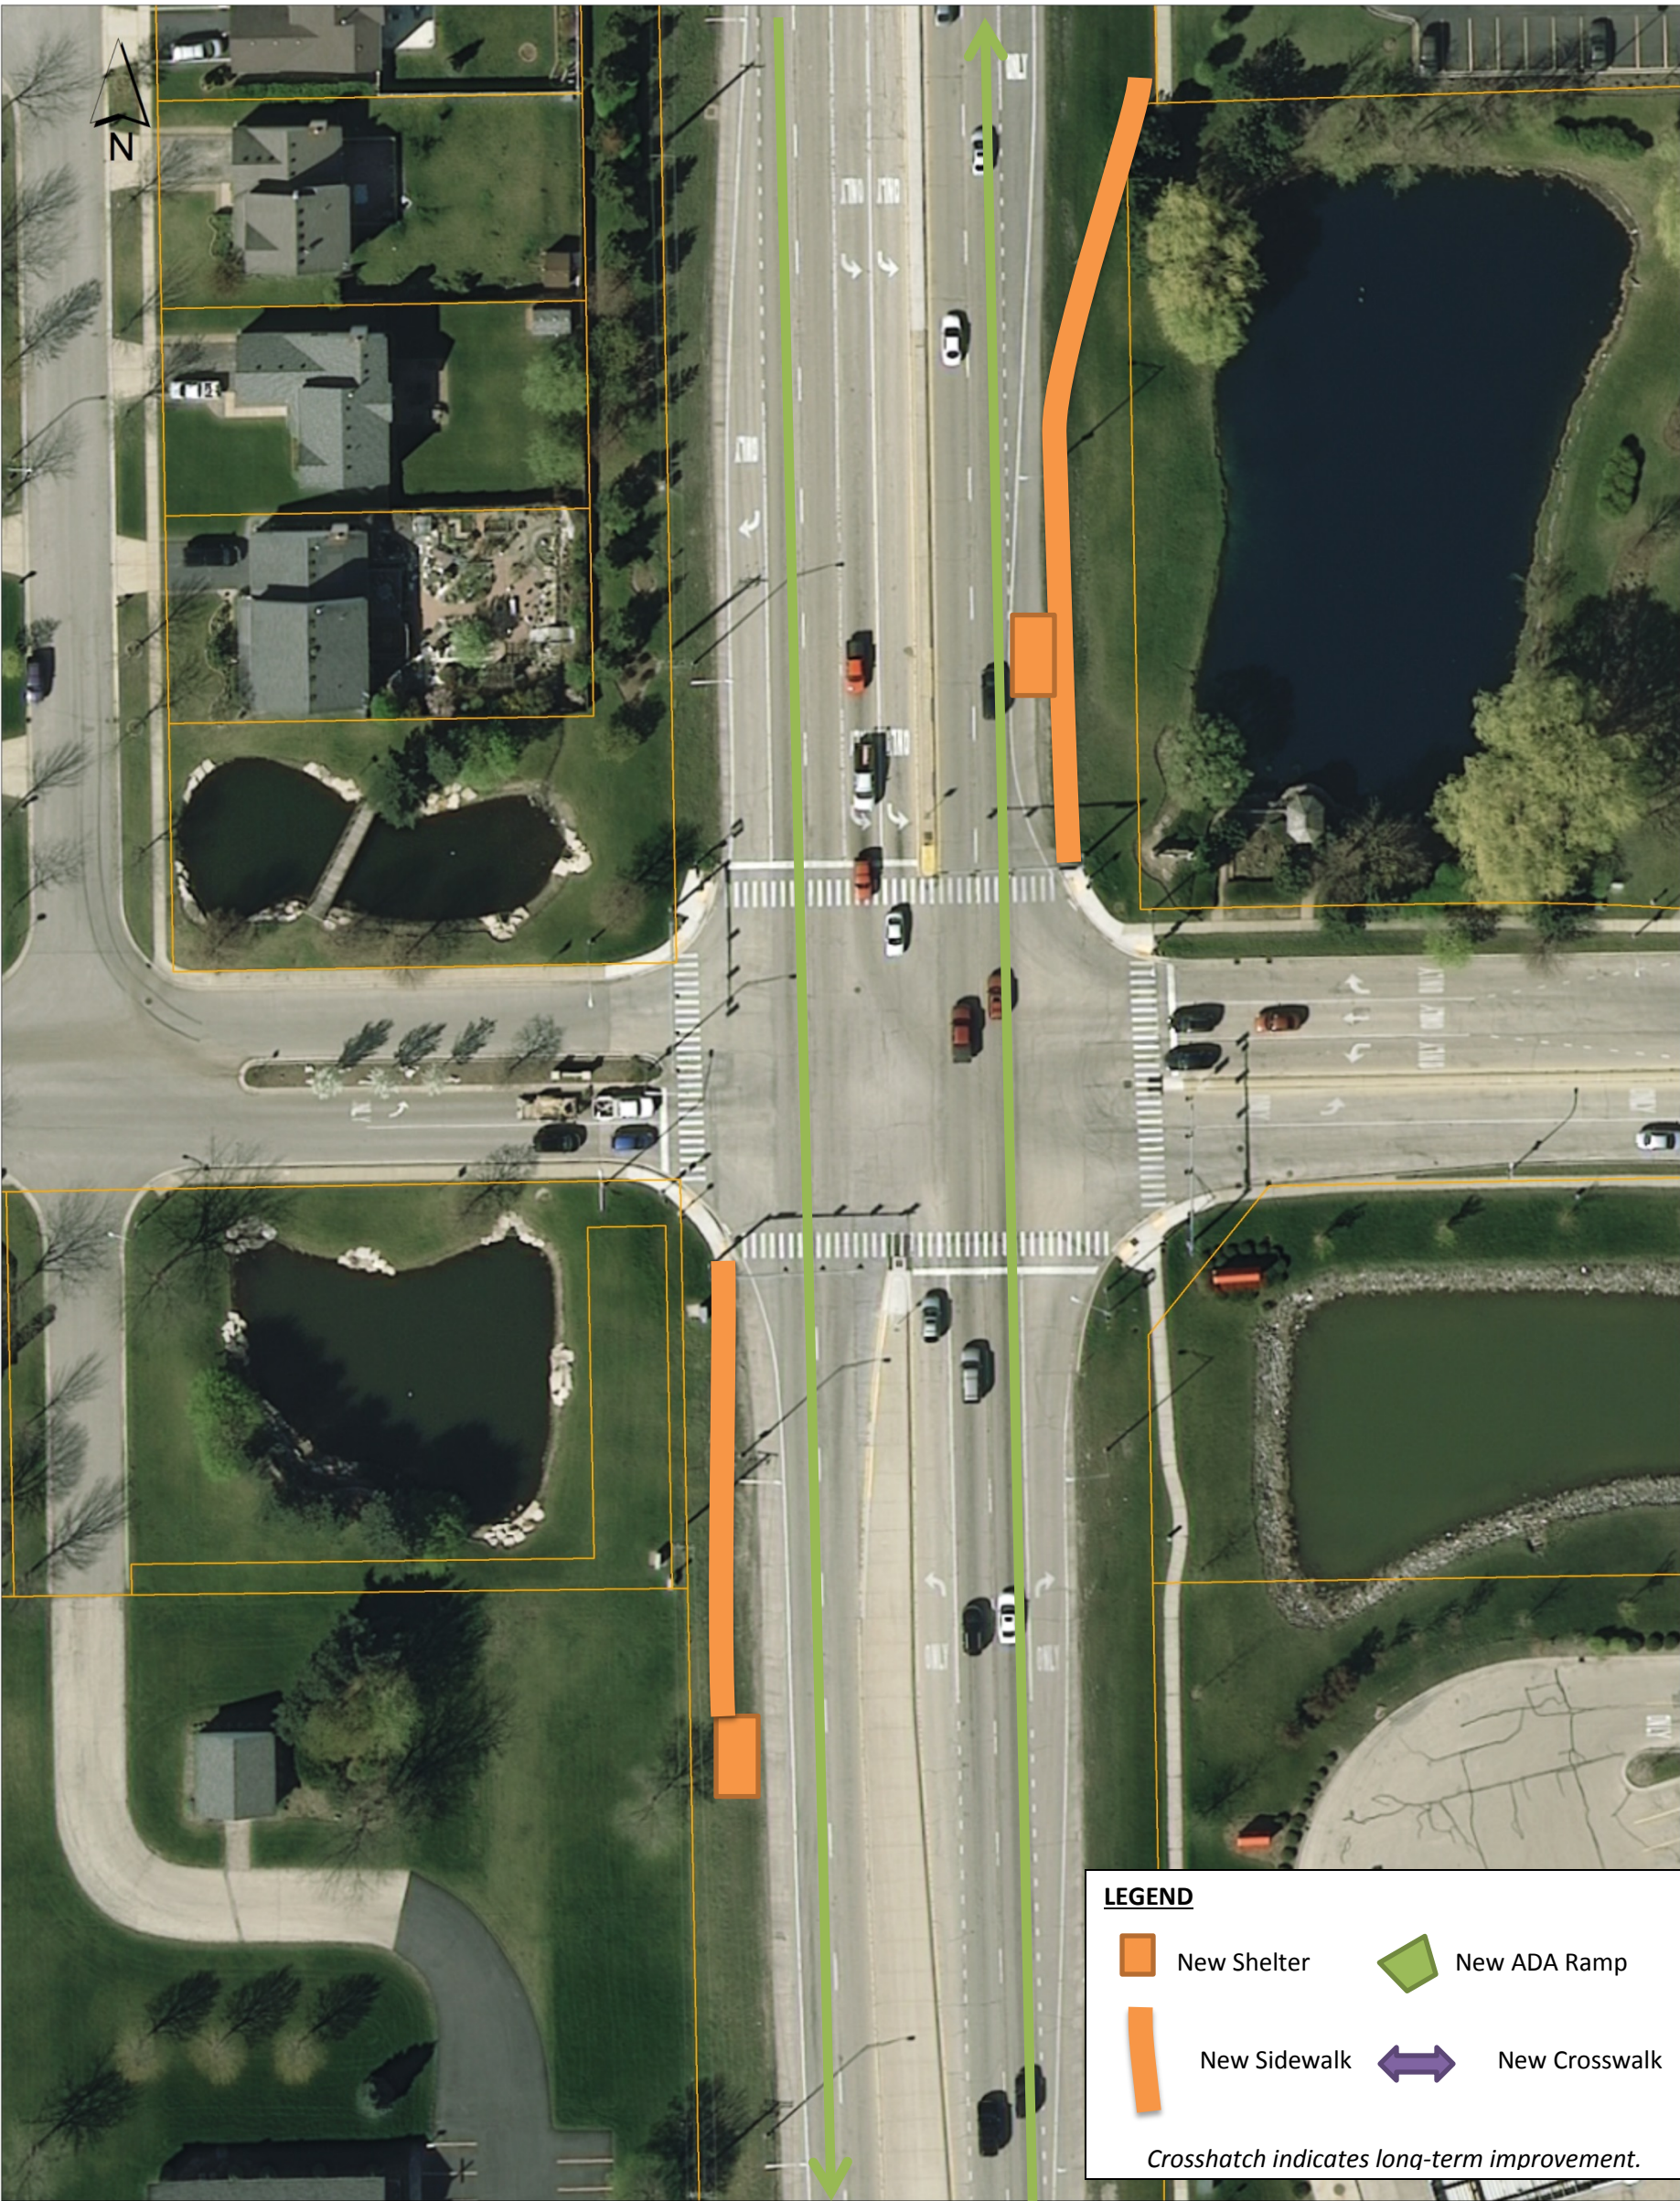
Randall Road at College Green Road
(Pace Route 549)

Existing Conditions	NE	NW	SW	SE	Notes: Full improved intersection with ramps and crosswalks at all four legs. Opportunity to connect sidewalk segments to complete access along this side of the street.
Pedestrian signals	Yes	Yes	Yes	Yes	
ADA ramps	Yes	Yes	Yes	Yes	
Crosswalk	Yes	Yes	Yes	Yes	
Shelter	No	No	No	No	No boardings No lightings
Additional sidewalk needed	300 LF	No	100 LF	No

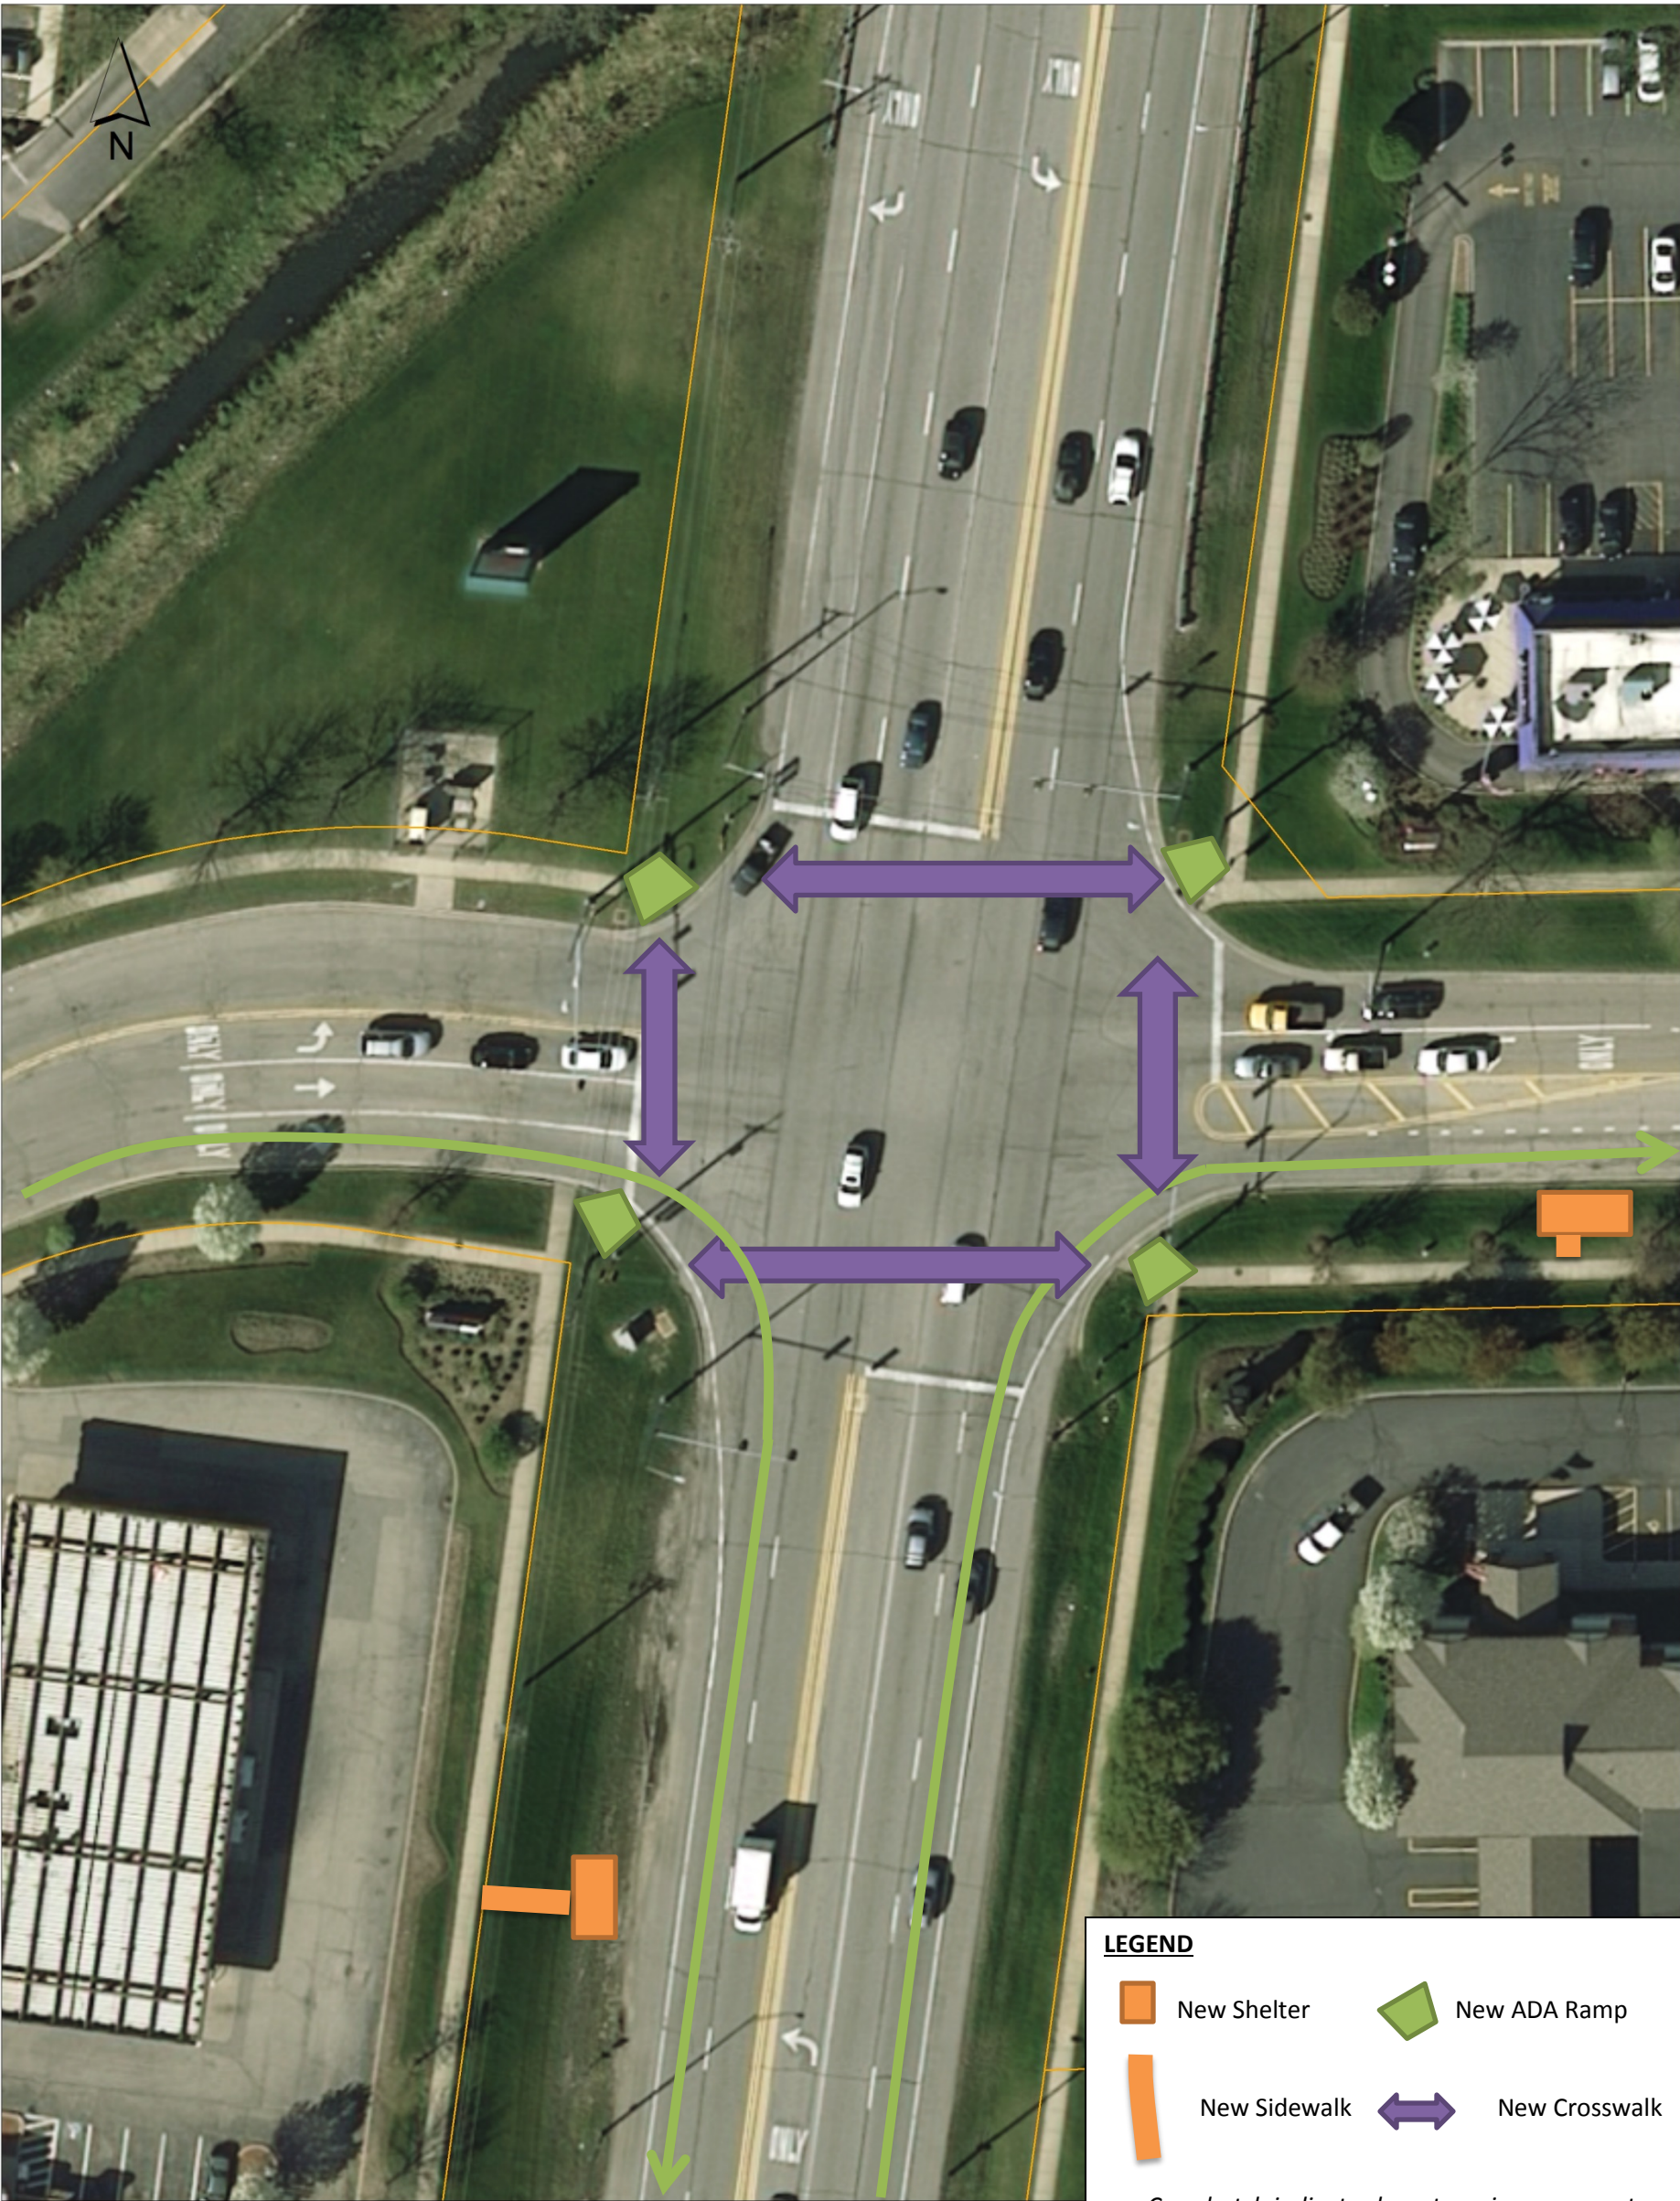
Randall Road at South Street
(Pace Route 549)

Existing Conditions	NE	NW	SW	SE	Notes: Northbound bus turns right to head east on South Street. Possible shelter location. Southbound bus makes a right turn out of Otter Creek Shopping Center, shelter could provide additional boarding location instead of walking through the shopping center to Target stop. No boardings No alightings
Pedestrian signals	No	No	No	No	
ADA ramps	No	No	No	No	
Crosswalk	No	No	No	No	
Shelter	No	No	No	No	
Additional sidewalk needed	No	No	25 LF	25 LF

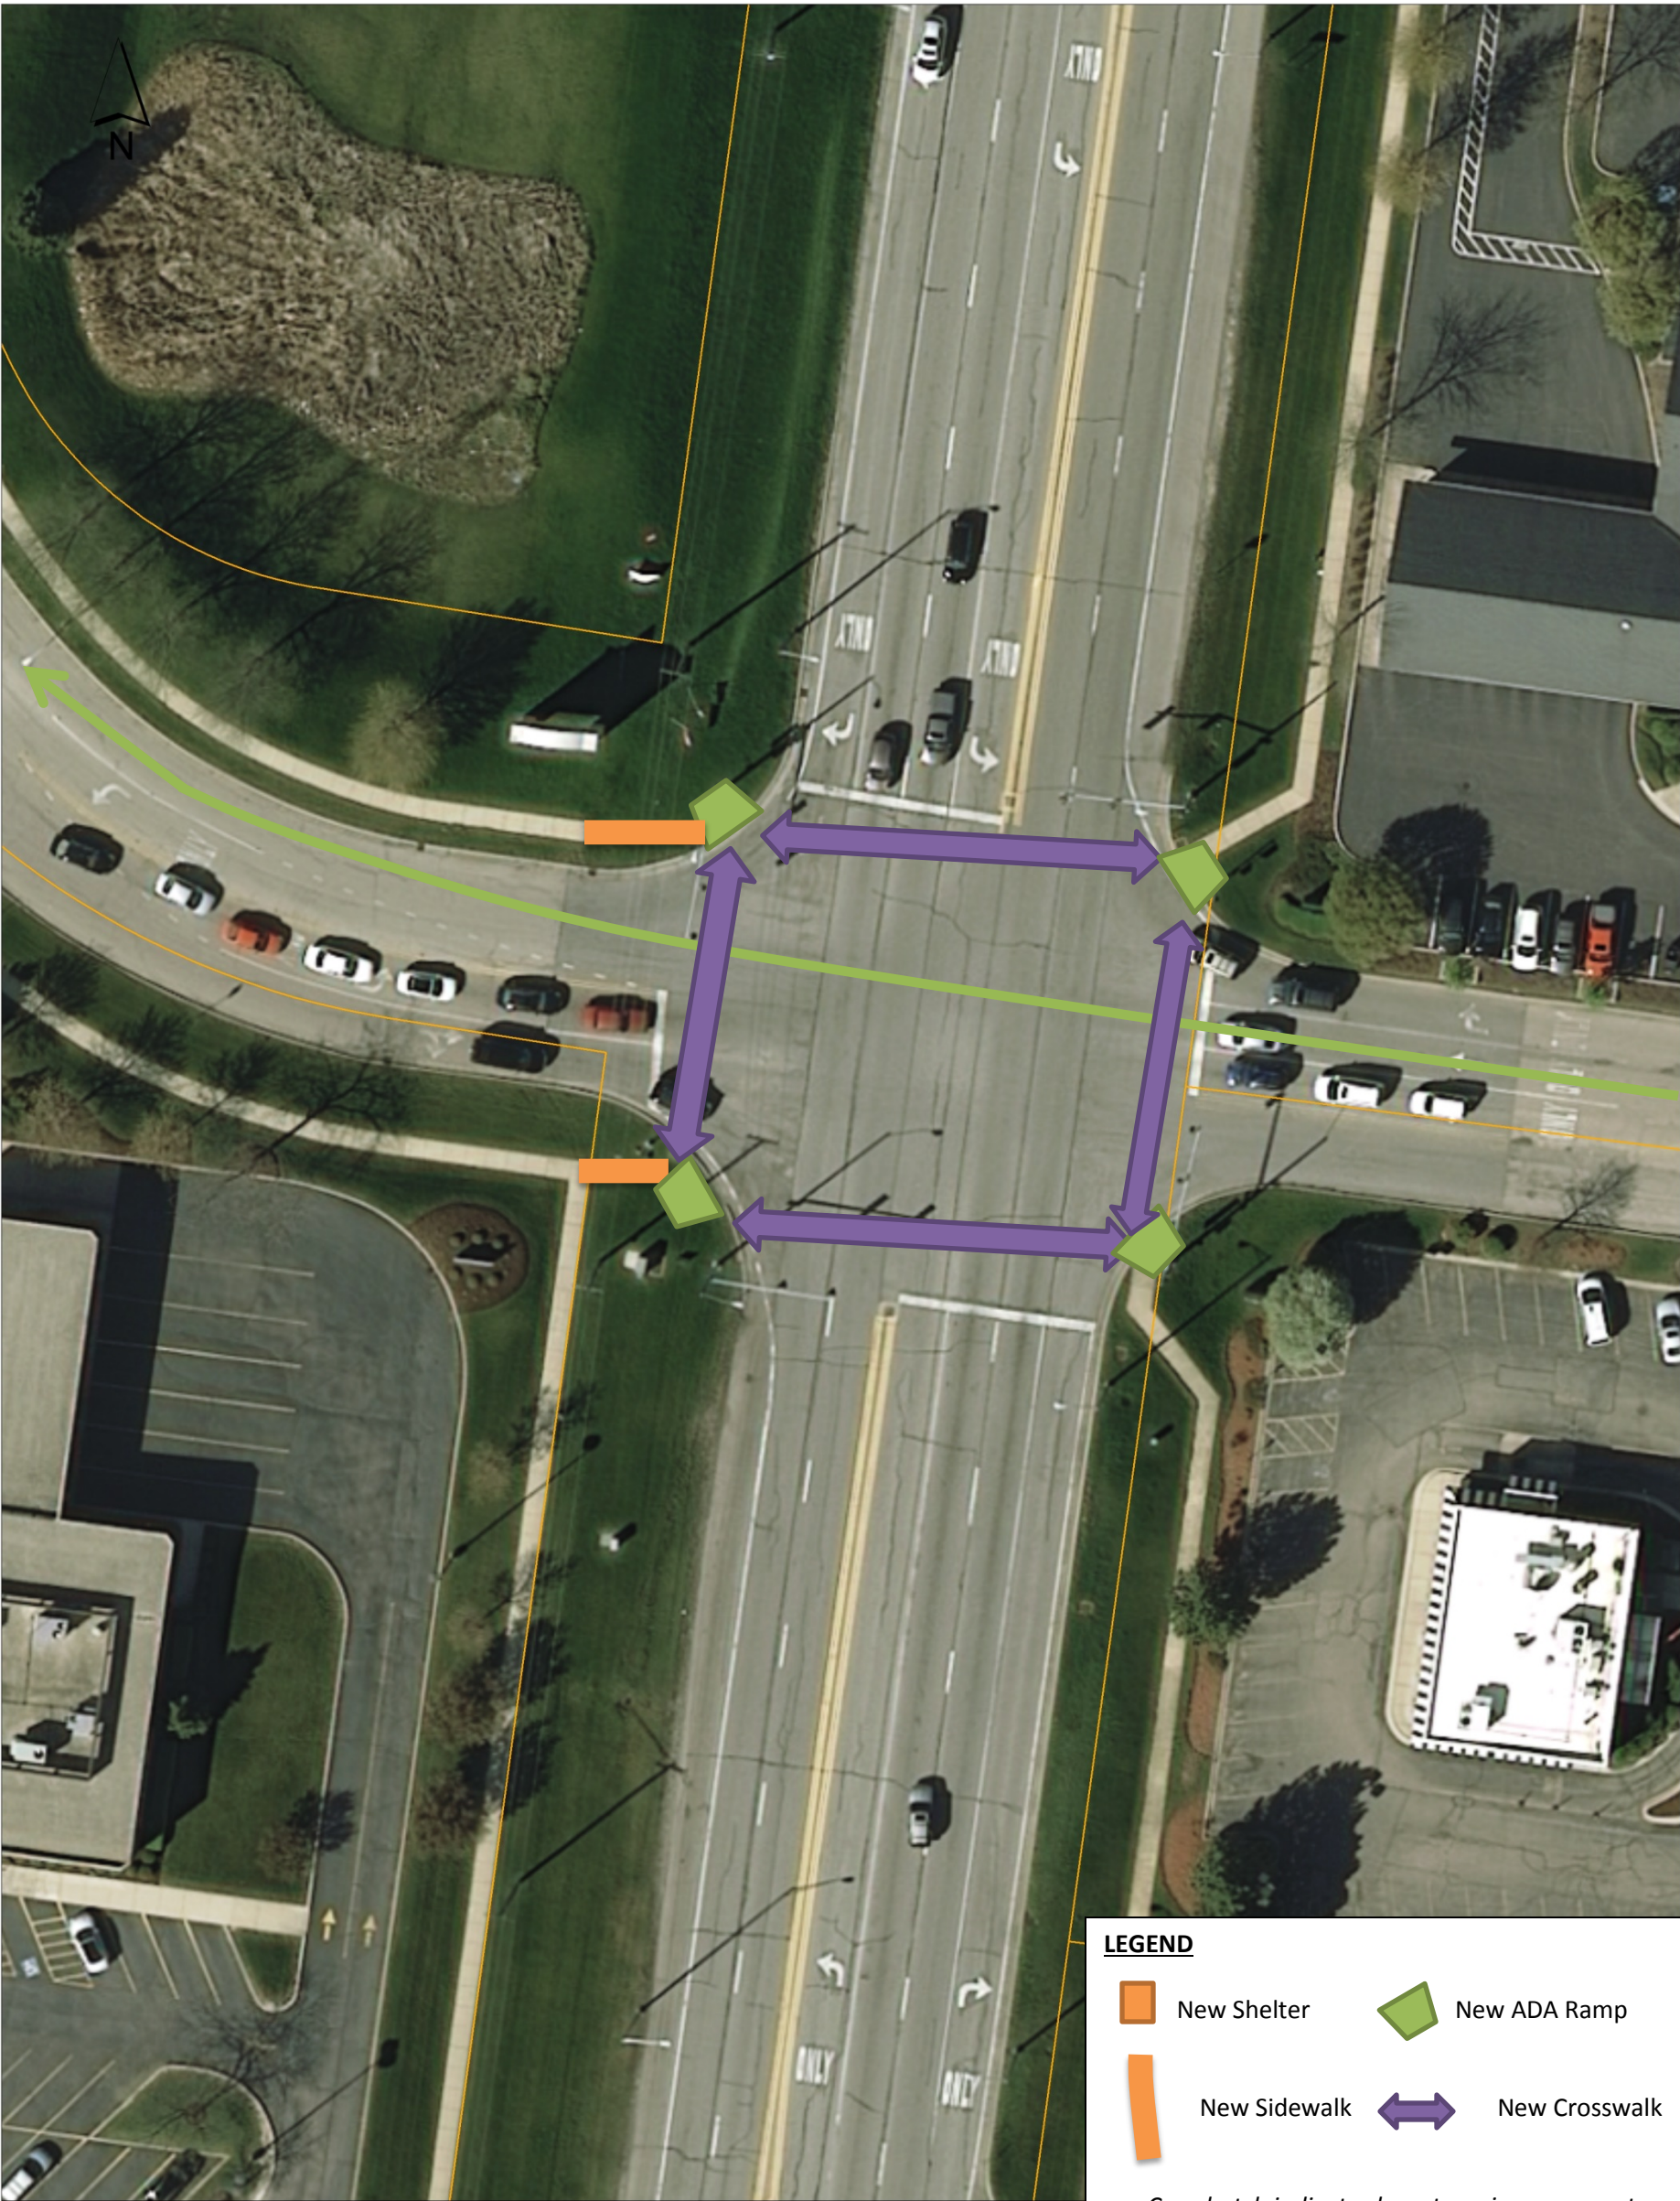
Randall Road at Weld Road
(Pace Route 549)

Existing Conditions	NE	NW	SW	SE	Notes: 4 boardings 1 alighting
Pedestrian signals	No	No	No	No	
ADA ramps	No	No	No	No	
Crosswalk	No	No	No	No	
Shelter	No	No	No	No	
Additional sidewalk needed	No	10 LF	10 LF	No
