**2018 QBS  
Request for Statement of Interest (SOI)  
Kane County Division of Transportation (KDOT)  
2019 Structure Inspections  
Section Number 18-00501-00-EG**

# Bridge Inspection Report

## STRUCTURE NO. 045-3166

Stearns Road / FAP 361 over Fox River

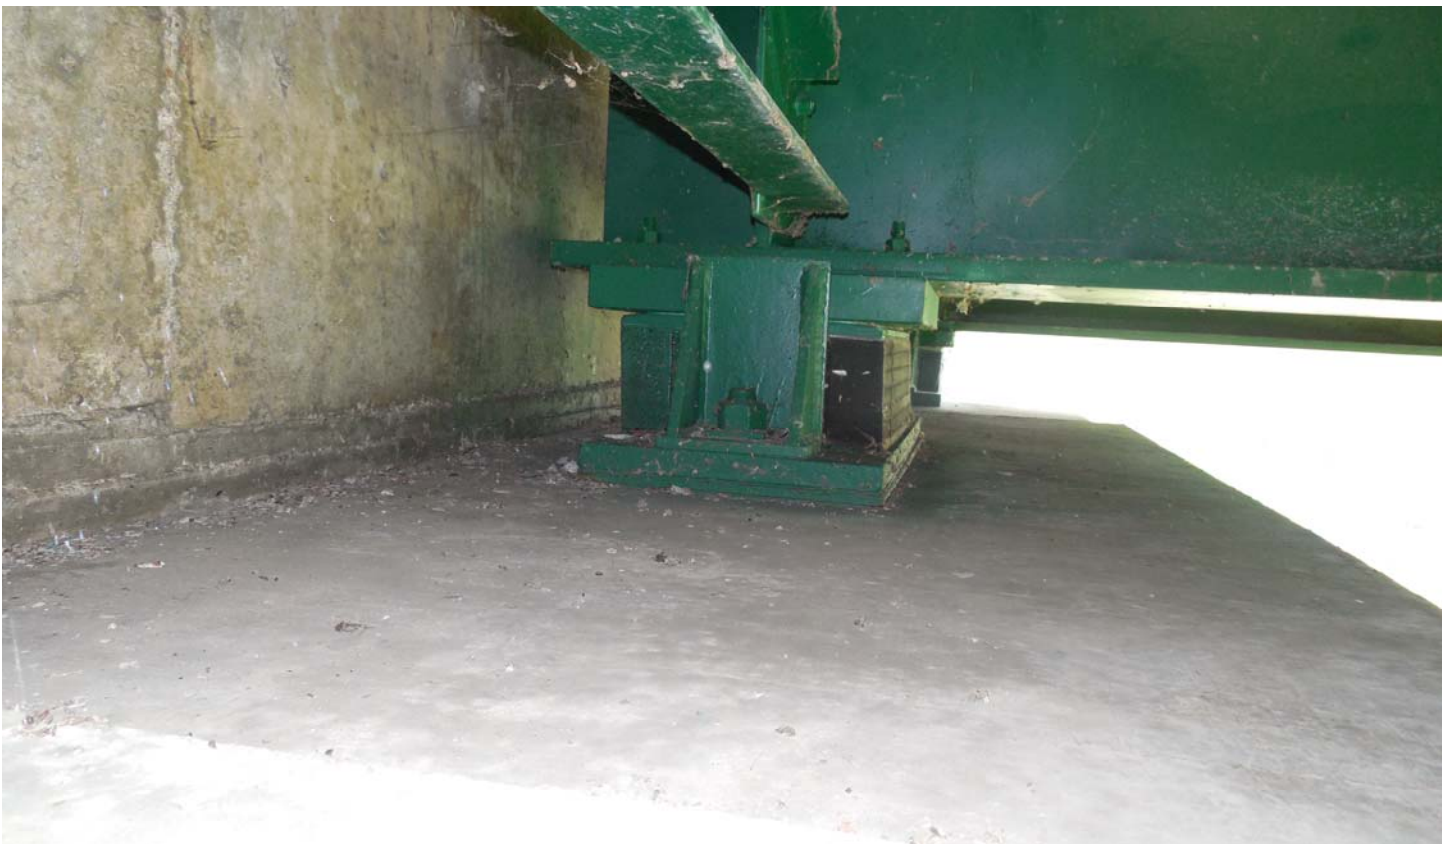
- Type II elastomeric expansion bearings at the west abutment. (See Photo Nos. 45 & 46).
- Type III elastomeric expansion bearings at the east abutment. (See Photo No. 69).
- Fixed bearings at Pier 2. (See Photo No. 2).
- Guided expansion bearings at Piers 1, 3, & 4. (See Photo Nos. 6, 12, 34,

Photo 45 - Bearing at the West Abutment
