2019 QBS
Request for Statement of Interest (SOI)
Kane County Division of Transportation (KDOT)
Harter Road Culvert Replacement
Section Number 19-00509-00-BR

Bridge Inspection Report

Harter Road Culvert

INSPECTION TYPE: Routine
DATE: May 24th, 2017

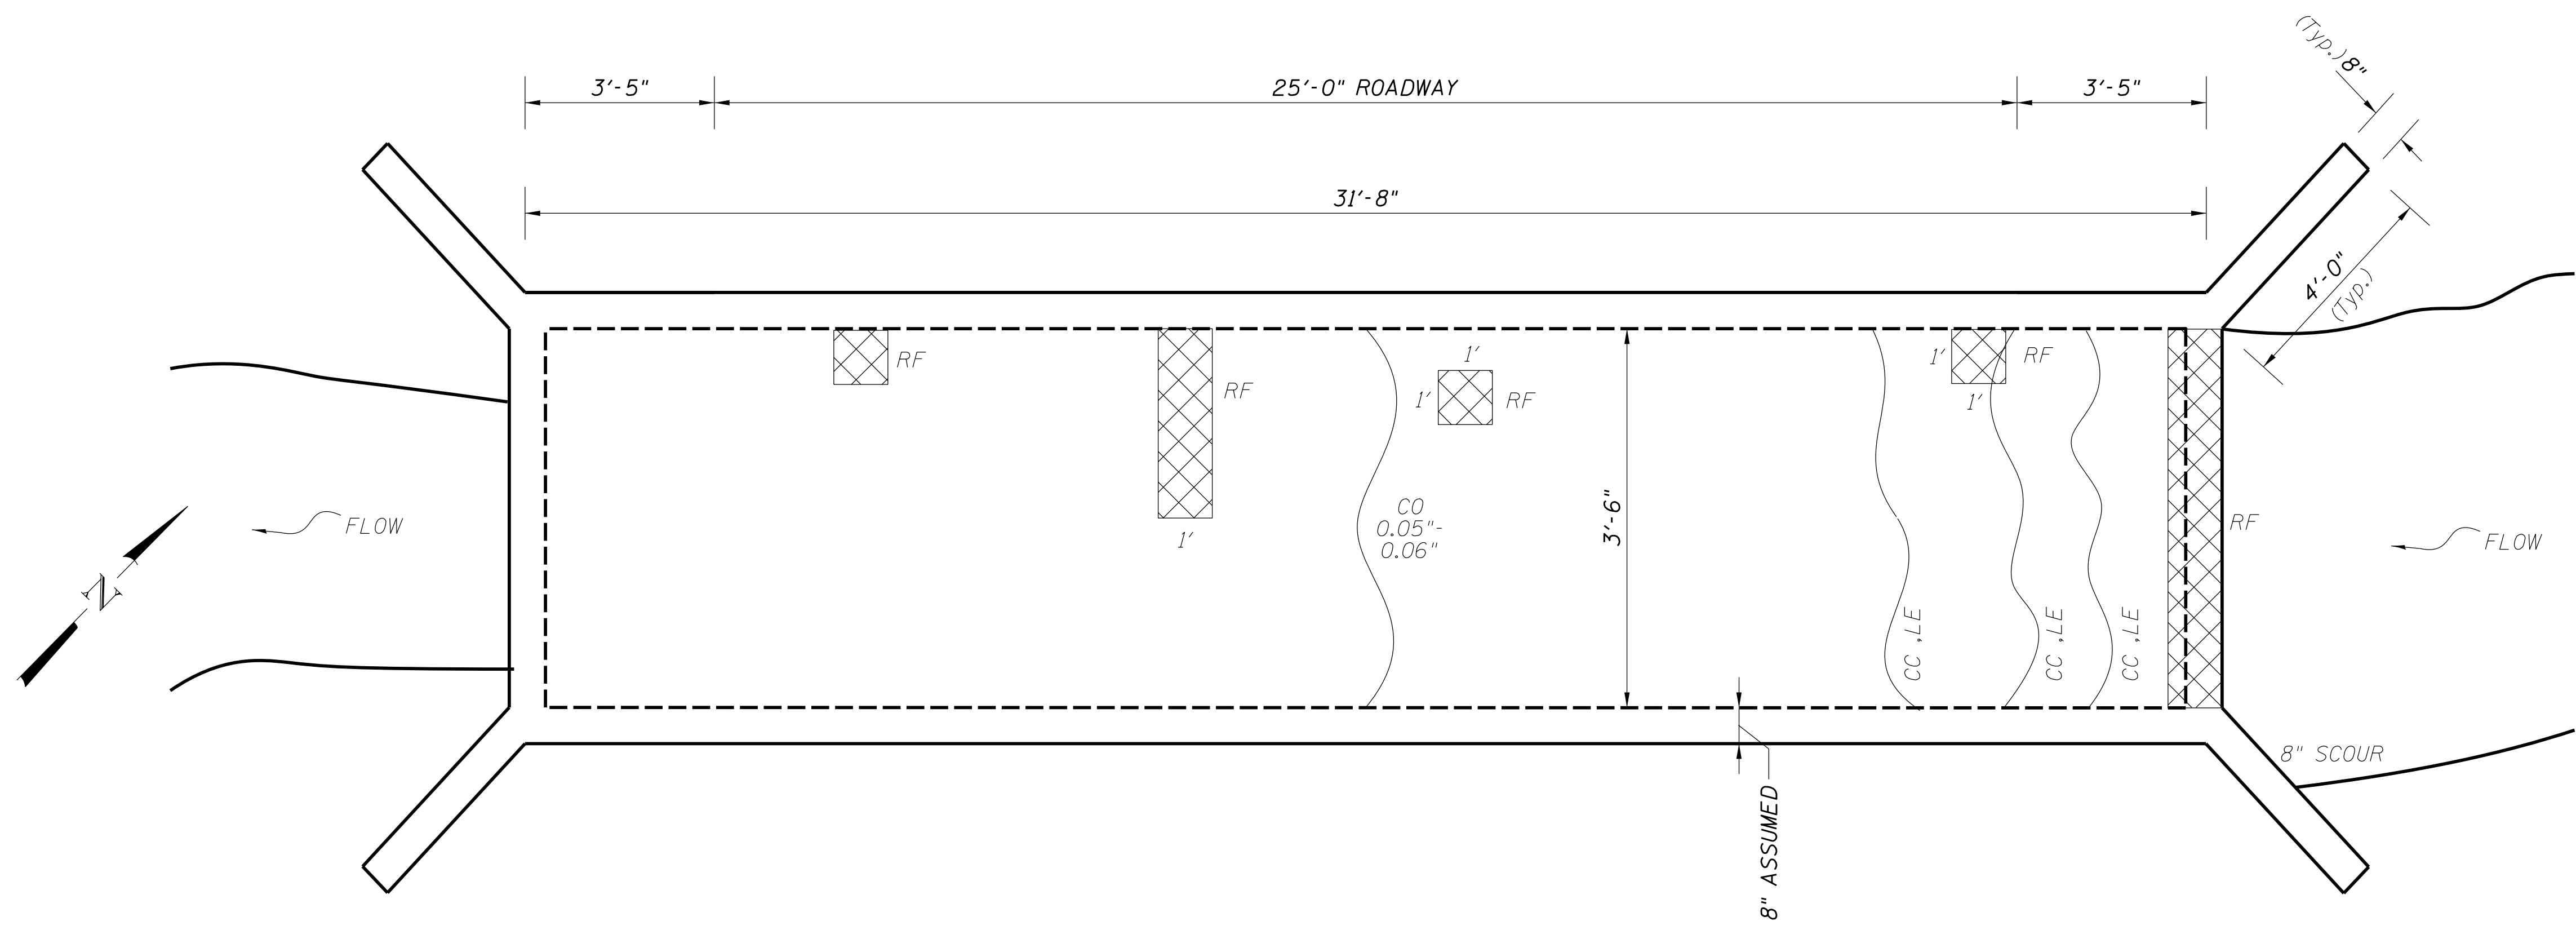
TOP SLAB-REFLECTED

The top slab is in overall **Poor** condition.

- There is a 0.05-0.06 inch wide cracking along the middle of the culvert.

- At the north end of the culvert, a 1 foot spall across the culvert exists with exposed and dangling reinforcement. (See Photo Nos. 15 & 16)
- Multiple spalls with exposed reinforcement and delaminated areas exist throughout the top slab. (See Photo Nos. 10 and 14)
- Minor cracking with efflorescence exists in the northernmost 10'. (See Photo No. 14)

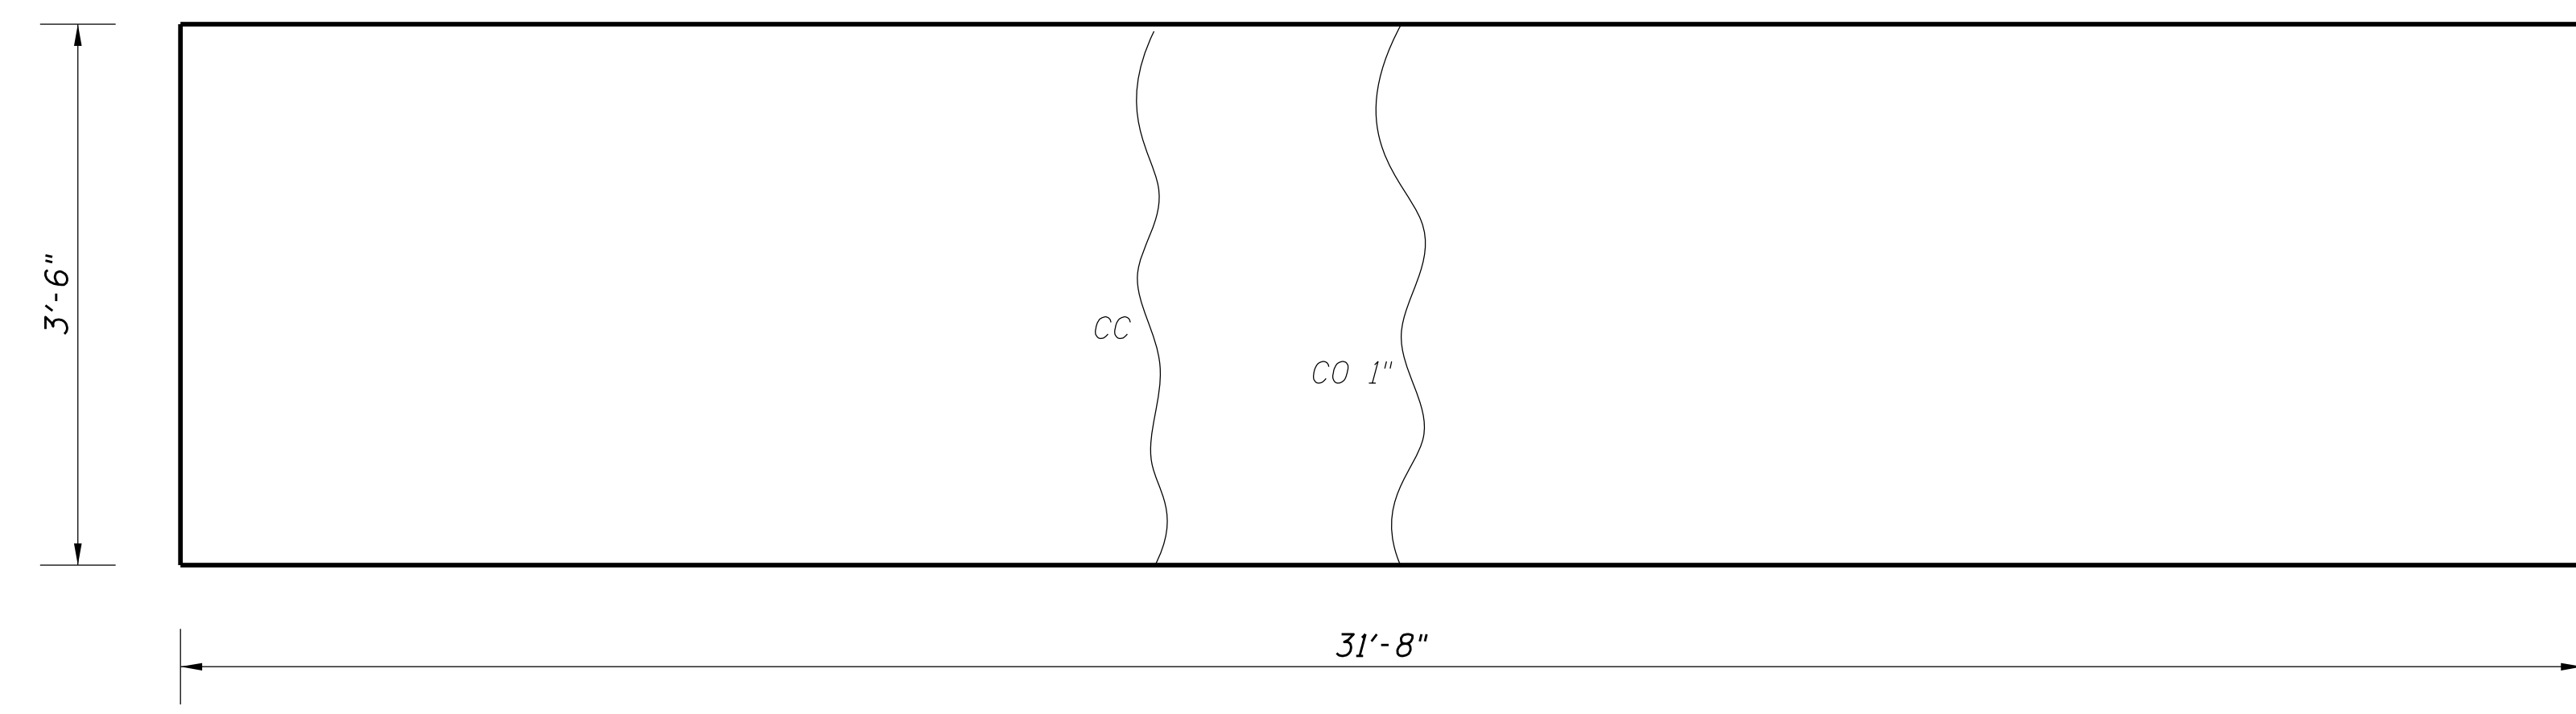
BOTTOM SLAB

The bottom of the culvert is in **Poor** condition.

- At the center of the culvert, there is a 1" crack.

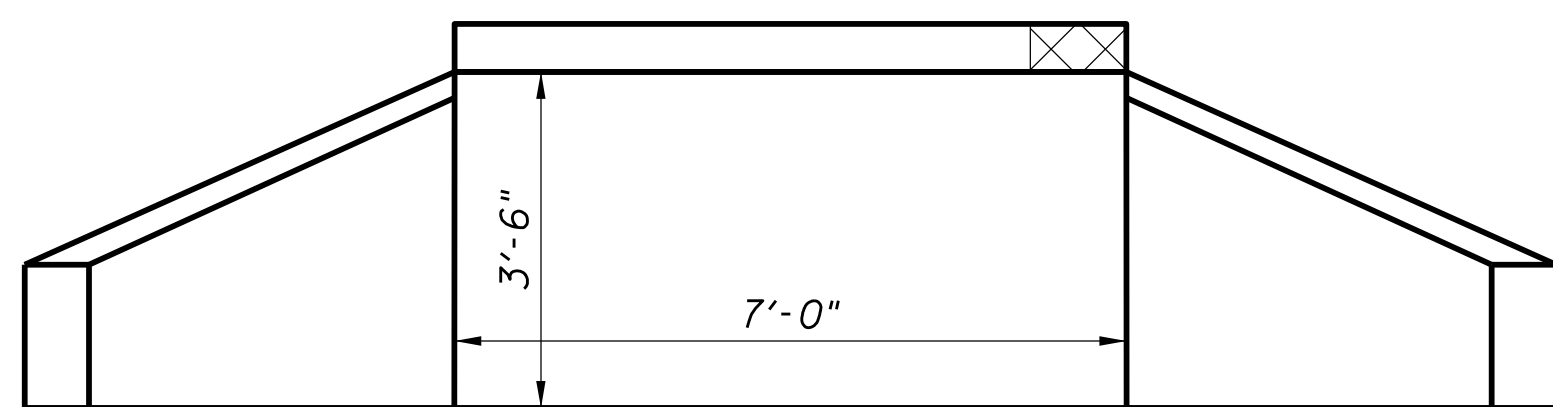
SOUTH ELEVATION

- There is a 6 inch by 12 inch spall on the south headwall at the southeast corner.
- Minor cracks with efflorescence are present on the north wing walls with a spalling on the north headwall. (See Photo No. 1)
