**2018 QBS  
Request for Statement of Interest (SOI)  
Kane County Division of Transportation (KDOT)  
2019 Structure Inspections  
Section Number 18-00501-00-EG**

# Bridge Inspection Report

## STRUCTURE NO. 045-3166

Stearns Road / FAP 361 over Fox River

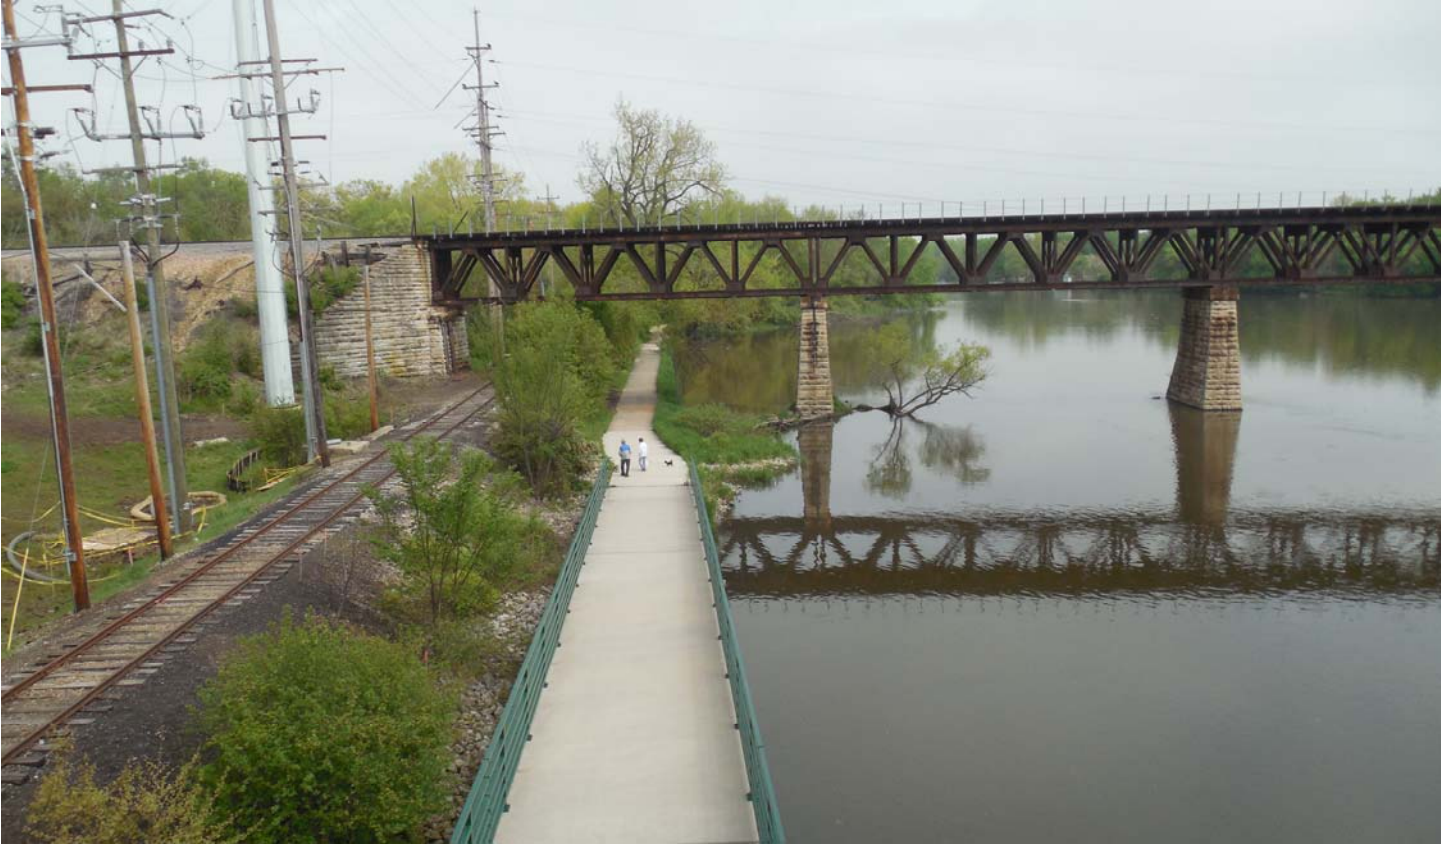
- The 1<sup>st</sup> and 2<sup>nd</sup> bays from each fascia carry conduits for the full length of the structure.
- Electrical utility lines parallel the railroad track beneath span 1. (See Photo No. 28).
- Decorative light standards are mounted north and south of the bridge on the parapet fascia above each pier location.

Photo 28 - Track and Power Lines in Span 2

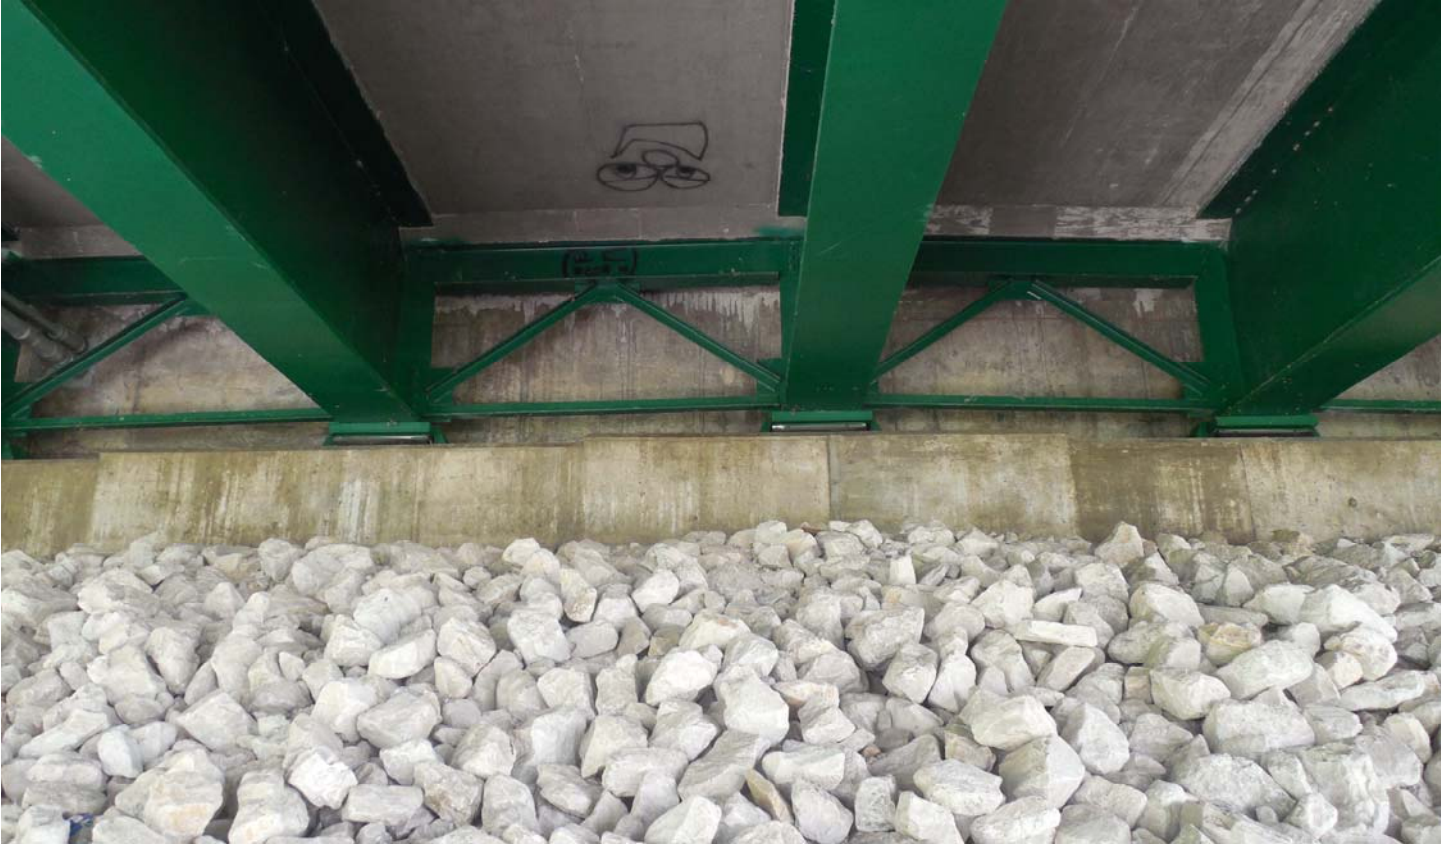
- Type II elastomeric expansion bearings at the west abutment. (See Photo Nos. 45 & 46).
- Type III elastomeric expansion bearings at the east abutment. (See Photo No. 69).
- Fixed bearings at Pier 2. (See Photo No. 2).
- Guided expansion bearings at Piers 1, 3, & 4. (See Photo Nos. 6, 12, 34,

Photo 46 - Bearing at the West Abutment
